Structural Strength Degradation of Oil and Gas Refinery Equipment. Case Study: Heat Exchanger Tubes of Hydrocarbon Vapor

Amin Suhadi^{1,*}, Adimas Aprilio¹ and Eka Febriyanti¹

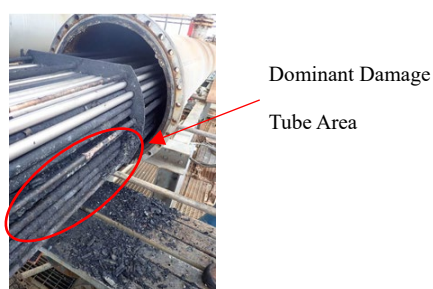
Fig. 2: Location of leaked tubes on bottom part of tube bundle as shown in red circle in Fig.1.

The deposits covered almost the whole outside surface of tubes, especially on the bottom part of the heat exchanger with different quantities as seen in Fig.2. Energy Dispersive Spectroscopy (EDS) analysis confirmed that the deposits were primarily composed of corrosion products of Cu-Ni alloy elements, including carbon, oxygen, and sulphur^{2,21-26)}. The detailed results are presented in Fig. 6-7 and Table 3.

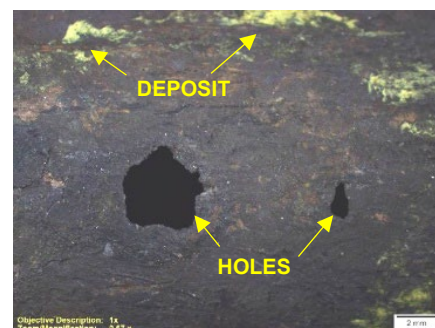
Visual and macrographic examinations yielded valuable insights. Tube E-2-10 displayed holes and wall thinning (Fig.3), with the initiation of wall thinning identified on the inner surface of the tube, propagating outward to eventually cause leakage (Fig.4). Additionally, black and green deposits were found around the hole area.

Fig. 3: Holes that were found on the leakage area of tube E-2-10. This area was covered by black and green deposits.

To mitigate the effects of wall thinning, it is strongly recommended that maintenance of the heat exchanger be performed routinely in accordance with established standard operational procedures. Additionally, if feasible, the use of chemical inhibitors for corrosion prevention should be considered.

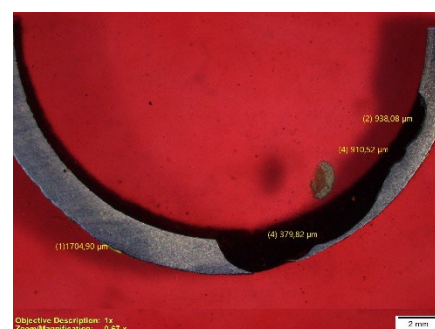
Fig. 4: Cross section of holes area showing wall thinning which initiated from the inner surface of the tube.

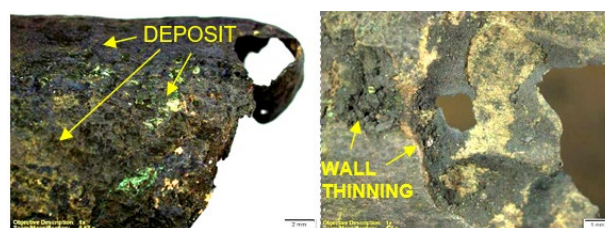
Tube E-2-11 exhibited similar deposit-related issues, with black and green deposits covering a larger area and more severe wall thinning compared to E-2-10 (Fig.5).

Fig. 5: The failure area of tube E-2-11 was covered by black and green deposits, while wall thinning was also found in this area.

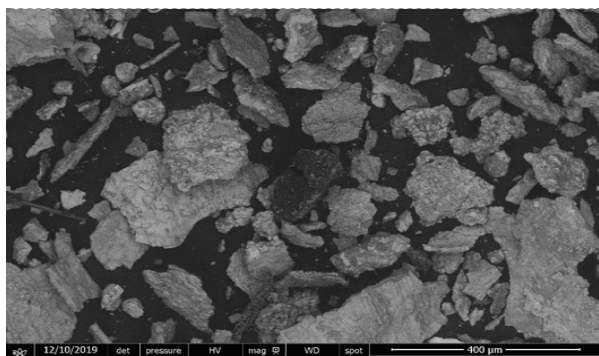
Fig. 6: SEM analysis result on flakes of outside tube deposit.

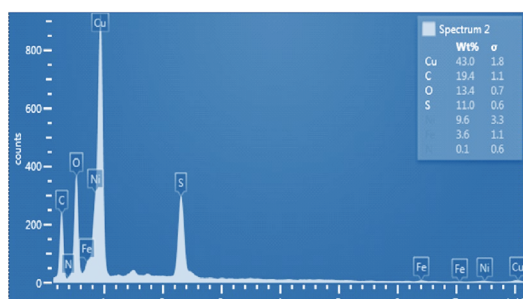
Fig. 7: Spectrum of EDS on flakes of outside tube deposit

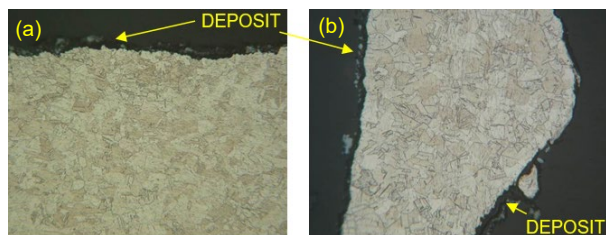
Metallographic examination results indicated that both tubes exhibited a Cu single-phase α microstructure, typical of Cu-Ni alloys^{7,11,15}. No indications of microcracks or other manufacturing defects were found in the microstructure, ruling out these factors as contributors to the initial leakage. However, material degradation was evident, as indicated by the presence of deposits on either the inner or outer surface of the base metal. These deposits cut trans-granularly across the grain of the microstructure, separating from the base metal and causing wall thinning (Fig.8). The presence of deposits on the surface resulted from a continuous reaction between the base metal and the surrounding atmosphere or media which made direct contact with the surface of metal²⁷⁻²⁹. This reaction produced deposits as it progressed during operation¹⁹⁻²¹.

Fig. 8: (a) Microstructure of tube consist of Cu single phase α , (b) deposit on the inner and outer surface.

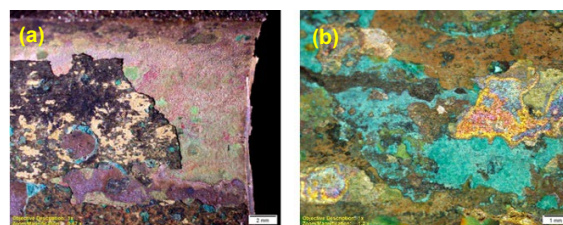
Fig. 9: (a) Transformation of a passive layer to different levels of patina, (b) permanent patina is formed and identified with tosca color.
