Structural Strength Degradation of Oil and Gas Refinery Equipment. Case Study: Heat Exchanger Tubes of Hydrocarbon Vapor

This research focuses on the study of strength degradation in heat exchanger tubes that failed during operation in an Indonesian oil refinery unit. Heat exchangers play a critical role in transferring heat between a source and a working fluid to achieve the desired temperature, serving in both cooling and heating processes. As a result, factors such as pressure, temperature, and environmental considerations like corrosion and oxidation are implicated in strength degradation⁷⁻¹¹. The investigation found that two heat exchanger tubes had leaked, rendering them inoperative and necessitating the shutdown of the entire system. Historical data indicates that these tubes had been in operation for six years prior to the leakage.

The specimens used for examination in this research were extracted from two heat exchanger tubes that had experienced leakage. These specimens were sourced from an oil refinery in Indonesia and were assigned specimen codes E-2-10 and E-2-11. These tubes were located in the lower section of the heat exchanger, as illustrated in Figures 1 and 2.

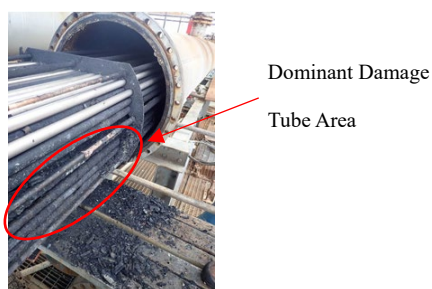
Fig. 2: Location of leaked tubes on bottom part of tube bundle as shown in red circle in Fig.1.

The deposits covered almost the whole outside surface of tubes, especially on the bottom part of the heat exchanger with different quantities as seen in Fig.2. Energy Dispersive Spectroscopy (EDS) analysis confirmed that the deposits were primarily composed of corrosion products of Cu-Ni alloy elements, including carbon, oxygen, and sulphur^{2,21-26)}. The detailed results are presented in Fig. 6-7 and Table 3.

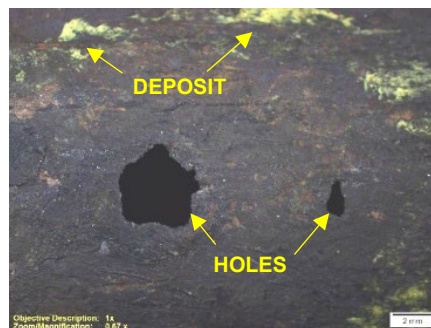
Visual and macrographic examinations yielded valuable insights. Tube E-2-10 displayed holes and wall thinning (Fig.3), with the initiation of wall thinning identified on the inner surface of the tube, propagating outward to eventually cause leakage (Fig.4). Additionally, black and green deposits were found around the hole area.

Fig. 3: Holes that were found on the leakage area of tube E-2-10. This area was covered by black and green deposits.

From this analysis, it becomes evident that the primary cause of leakage is the presence of sulphur (S) from seawater and carbon from hydrocarbon vapor. This combination leads to deposit formation, followed by corrosion reactions and subsequent wall thinning. Notably, the typical hole shape of the leakage provides no indication or evidence that it is caused by operational pressure or temperature.

To mitigate the effects of wall thinning, it is strongly recommended that maintenance of the heat exchanger be performed routinely in accordance with established standard operational procedures. Additionally, if feasible, the use of chemical inhibitors for corrosion prevention should be considered.

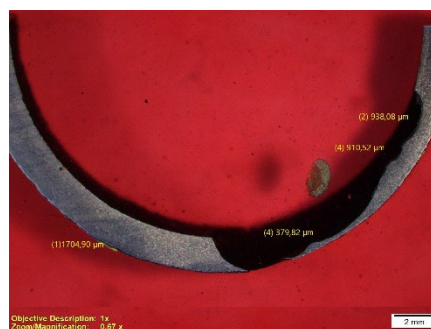
Fig. 4: Cross section of holes area showing wall thinning which initiated from the inner surface of the tube.

The main cause of leakage in both tubes, E-2-10 and E-2-11, was found to be similar: it initiated with the formation of deposits and was followed by wall thinning and eventual leakage. The rate of wall thinning was dependent on the reactivity of the element connected with the base metal in a specific area and the thickness of deposits. This rate of wall thinning aligned with the likelihood of leakage²⁷⁻²⁹. Copper-based alloys typically form a passive layer, Cu_2O , in brown color on the surface. When this passive layer is removed, the metal surface makes direct contact with corrosive elements, leading to corrosion and the formation of corrosion products referred to as patina. Patina is characterized by various colors, with a typical patina being greenish-blue (tosca)^{21,22}. The transformation process from passive layer Cu_2O to patina was visually evident by the change in color on the surface of the tubes, ranging from light red to pink, orange, blue, green, and purple, with permanent patina typically appearing greenish-blue (tosca), as observed in Fig. 9. The reaction of Cu base alloy with reactive elements like oxygen, carbon and sulphur can be accelerated with the presence of chlorine (Cl) to form a patina. In this research, chlorine was introduced through contact with seawater^{12,21}. Chlorine reacted with copper base alloy to form atacamite ($\text{Cu}_2(\text{OH})_3\text{Cl}$), which is a form of green-colored patina called hydroxychloride. Additionally, high humidity in the heat exchanger, caused by the presence of seawater inside the tube and hydrocarbon vapor outside, accelerated the corrosion rate of the tubes.

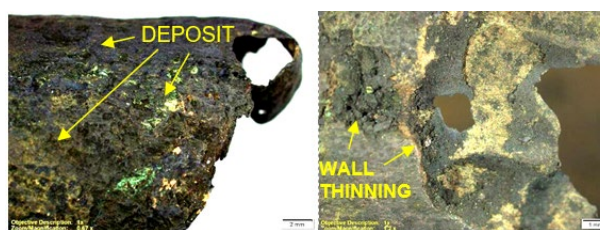
Tube E-2-11 exhibited similar deposit-related issues, with black and green deposits covering a larger area and more severe wall thinning compared to E-2-10 (Fig.5).

Fig. 5: The failure area of tube E-2-11 was covered by black and green deposits, while wall thinning was also found in this area.

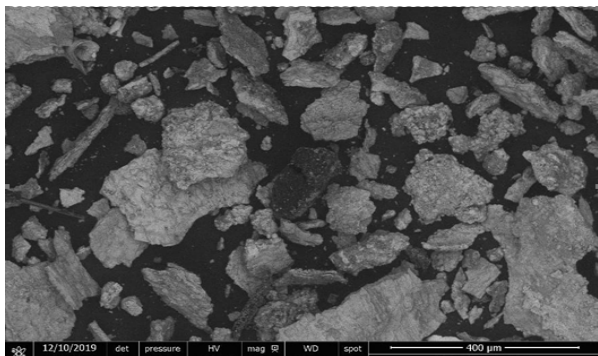
Fig. 6: SEM analysis result on flakes of outside tube deposit.

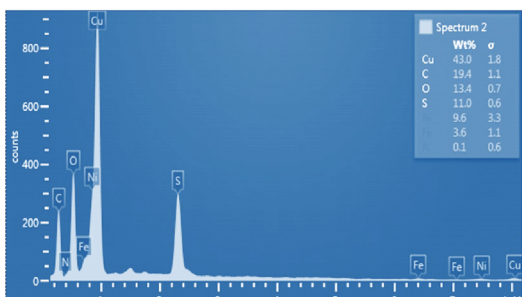
Fig. 7: Spectrum of EDS on flakes of outside tube deposit

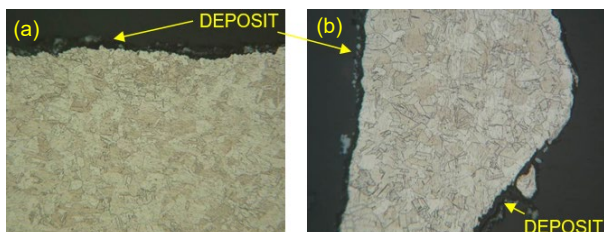
Metallographic examination results indicated that both tubes exhibited a Cu single-phase α microstructure, typical of Cu-Ni alloys^{7,11,15}. No indications of microcracks or other manufacturing defects were found in the microstructure, ruling out these factors as contributors to the initial leakage. However, material degradation was evident, as indicated by the presence of deposits on either the inner or outer surface of the base metal. These deposits cut trans-granularly across the grain of the microstructure, separating from the base metal and causing wall thinning (Fig.8). The presence of deposits on the surface resulted from a continuous reaction between the base metal and the surrounding atmosphere or media which made direct contact with the surface of metal²⁷⁻²⁹. This reaction produced deposits as it progressed during operation¹⁹⁻²¹.

Fig. 8: (a) Microstructure of tube consist of Cu single phase α , (b) deposit on the inner and outer surface.

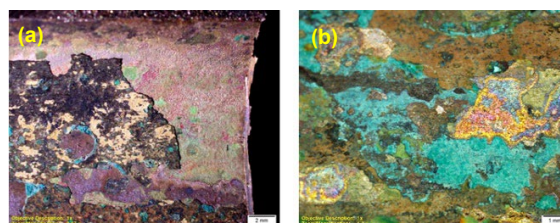
Fig. 9: (a) Transformation of a passive layer to different levels of patina, (b) permanent patina is formed and identified with toska color.
