# Structural Strength Degradation of Oil and Gas Refinery Equipment. Case Study: Heat Exchanger Tubes of Hydrocarbon Vapor

The specimens used for examination in this research were extracted from two heat exchanger tubes that had experienced leakage. These specimens were sourced from an oil refinery in Indonesia and were assigned specimen codes E-2-10 and E-2-11. These tubes were located in the lower section of the heat exchanger, as illustrated in Figures 1 and 2.

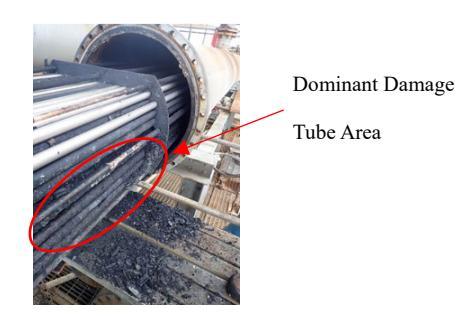
Fig. 2: Location of leaked tubes on bottom part of tube bundle as shown in red circle in Fig.1.

The deposits covered almost the whole outside surface of tubes, especially on the bottom part of the heat exchanger with different quantities as seen in Fig.2. Energy Dispersive Spectroscopy (EDS) analysis confirmed that the deposits were primarily composed of corrosion products of Cu-Ni alloy elements, including carbon, oxygen, and sulphur<sup>2,21-26)</sup>. The detailed results are presented in Fig. 6-7 and Table 3.

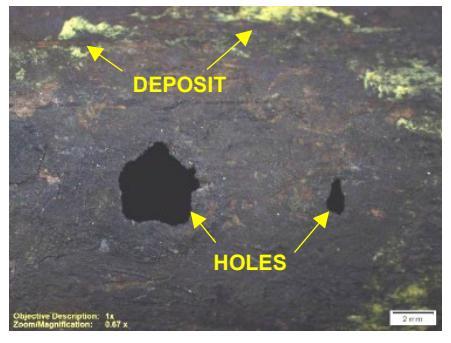
Visual and macrographic examinations yielded valuable insights. Tube E-2-10 displayed holes and wall thinning (Fig.3), with the initiation of wall thinning identified on the inner surface of the tube, propagating outward to eventually cause leakage (Fig.4). Additionally, black and green deposits were found around the hole area.

**Fig. 3:** Holes that were found on the leakage area of tube E-2-10. This area was covered by black and green deposits.

To mitigate the effects of wall thinning, it is strongly recommended that maintenance of the heat exchanger be performed routinely in accordance with established standard operational procedures. Additionally, if feasible, the use of chemical inhibitors for corrosion prevention should be considered.

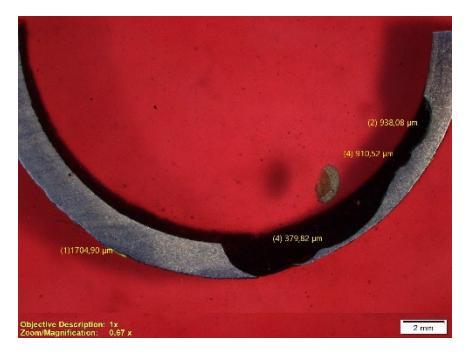
Fig. 4: Cross section of holes area showing wall thinning which initiated from the inner surface of the tube.

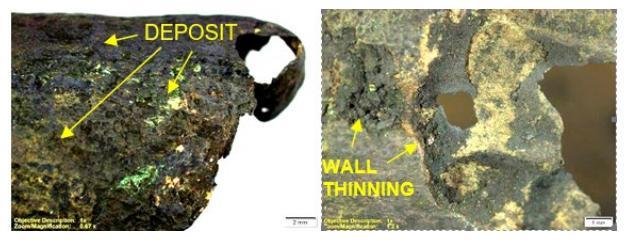
Tube E-2-11 exhibited similar deposit-related issues, with black and green deposits covering a larger area and more severe wall thinning compared to E-2-10 (Fig.5).

Fig. 5: The failure area of tube E-2-11 was covered by black and green deposits, while wall thinning was also found in this area.

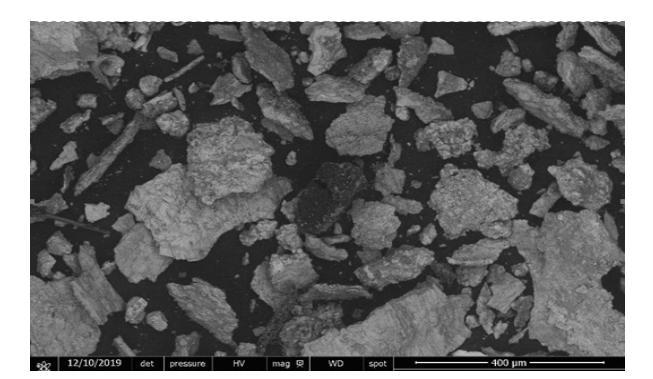
Fig. 6: SEM analysis result on flakes of outside tube deposit.

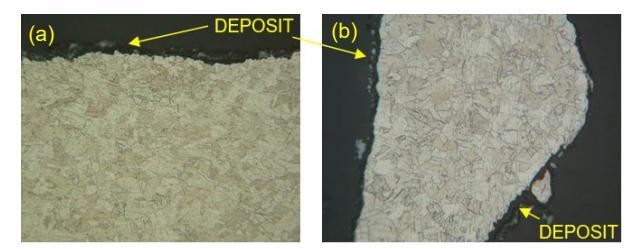
Metallographic examination results indicated that both tubes exhibited a Cu single-phase  $\alpha$  microstructure, typical of Cu-Ni alloys<sup>7,11,15</sup>. No indications of microcracks or other manufacturing defects were found in the microstructure, ruling out these factors as contributors to the initial leakage. However, material degradation was evident, as indicated by the presence of deposits on either the inner or outer surface of the base metal. These deposits cut trans-granularly across the grain of the microstructure, separating from the base metal and causing wall thinning (Fig.8). The presence of deposits on the surface resulted from a continuous reaction between the base metal and the surrounding atmosphere or media which made direct contact with the surface of metal<sup>27-29</sup>. This reaction produced deposits as it progressed during operation<sup>19-21</sup>.

Fig. 8: (a) Microstructure of tube consist of Cu single phase  $\alpha$ , (b) deposit on the inner and outer surface.

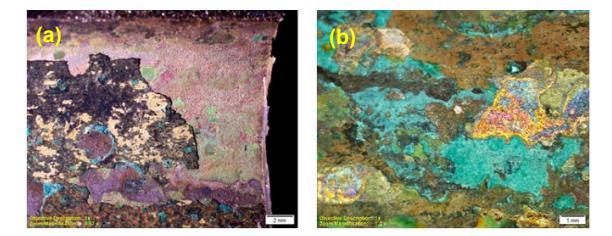
The main cause of leakage in both tubes, E-2-10 and E-2-11, was found to be similar: it initiated with the formation of deposits and was followed by wall thinning and eventual leakage. The rate of wall thinning was dependent on the reactivity of the element connected with the base metal in a specific area and the thickness of deposits. This rate of wall thinning aligned with the likelihood of leakage<sup>27-29</sup>. Copper-based alloys typically form a passive layer, Cu<sub>2</sub>O, in brown color on the surface. When this passive layer is removed, the metal surface makes direct contact with corrosive elements, leading to corrosion and the formation of corrosion products referred to as patina. Patina is characterized by various colors, with a typical patina being greenish-blue  $(tosca)^{21,22}$ . The transformation process from passive layer Cu2O to patina was visually evident by the change in color on the surface of the tubes, ranging from light red to pink, orange, blue, green, and purple, with permanent patina typically appearing greenish-blue (tosca), as observed in Fig. 9. The reaction of Cu base alloy with reactive elements like oxygen, carbon and sulphur can be accelerated with the presence of chlorine (Cl) to form a patina. In this research, chlorine was introduced through contact with seawater<sup>12,21)</sup>. Chlorine reacted with copper base alloy to form atacamite (Cu<sub>2</sub>(OH)<sub>3</sub>Cl), which is a form of greencolored patina called hydroxychloride. Additionally, high humidity in the heat exchanger, caused by the presence of seawater inside the tube and hydrocarbon vapor outside, accelerated the corrosion rate of the tubes.

Fig. 9: (a) Transformation of a passive layer to different levels of patina, (b) permanent patina is formed and identified with tosca color.
