LIFE-EXTENSION OF RC STRUCTURE BY CATHODIC PROTECTION USING ZINC SACRIFICIAL ANODE EMBEDDED IN CONCRETE

A DISSERTATION

Submitted to
Kyushu University
in partial fulfillment of the requirements
for the degree of
Doctor of Engineering

DEPARTMENT OF CIVIL AND STRUCTURAL ENGINEERING
GRADUATE SCHOOL OF ENGINEERING
KYUSHU UNIVERSITY
Fukuoka, Japan
August, 2016

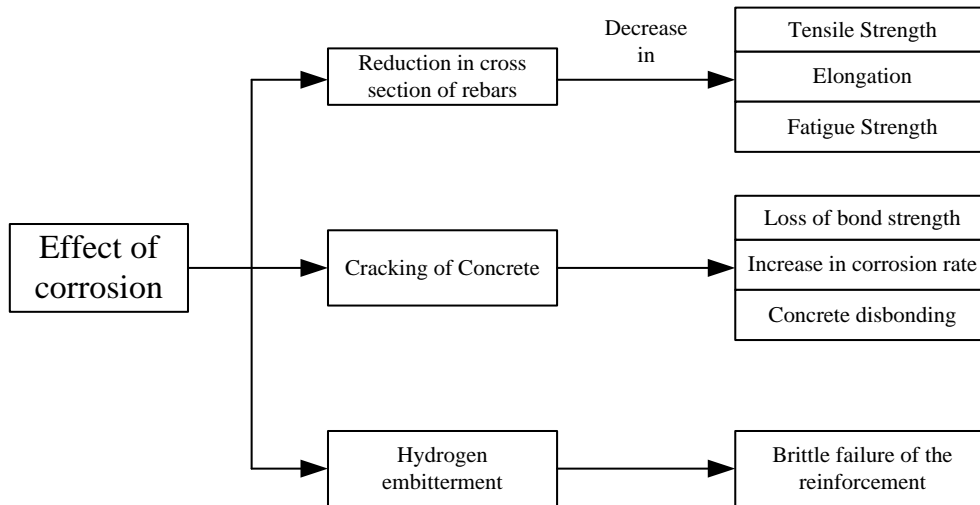
Fig 2.11 Structural consequences of corrosion in reinforced concrete structure

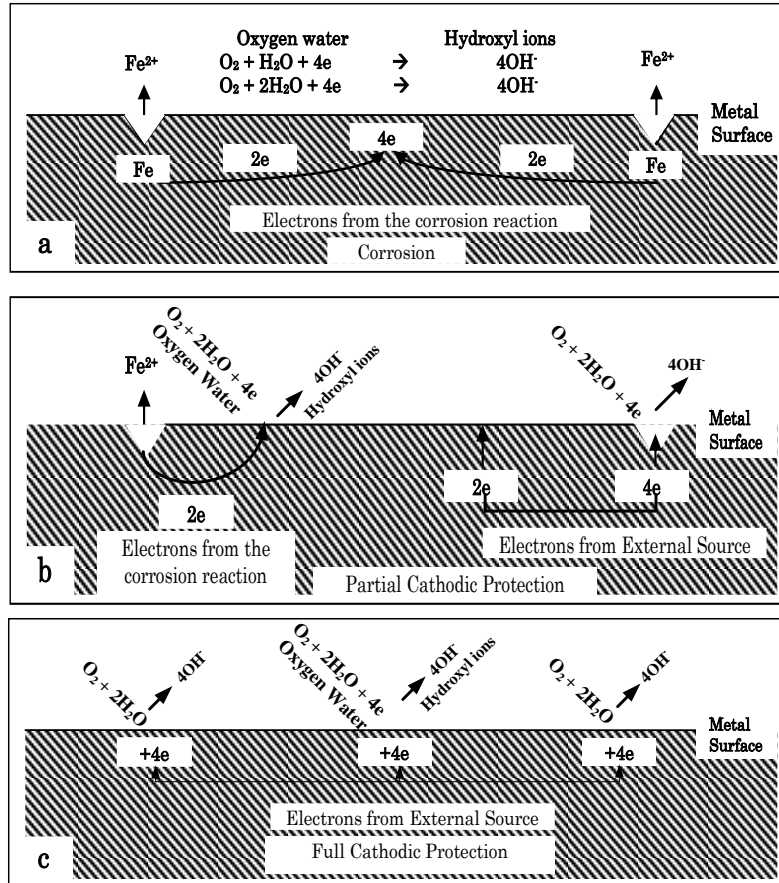
may also produce electrons as shown in (b). Full cathodic protection (c) is only achieved where the supply of electrons from an external source is able to react with all the oxygen.

Fig 2.15 Stage of cathodic protection system (2.22)

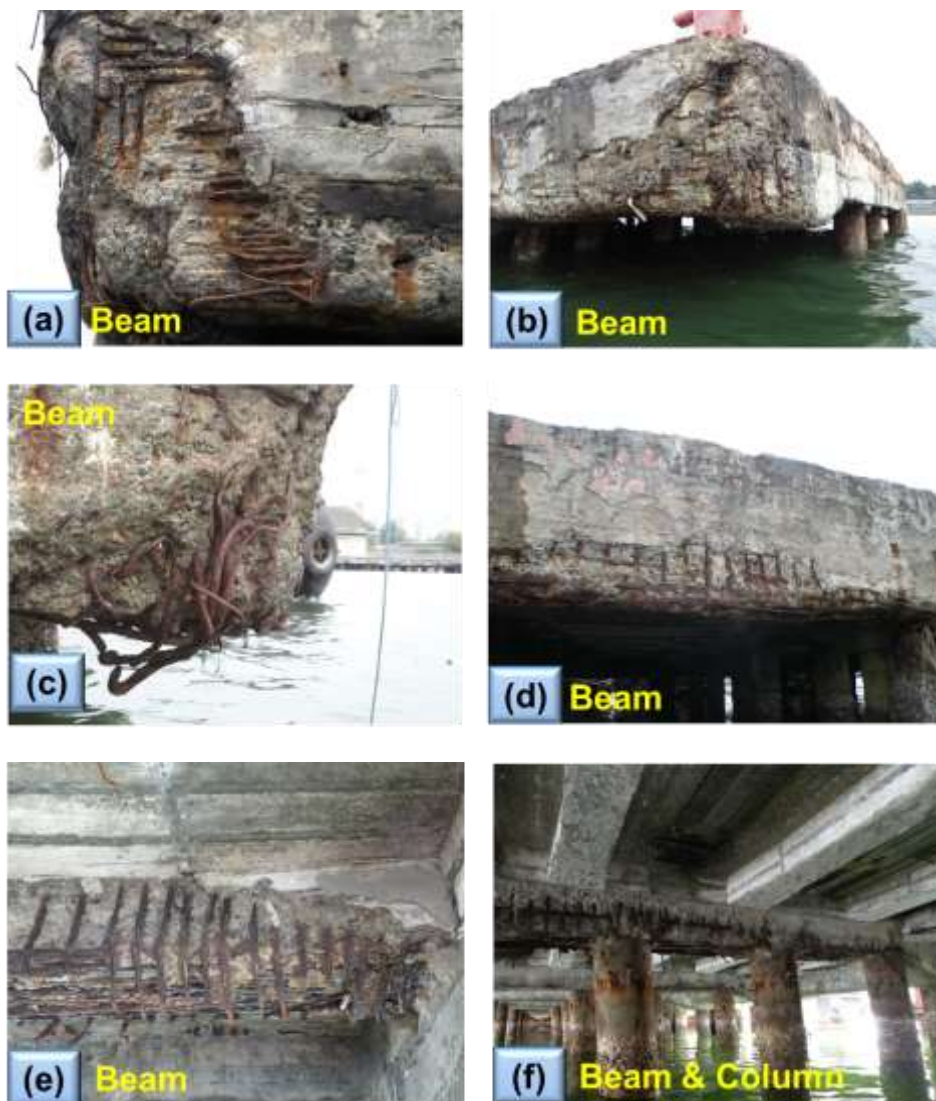
Photo 3.6 shows about the visual condition of beam and column structures of Indonesian Port at area A in general. It is clearly seen that chipped and corroded reinforcement on the beams has large extent of rust stain and categorized as deterioration grade A. Many wide cracks also occurs and spalling on the concrete cover easily to found especially at the beams elements. The most large extent of spalling of concrete cover were found to beam structures, following by pier head and slab structures.

Photo 3.6 Port damages at area A after 77 years of exposure

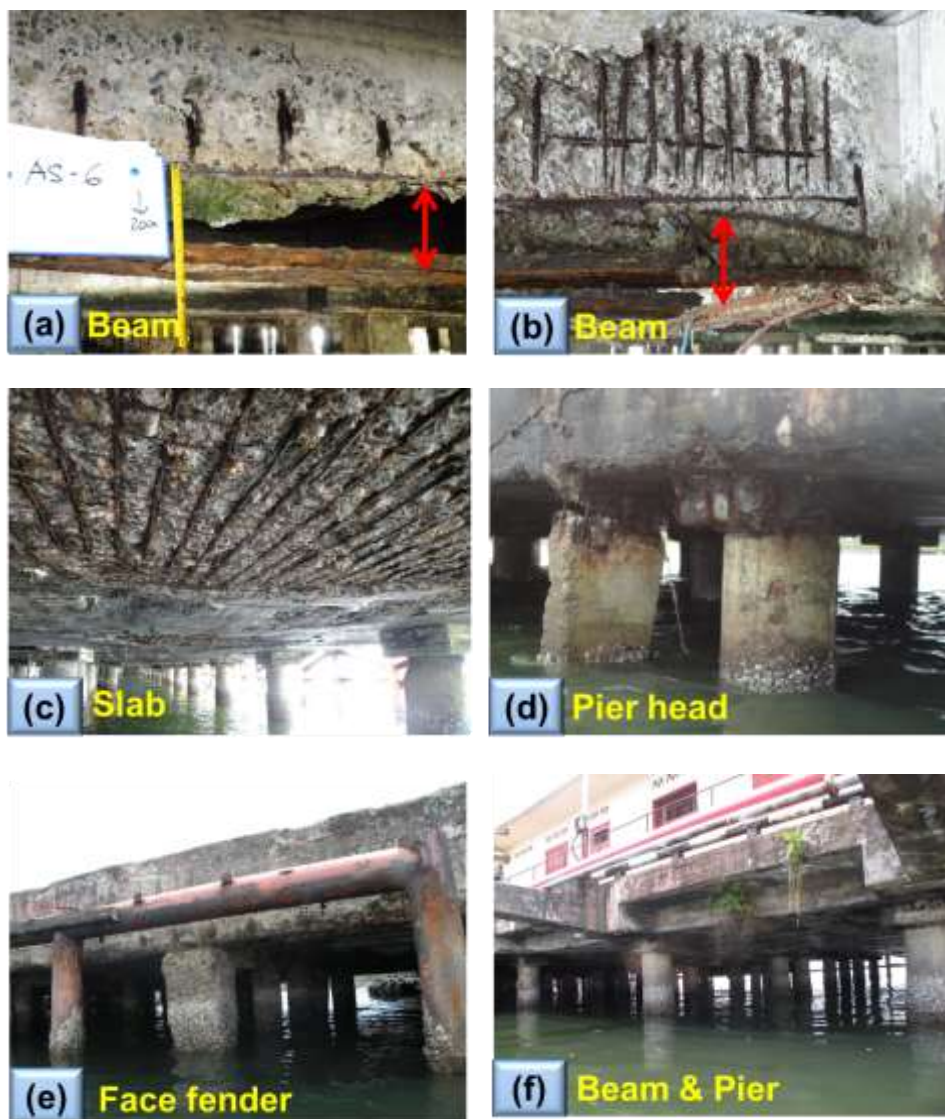
Photo 3.7 illustrates the condition of Indonesian Port at area B. It was observed that there was a loss of concrete-cross section a beam with dimension 500x550 mm in the splash zone at B area around 20 cm. This means there was a loss of almost 50% of height section of this beam due to chloride attack and categorized to deterioration grade A for large extent of spalling. Moreover, heavy corroded reinforcement also clearly seen under the slab structures and pier-head of column and categorized to deterioration grade A for heavy rust stain.

Photo 3.7 Typical deterioration of point B after 77 years of exposure

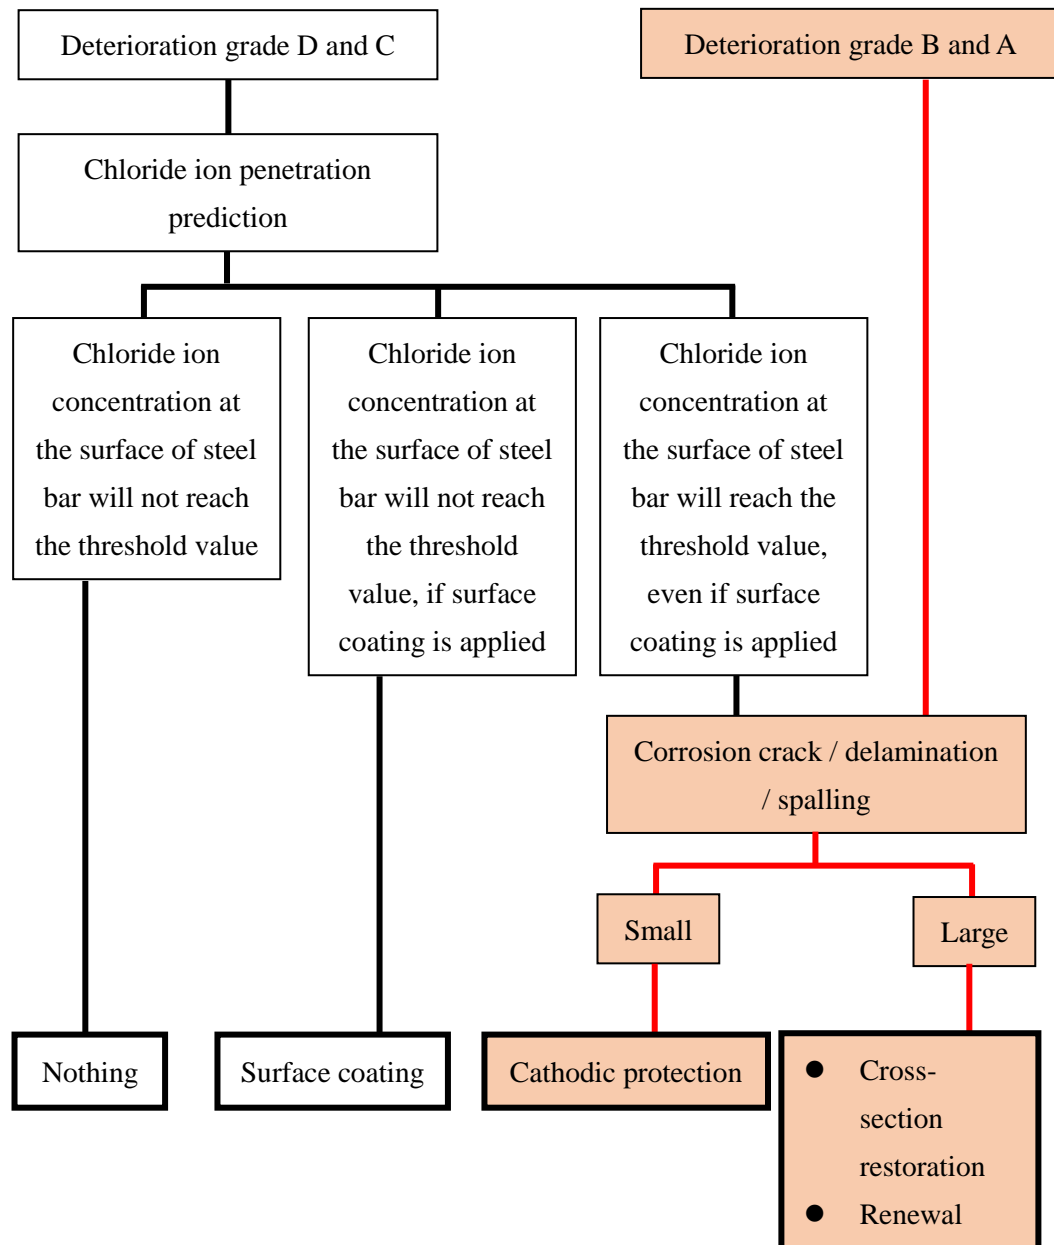
Selection of the repair method and area in each member was dependent on the deterioration grade, chloride ion concentration at the surface of steel bar and the scale of deteriorated part ^(3.5). The selection flow of repair works for port structure as shown in **Fig 3.10** ^(3.5).

Fig 3.10 Selection flow of repair works based on deterioration grade

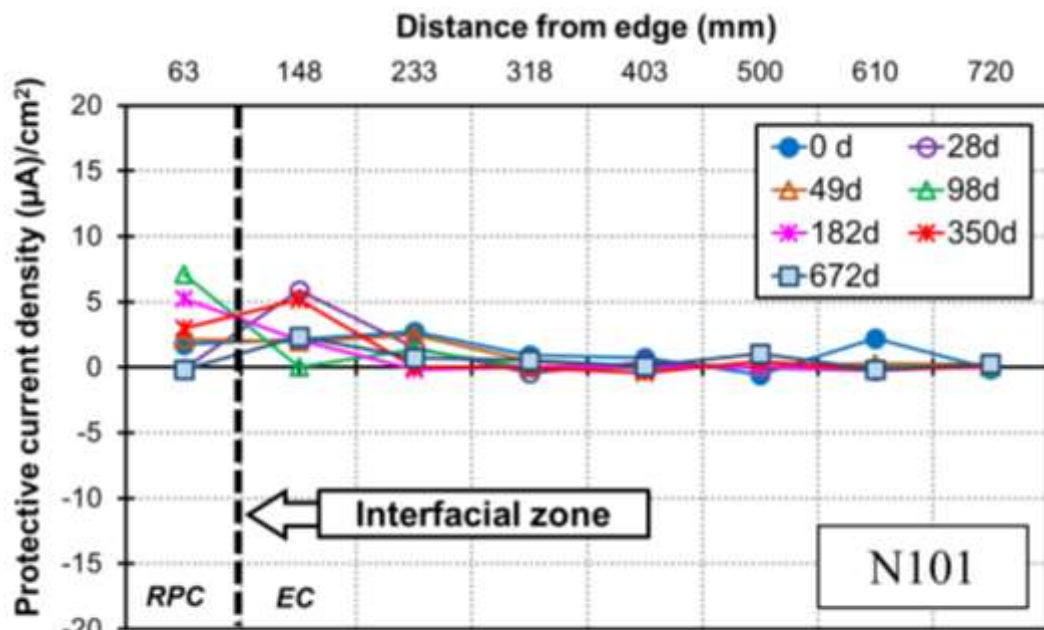
The periodic macro-cell protective current density on anode with one-steel bar element in repair concrete against the distance from edge of repair concrete is shown in **Fig 4.5**. It was also observed that protective current still flow up to 672-day from steel bar in patch repair concrete to segmented steel bar in existing concrete. The current flow is $\sim 8 \mu\text{A}/\text{cm}^2$ for N41 and $\sim 0.2 \mu\text{A}/\text{cm}^2$ for N101 at 672 days of polarization time. It means the throwing current of anode fulfill the cathodic protection current design.

EC: Existing Concrete, chloride contaminated $4 \text{ kg}/\text{m}^3$
 RPC: Repair Concrete, chloride free

EC: Existing Concrete, chloride contaminated $10 \text{ kg}/\text{m}^3$
 RPC: Repair Concrete, chloride free

Fig 4.5 Macro-cell protective current density on SCP of N41 and N101

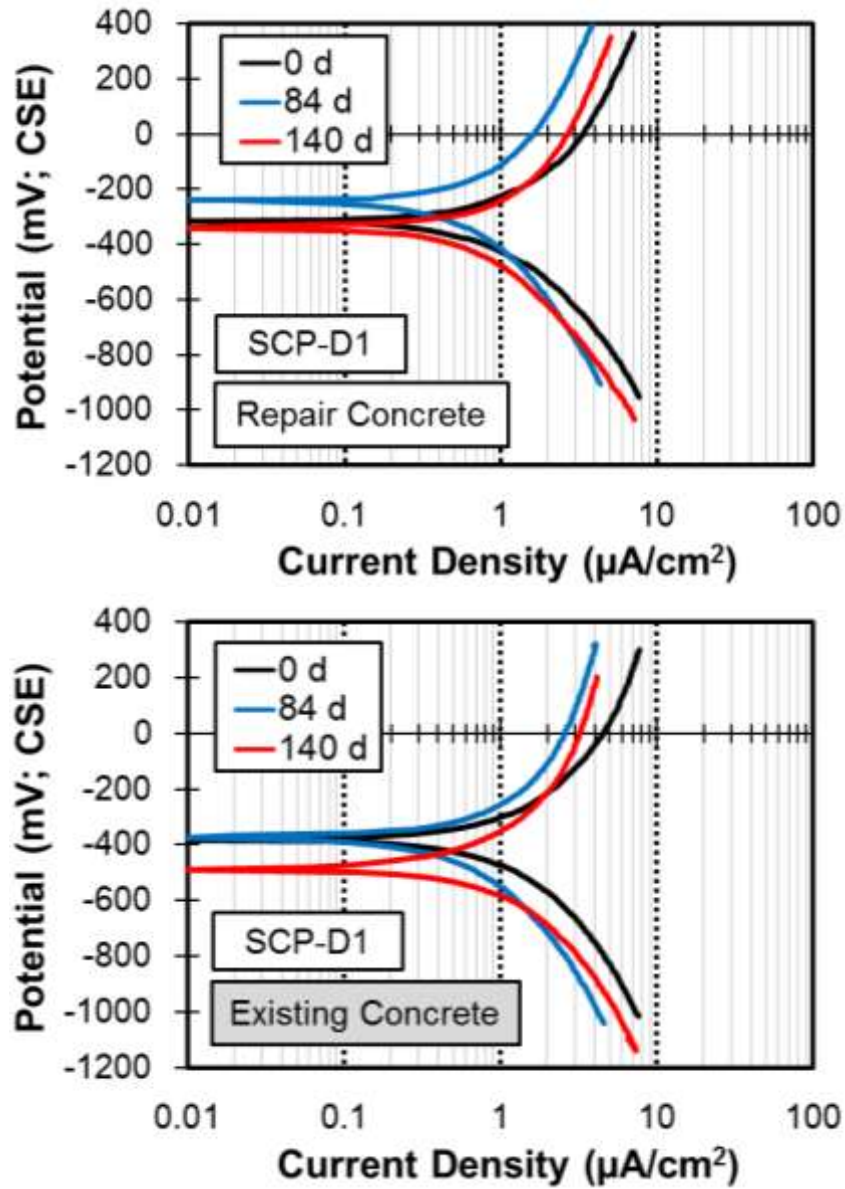
Fig 5.12 Anodic-cathodic polarization curve of SCP-D1
