Erosion in the Western Middle Mountain Watersheds of Nepal: A Review

Prem P. PAUDEL*, Jagannath JOSHI* and Hiroshi OMURA**

Key words: Landslide, bank erosion, surface erosion, Nepalese middle mountain

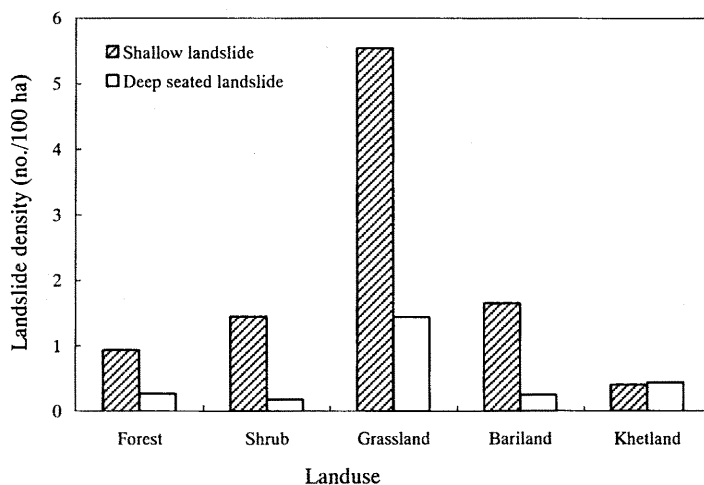
Fig. 3. Density of landslides by landuse type.

The landslides occurred in the watersheds are classified as shallow type and deep seated one. The former one has a scale within a depth of 1.0 m to 3.0 m and affected area size is 100–3000 m². The latter is deeper than 3.0 m and of more than 3000 m². Landslides in each watershed is listed in Table 1. Concerning about the density per 100 ha by land use type is the largest at grassland with 6.98, followed by Bari land with 1.90, shrub with 1.63,

forest with 1.20 and Khet land with 0.85 (Figure 3). In terms of slope, the density is greatest at more than 30° slope category (Figure 4). One of the probable reason for higher number of landslide density in grassland is due to thick soil cover, low vegetation coverage and shallow rooting system. The density of landslide in Parbat south watershed is highest among others. This might be due to deeply weathered bed rocks eroded by undercutting effect of Argaudi stream. An example of a deep seated landslide is shown in Photo 1.

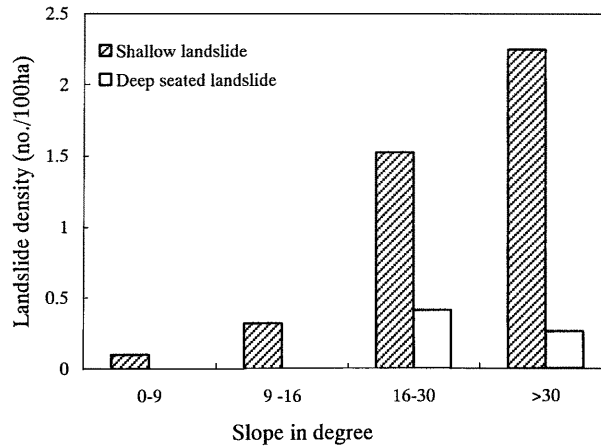
Fig. 4. Density of landslides by slope category.

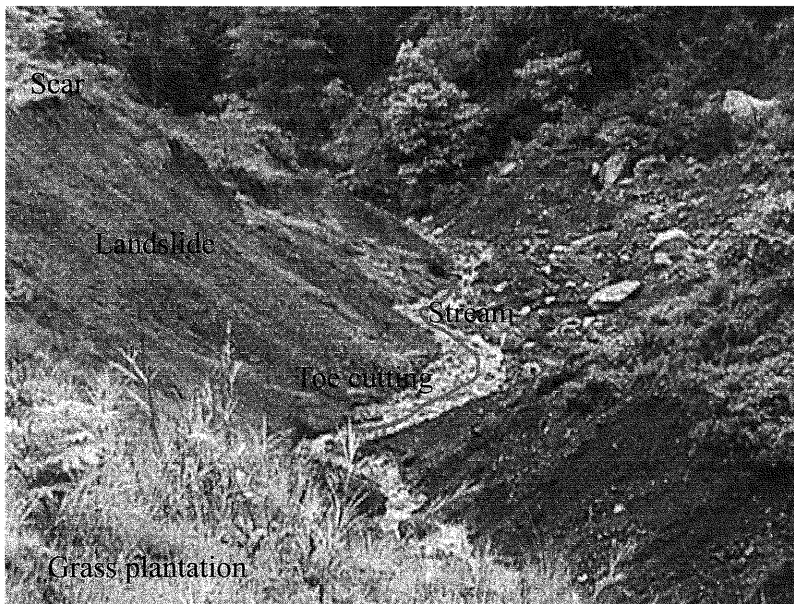
Photo. 1. Toe cutting of a deep seated landslide and side erosion by a stream in Parbat North watershed.

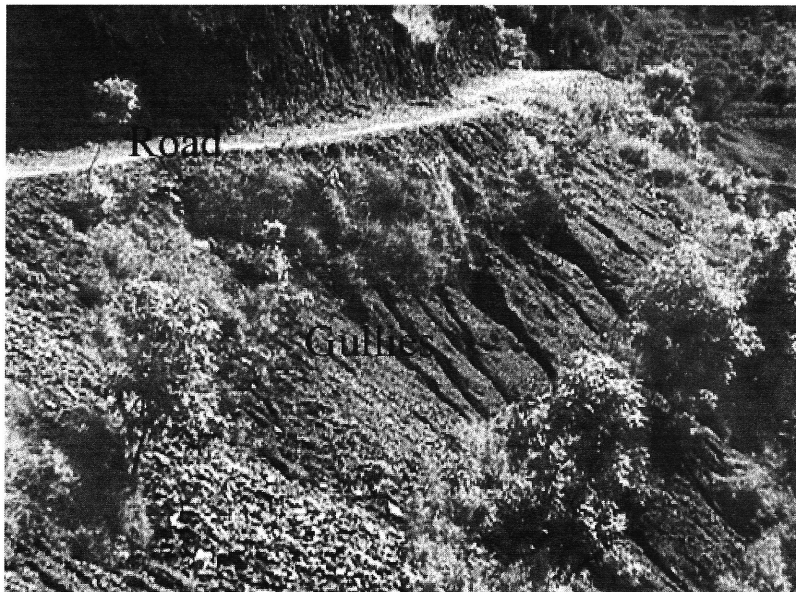
Photo. 2. V shape gully formation on filled bank slope formation below the road.

The gully erosion has occurred mainly due to an increase of surface run-off because of over-grazing, improper farmland management, construction of trails and rural roads without side drainage. It looks more serious in cultivated land. There are so many gullies in the watersheds most prominent areas are in Kaski North and Parbat south area. The conditions of gullies are presented in Table 2, where the shape of gullies depends on soil properties and direction of flow of water in the ground. The U shape gully is formed if the resistance of the subsoil against erosion is equals with that of the top soil. On the contrary V shape gully is formed if the subsoil is more resistive than the top soil (HMG/JICA 1998a). The view of gully formation in filled bank slope is shown in Photo 2.

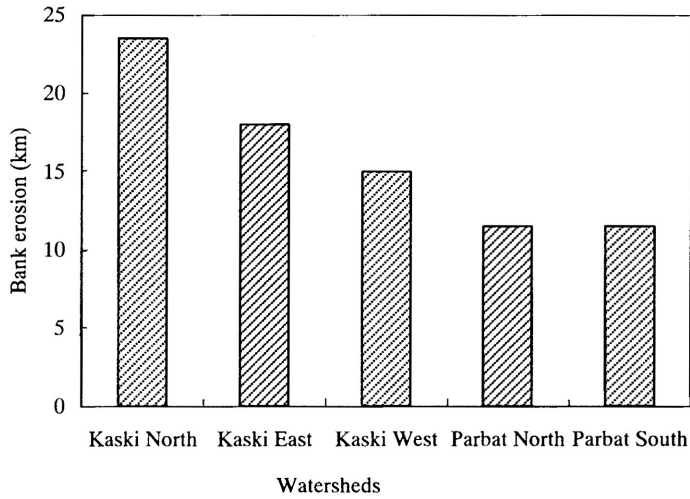
Fig. 5. Condition of bank erosion at both sides of streams.

mainly during monsoon season. The bank erosion on both sides of the streams of each watershed is shown in Figure 5. The erosion in Kaski North watershed is highest. It might be due to activities of major tributaries like Bijayapur stream, Kali stream, and Bhoti streams. A typical example of bank erosion is shown in Photo 3.

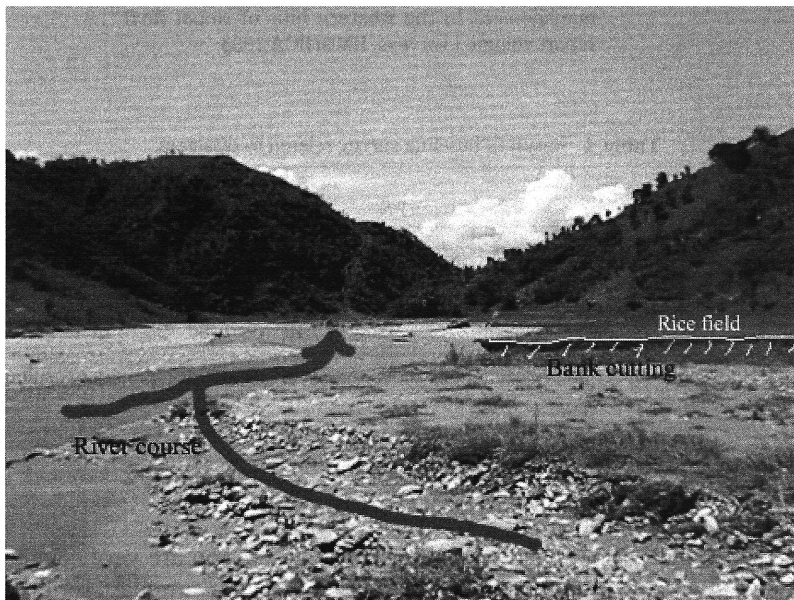
Photo. 3. View of Bank cutting by Bijayapur stream in Kaski North Watershed area.
