Vegetation Morphology and Soil Features Along Unstable Road Slope : A Case Study from Mugling narayanghat Road Section, Central Nepal

Vegetation Morphology and Soil Features Along Unstable Road Slope: A Case Study from Mugling Narayanghat Road Section, Central Nepal

Bimala Devi DEVKOTA¹, Hiroshi OMURA^{1,*}, Tetsuya KUBOTA¹,
Prem P. PAUDEL² and HASNAWIR¹

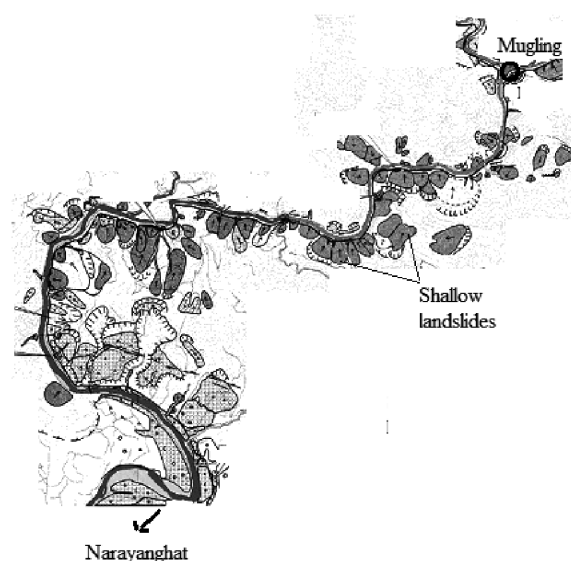
Fig. 1. Landslides distribution along Mugling–Narayanghat road. (after Hasegawa *et al.*, 2006)

year. For instance, intensive rainfall of 446 mm in 24 hours on July 2003 triggered 213 shallow landslides, as shown in Fig. 1. This has caused washed away of bridges and retaining walls, and blocked traffic for couple of days (Joshi, 2006). Sometimes road-blocked problems create food scarcity in Kathmandu. Hence, considerations on its measures for slope stabilization are recognized as an important matter.

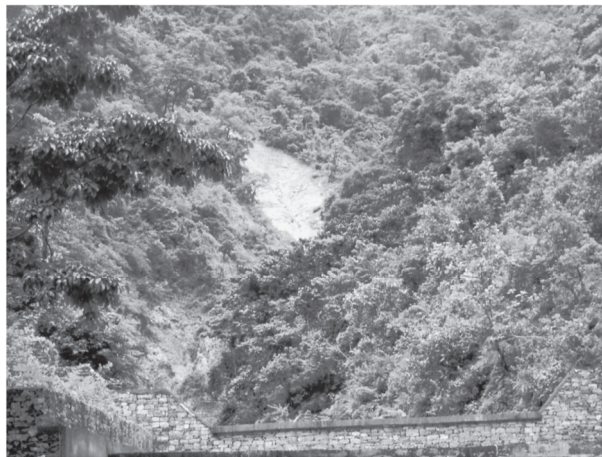
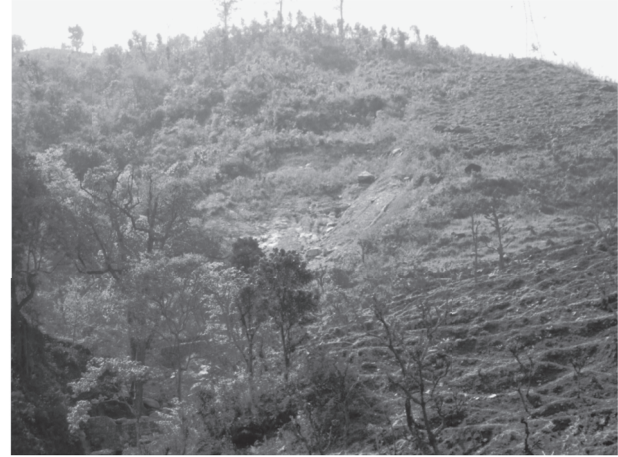
slide on forested slope

slide near cultivated slope

Fig. 3. Occurrence of landslides along the road side slopes.

The road passes through plain rolling terrain with curved alignment which is shown in fig. 2b and 2c. The area receives average annual rainfall of about 2400 mm and the area belongs to subtropical zone. The local farmers are practicing agriculture farming on steep slopes parts of road side slopes. The forest condition is in degraded conditions with shrubs and bush as dominant communities. The tree species are sparse. Every year many landslides, debris flows are occurring along the road slopes in vegetative, as well as in cultivated slopes, as shown in Fig. 3.

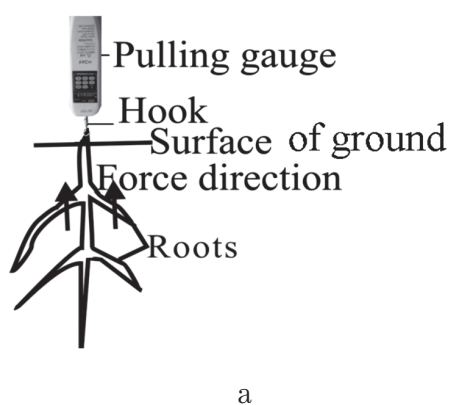
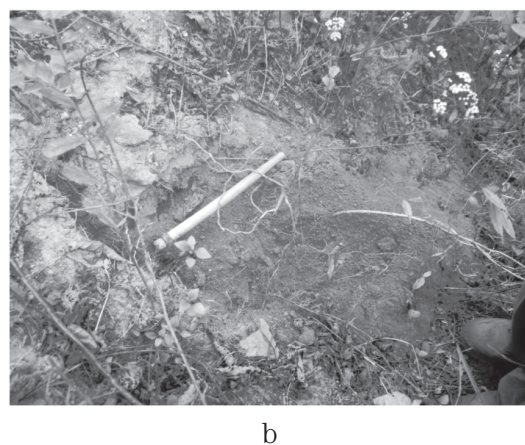
Fig. 6. Methods applied for extraction of plants from ground surface.

a) shows pulling a plant using digital gauge

b) plant extracting by digging a circular pit

The soil samples were taken from each sampling sites and soil features like permeability, density and mineral contents (NPK) were tested at the laboratory. The vegetative features were analyzed in the field on 2006 August and 2007 March. The plant morphological features such as shoot height, roots numbers, root diameter, and numbers of root tendrils of an individual plant species were examined by extracting from the ground. The plants were extracted by following two ways, as shown in Fig. 6;

- 1) using Digital Push Pull Gauge. This was applied where it was possible to extract plant without damage to the roots. Sometimes extraction work of plants was difficult because of its limited capacity (maximum of 1000 N),
- 2) by digging a circular pit to observe root morphology at the impossible case of digital gauge. In this case the data on Pulling Resistance Force (PRF) of an individual plant are not measured.

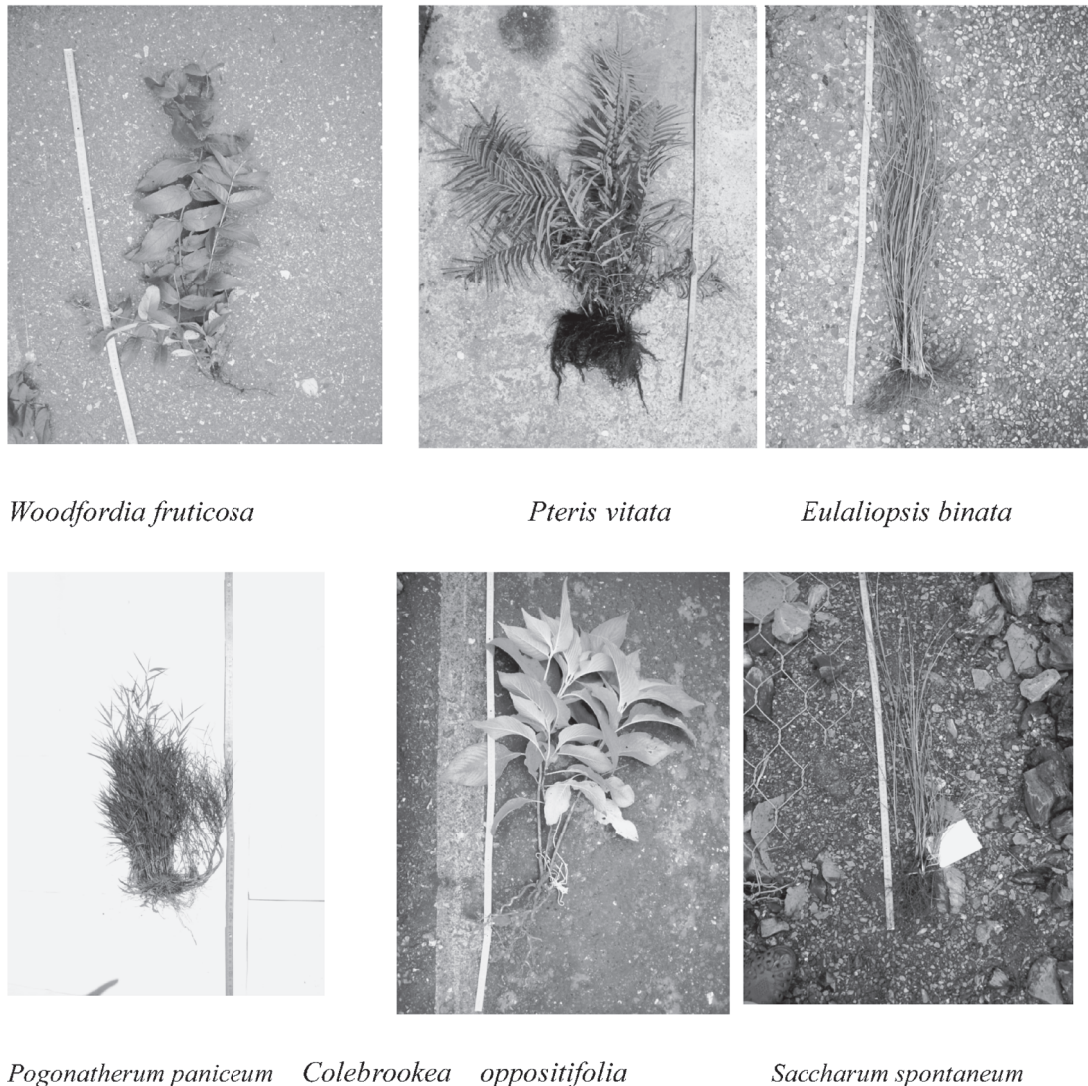
Fig. 7. Morphological views of some plants after extraction.

might be considered more effective for bioengineering solution. The morphological views of these plants are shown in Fig. 7
