Historical Development of Rice Paddy Irrigation System and Problems on Water Management in Recent Years : Yamada Diversion Dam Command Area in Japan

Historical Development of Rice Paddy Irrigation System and Problems on Water Management in Recent Years – Yamada Diversion Dam Command Area in Japan–

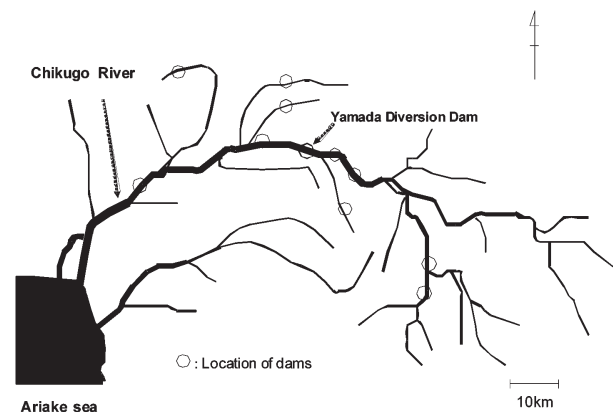
Fig. 1. Dams and diversion dams along the Chikugo River.

The Chikugo River is located northern Kyushu, Japan. Total length of this river is 143 km and catchments area is 2,860 km², which is mostly composed of mountainous area. Many dams and diversion dams were constructed for supplying water to rice paddy area and to urban area as shown in Fig. 1. Diversion dam named Yamada is located about 55 km from the Ariake sea. The water is delivered to command area about 600 ha through main canal with 12 km and branch and tertiary canals about 20 km. The number of farmers decreased about 18.2% during these 10 years. The percentage of farmer over 65 years old is 48.6% and the percentage is still increasing. The percentage of full time farmers is

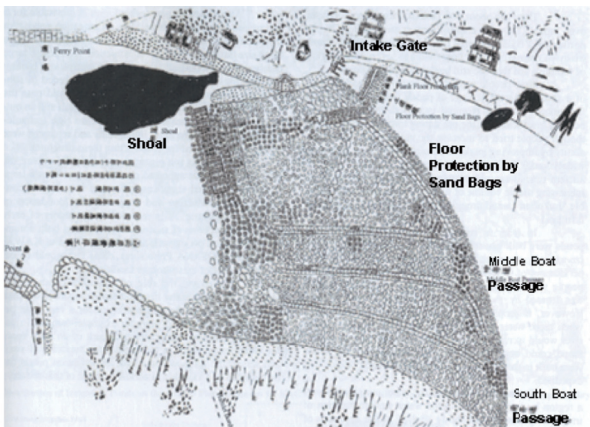
Fig. 2. Original Yamada diversion dam constructed in 1663 (SNRKK., 2004).

The Yamada diversion dam was constructed in 1663 with rocks. The total length of dam was 330 m with passages for rafts and ships as shown in Fig. 2. At the same time, main irrigation canal named Horikawa length about 8,500 m was constructed for supplying water to 150 ha of rice paddy area. The stone monument shown in Fig. 3 is the bench mark for surveying the area at that time. After 60 years, new project was started to reform the intake gate because the sedimentation of gravels in front of gate impeded the water flow. At the same time main irrigation canal was extended. When the project was ended in 1760, total command area became about 370 ha. After the heavy draught happened in 1782, old diversion dam was slightly reformed to develop more water. In 1789, new plan to develop to increase water intake rate for overcoming heavy draught was proposed by a village headman. But farmers in the lowest level area protested because they were afraid of damages by water logging. Succeeding to get the support of local government, the plan was started in 1790 and ended in 1825. The water logging problems were cleared by the drainage devices. In 1874, the dam was seriously damaged by the big flood. Almost one third of dam 8100 m² was broken. In 1885, the dam was seriously damaged again by the big flood, and about 8700 m² were broken. In 1953, the command area about 700 ha was flooded and irrigation canal system was seriously damaged. In 1955, the dam was seriously damaged again by the flood. Every time the dam was damaged, the farmers repeatedly repaired it within one year.

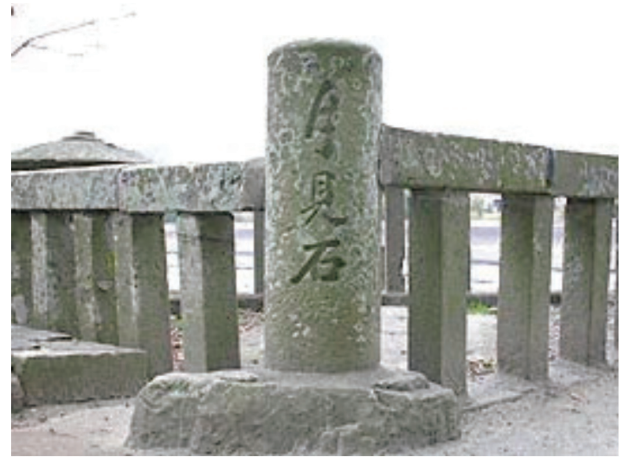
Fig. 3. Bench mark used for surveying (Fukuoka Pref., 2005).

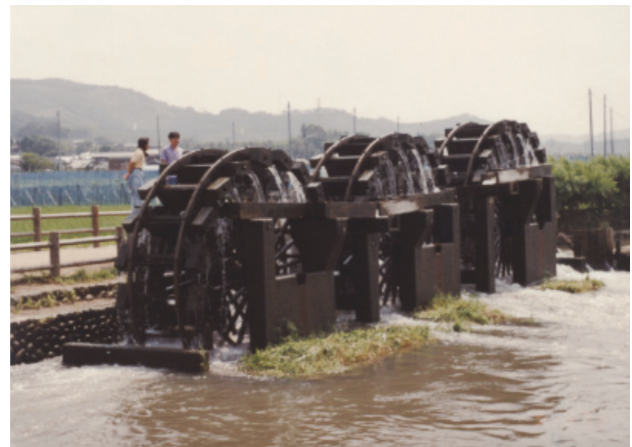
Fig. 4. Triple linked waterwheels for irrigation.

Many wooden waterwheels have been installed along the irrigation canal led from the Yamada diversion dam, for irrigating rice fields which could not be irrigated by gravity flow. Fig. 4 shows one of the historical triple linked waterwheels which pumps up 7,892 m³/day for rice paddy with 13.5 ha. Double and triple linked water-

wheels are still working for irrigating totally 35 ha rice paddy. Every five years, these wooden waterwheels are needed to be renewed.

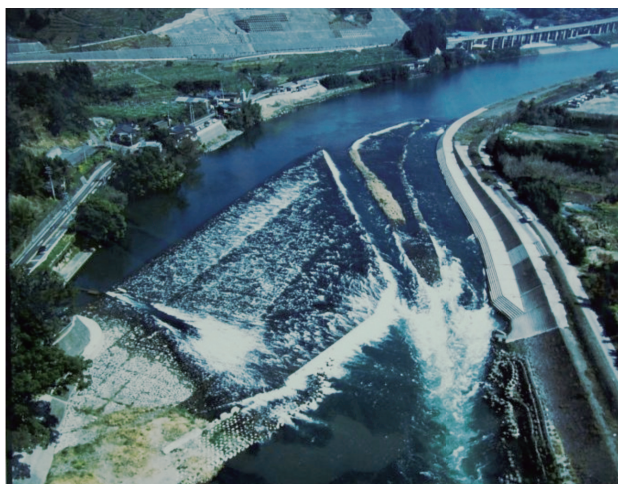
Fig. 5. Yamada diversion dam rehabilitated in 1980 (MLITJ, 2007).

The old diversion dam was seriously damaged several times as stated above. Finally this dam was reformed in 1980 with modernized technique taking into account historical structure as shown in Fig. 5. The length and width of inclined dam is 309 m and 47 m, respectively. Roller gates for intake water and for evacuating sediment gravels were installed, and passages for raft and boats were remained as before. The number of farmers was 1,281 in this rice paddy command area of 664 ha. Following the traditional water right, intake water gate is opened during 20 May and 15 Oct. The maximum flow rate at irrigation season is 5 m³/s and at non irrigation season is 1.5 m³/s. The water at non irrigation season is used for canal maintenance, fish culture and fire prevention.

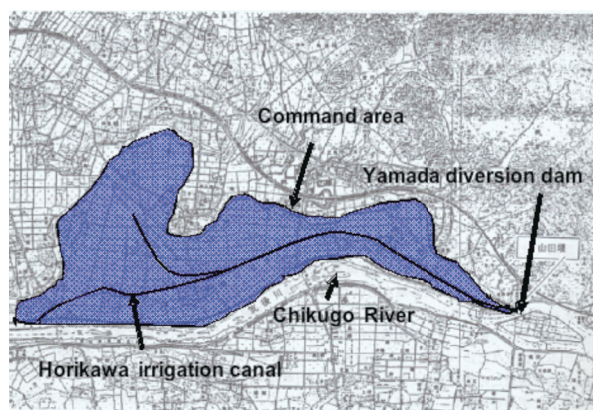
Fig. 6. Command area of the Yamada diversion dam.

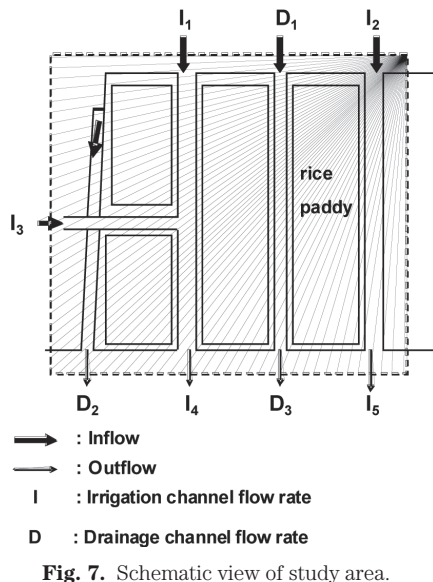
Fig. 7. Schematic view of study area.

The irrigation and drainage canals are shown in Fig. 7. Observation of water levels was conducted throughout the rice growth stage.

Where I_1 , I_2 , I_3 , I_4 and I_5 are flow rates in irrigation chan-

nels. D_1, D_2 and D_3 are flow rates in drainage channels. The water uptake rate, $Irrri$, to the block is determined as,

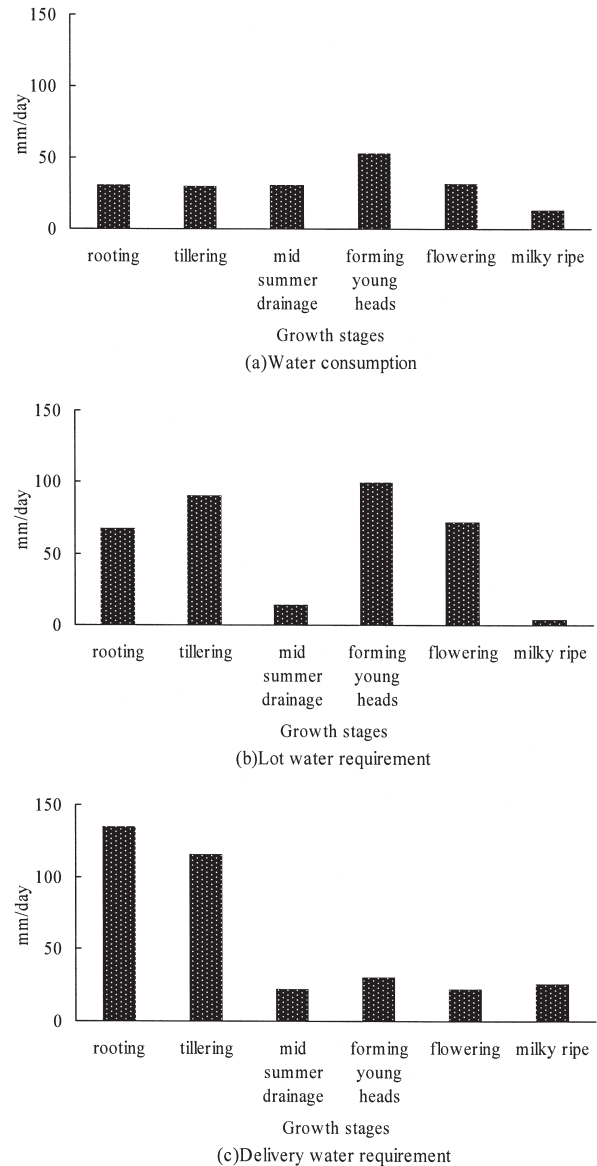
Fig. 8. Water management components in 1981.

Fig. 8 shows the water management components observed in 1981. Water consumption rates ranged from 23 mm/day to 53 mm/day. These high values were caused by the porous soil layer originated the flood of the Chikugo River. Lot water requirements were ranged from 15 mm/day to 27 mm/day. The delivery water requirements were ranged from 15 mm/day to 50 mm/day

day. Percentages of these three components are listed in Table 4. The percentages of water consumption, lot water requirements and delivery water requirements were ranged from 33.2% to 57%, from 20.5% to 27.1% and from 15.9% to 44.0%, respectively.

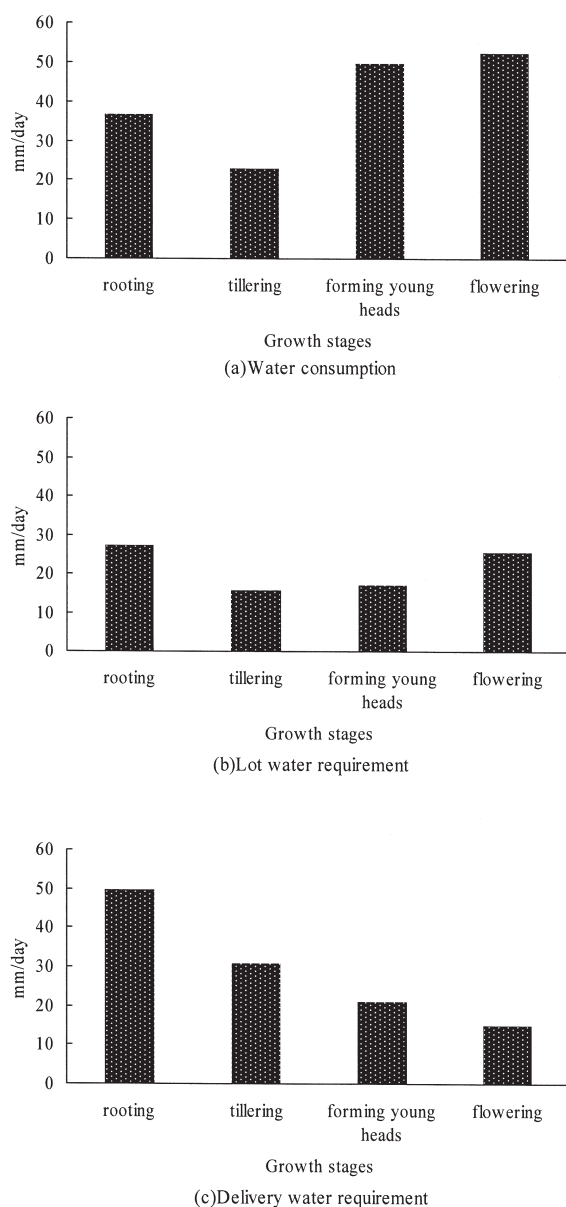
Fig. 9. Water management components in 1998.

Fig. 9 shows the water management components observed in 1998. Water consumption rates ranged from 20 mm/day to 52 mm/day. The values were almost the same range with the observation in 1981. Lot water requirement were ranged from 5 mm/day to 100 mm/day. Delivery water requirements were ranged from 25 mm/day to 137 mm/day. It will be emphasized that the maximum values of Lot water requirements and delivery water requirements were over twice of the values in 1981. It would be the results of decreasing the rice paddy area about 23.5%. Another reason would be decreased number of farmers. In the total command

area, the farm household number in 1980 was 968 and this number became 593. Within 20 years, the percentages of farm household number decreased 38.7%. The water demand for rough management would be caused the additional need of water. Percentages of these three components are listed in Table 5. The percentages of water consumptions, lot water requirements and delivery water requirements were ranged from 13.3% to 44.8%, from 22.7% to 59.3% and from 16.4% to 57.1%, respectively.

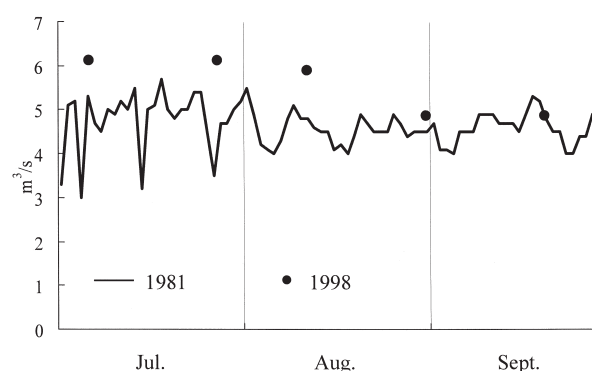
Fig. 10. Water intake rate at the head of the Yamada diversion dam.

Fig. 10 shows the water intake rate at the head of command area. Most of the values in 1981 ranged from 4 m³/s to 5 m³/s. These values were within the traditional water intake right 5 m³/s. The values in 1998 were ranged from 5 m³/s to 6 m³/s, though the observation data were not enough. It is interesting to note that the rice planted paddy area showed maximum value 755 ha in 1970, and decreased to 358 ha in 2,000. The percentages of decreasing were 52.6% during 30 years. But the water intake rates were not changed. The excessive irrigation water would be required for and delivery water managements.
