Historical Development of Rice Paddy Irrigation System and Problems on Water Management in Recent Years : Yamada Diversion Dam Command Area in Japan

Historical Development of Rice Paddy Irrigation System and Problems on Water Management in Recent Years – Yamada Diversion Dam Command Area in Japan–

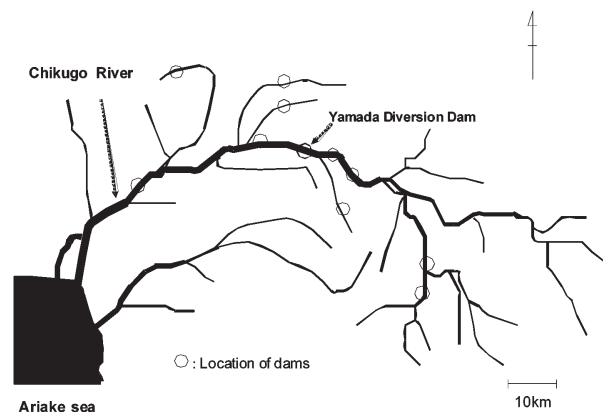
Fig. 1. Dams and diversion dams along the Chikugo River.

The Chikugo River is located northern Kyushu, Japan. Total length of this river is 143 km and catchments area is 2,860 km², which is mostly composed of mountainous area. Many dams and diversion dams were constructed for supplying water to rice paddy area and to urban area as shown in Fig. 1. Diversion dam named Yamada is located about 55 km from the Ariake sea. The water is delivered to command area about 600 ha through main canal with 12 km and branch and tertiary canals about 20 km. The number of farmers decreased about 18.2% during these 10 years. The percentage of farmer over 65 years old is 48.6% and the percentage is still increasing. The percentage of full time farmers is

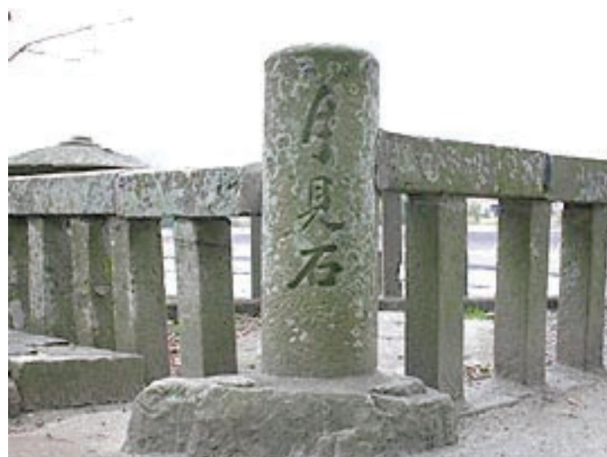
Fig. 3. Bench mark used for surveying (Fukuoka Pref., 2005).

The Yamada diversion dam was constructed in 1663 with rocks. The total length of dam was 330 m with passages for rafts and ships as shown in Fig. 2. At the same time, main irrigation canal named Horikawa length about 8,500 m was constructed for supplying water to 150 ha of rice paddy area. The stone monument shown in Fig. 3 is the bench mark for surveying the area at that time. After 60 years, new project was started to reform the intake gate because the sedimentation of gravels in front of gate impeded the water flow. At the same time main irrigation canal was extended. When the project was ended in 1760, total command area became about 370 ha. After the heavy draught happened in 1782, old diversion dam was slightly reformed to develop more water. In 1789, new plan to develop to increase water intake rate for overcoming heavy draught was proposed by a village headman. But farmers in the lowest level area protested because they were afraid of damages by water logging. Succeeding to get the support of local government, the plan was started in 1790 and ended in 1825. The water logging problems were cleared by the drainage devices. In 1874, the dam was seriously damaged by the big flood. Almost one third of dam 8100 m² was broken. In 1885, the dam was seriously damaged again by the big flood, and about 8700 m² were broken. In 1953, the command area about 700 ha was flooded and irrigation canal system was seriously damaged. In 1955, the dam was seriously damaged again by the flood. Every time the dam was damaged, the farmers repeatedly repaired it within one year.

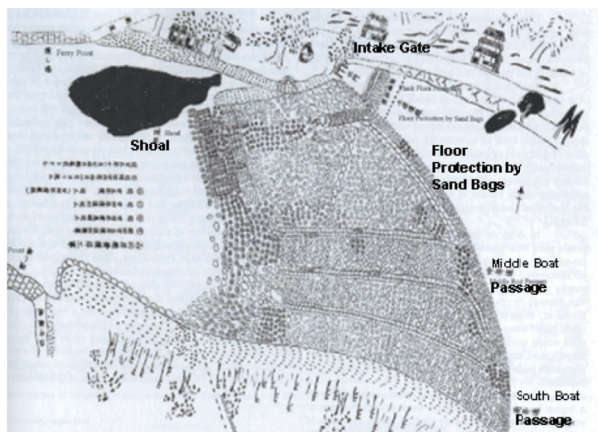
Fig. 2. Original Yamada diversion dam constructed in 1663 (SNRKK., 2004).

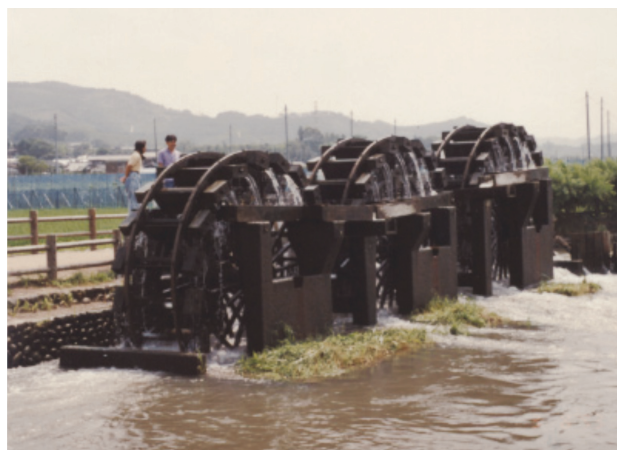
Fig. 4. Triple linked waterwheels for irrigation.

Many wooden waterwheels have been installed along the irrigation canal led from the Yamada diversion dam, for irrigating rice fields which could not be irrigated by gravity flow. Fig. 4 shows one of the historical triple linked waterwheels which pumps up 7,892 m³/day for rice paddy with 13.5 ha. Double and triple linked water-

wheels are still working for irrigating totally 35 ha rice paddy. Every five years, these wooden waterwheels are needed to be renewed.

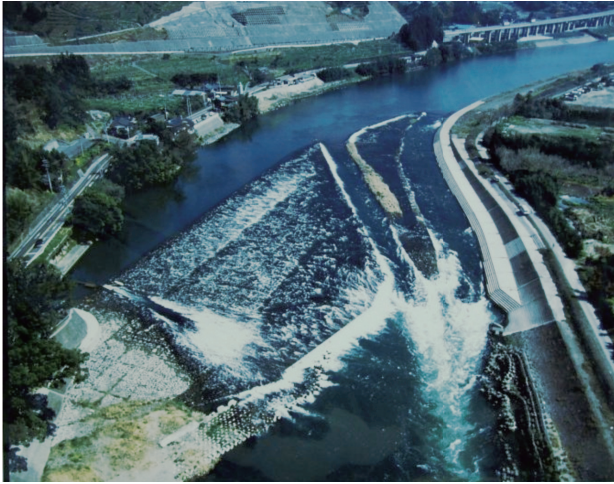
Fig. 5. Yamada diversion dam rehabilitated in 1980 (MLITJ, 2007).

The old diversion dam was seriously damaged several times as stated above. Finally this dam was reformed in 1980 with modernized technique taking into account historical structure as shown in Fig. 5. The length and width of inclined dam is 309 m and 47 m, respectively. Roller gates for intake water and for evacuating sediment gravels were installed, and passages for raft and boats were remained as before. The number of farmers was 1,281 in this rice paddy command area of 664 ha. Following the traditional water right, intake water gate is opened during 20 May and 15 Oct. The maximum flow rate at irrigation season is 5 m³/s and at non irrigation season is 1.5 m³/s. The water at non irrigation season is used for canal maintenance, fish culture and fire prevention.

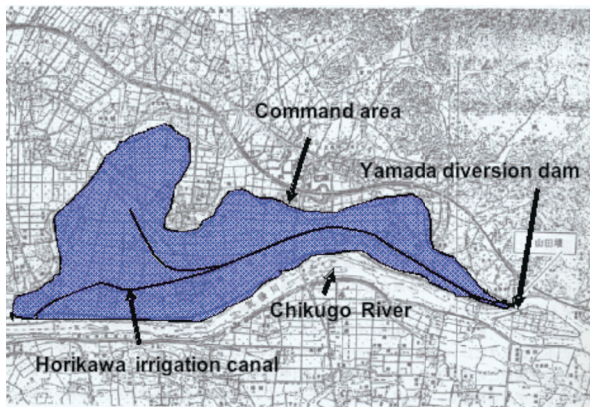
Fig. 6. Command area of the Yamada diversion dam.

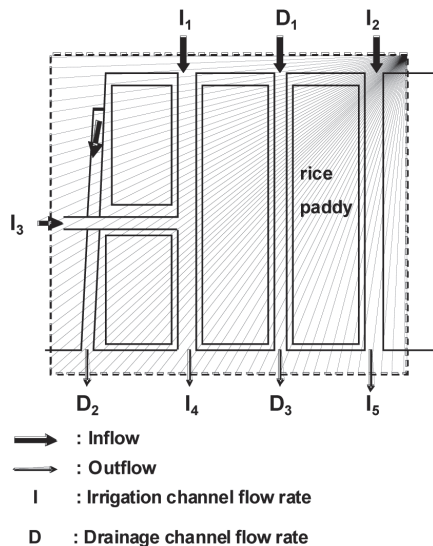
Fig. 7. Schematic view of study area.

The irrigation and drainage canals are shown in Fig. 7. Observation of water levels was conducted throughout the rice growth stage.

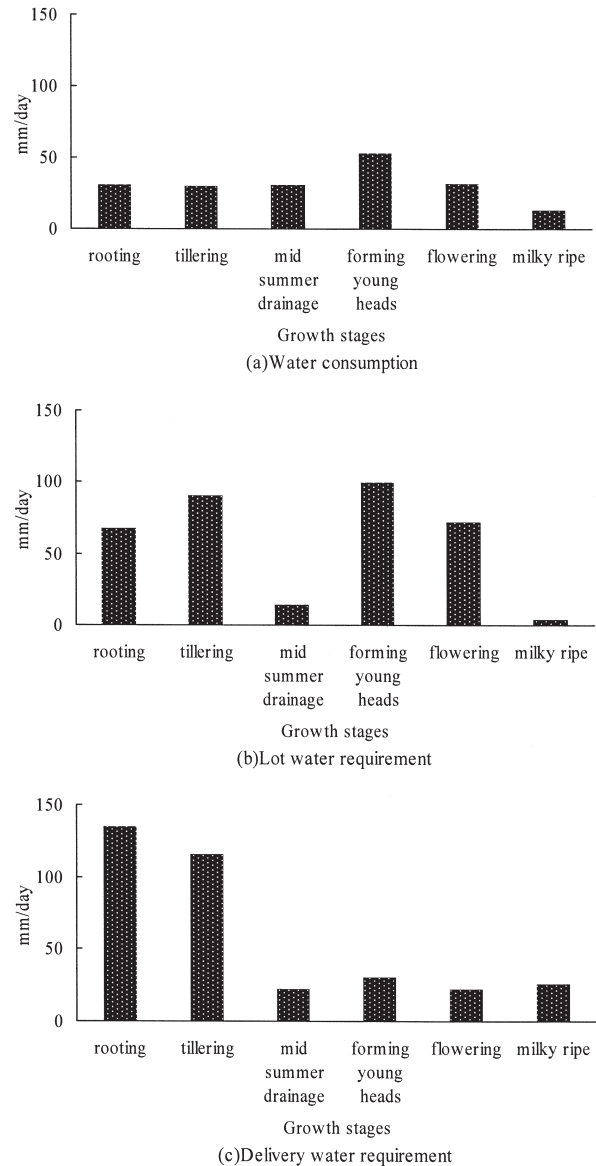
Fig. 8. Water management components in 1981.

Fig. 8 shows the water management components observed in 1981. Water consumption rates ranged from 23 mm/day to 53 mm/day. These high values were caused by the porous soil layer originated the flood of the Chikugo River. Lot water requirements were ranged from 15 mm/day to 27 mm/day. The delivery water requirements were ranged from 15 mm/day to 50 mm/day.

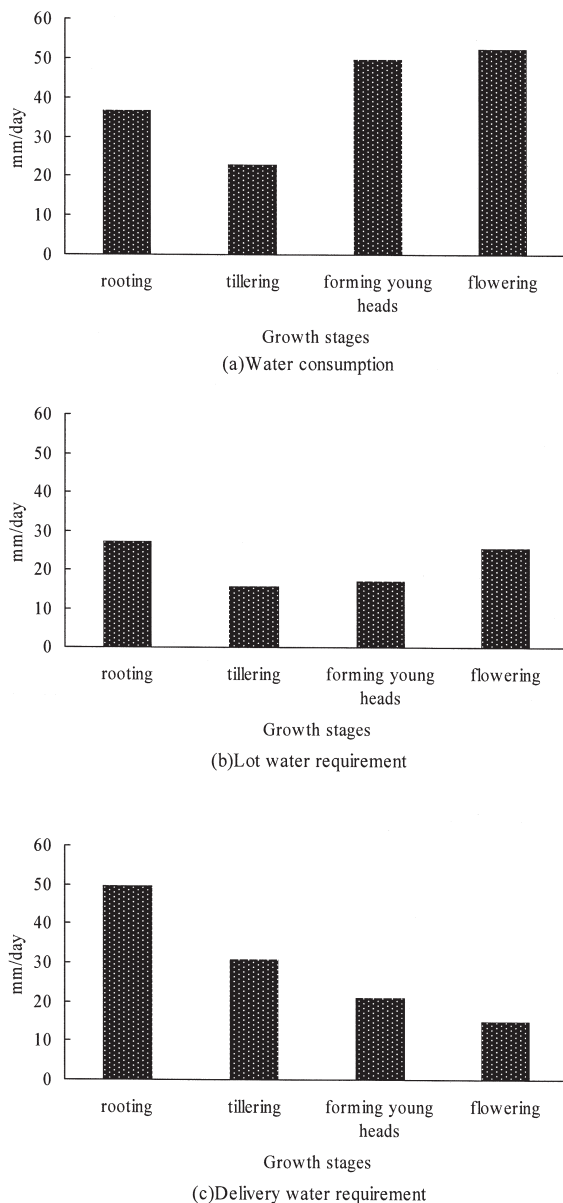
Fig. 9. Water management components in 1998.

Fig. 9 shows the water management components observed in 1998. Water consumption rates ranged from 20 mm/day to 52 mm/day. The values were almost the same range with the observation in 1981. Lot water requirement were ranged from 5 mm/day to 100 mm/day. Delivery water requirements were ranged from 25 mm/day to 137 mm/day. It will be emphasized that the maximum values of Lot water requirements and delivery water requirements were over twice of the values in 1981. It would be the results of decreasing the rice paddy area about 23.5%. Another reason would be decreased number of farmers. In the total command

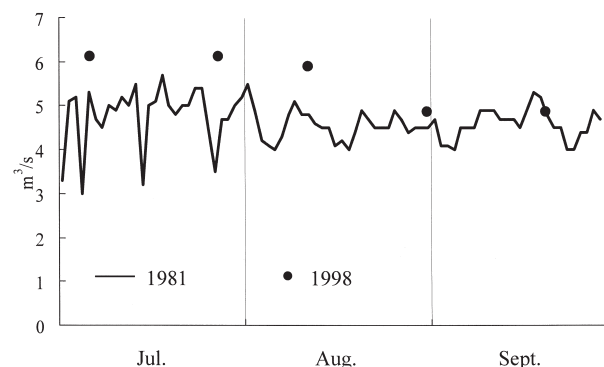
Fig. 10. Water intake rate at the head of the Yamada diversion dam.

Fig. 10 shows the water intake rate at the head of command area. Most of the values in 1981 ranged from 4 m³/s to 5 m³/s. These values were within the traditional water intake right 5 m³/s. The values in 1998 were ranged from 5 m³/s to 6 m³/s, though the observation data were not enough. It is interesting to note that the rice planted paddy area showed maximum value 755 ha in 1970, and decreased to 358 ha in 2,000. The percentages of decreasing were 52.6% during 30 years. But the water intake rates were not changed. The excessive irrigation water would be required for and delivery water managements.
