## Performance Assessment of Existing Korean School Building (I) : Mechanical and Physical Properties of the Rafter Members

## Performance Assessment of Existing Korean School Building (I) – Mechanical and Physical Properties of the Rafter Members –

The case study for this current research is the rafter members of the Iksan national college educational building in Korea. The roof system of the building has been recently remodeled. A sequence of studies has been carried out by the author on an assessment of the residual capacities of lumber found in this older structure.

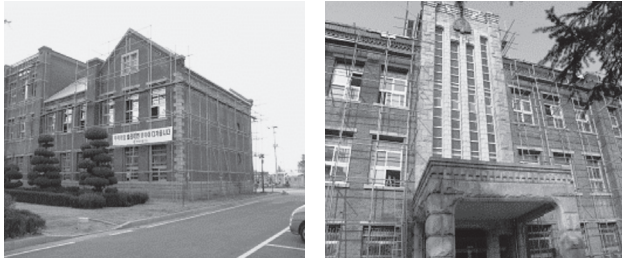
**Fig. 1.** The target building for current research.

The target building for this current research is the educational building of Iksan National College in Korea. The building has been used as a lecture hall since 1959. The age of the rafter members is therefore estimated to be 50 years. The building is of a mixed structural type, with stone, wood and brick. In 2007, the building was remodeled for the installation of a heating and air-conditioning system. The rafter members in the roof frame were procured for this study.

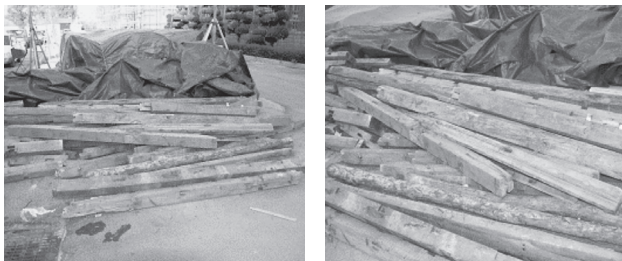
**Fig. 2.** Photos of rafter members.

group II. Group I were almost yellow or yellowish brown color, while, group II were almost light white color and some silk color. Figure 1 is the target building for current research and Fig. 2 is rafter members of target building. Figure 3 show the cross section cutting specimens of rafter members (Left: group I, Right: group II). The size and number of rafter members by group were presented in Table 1.

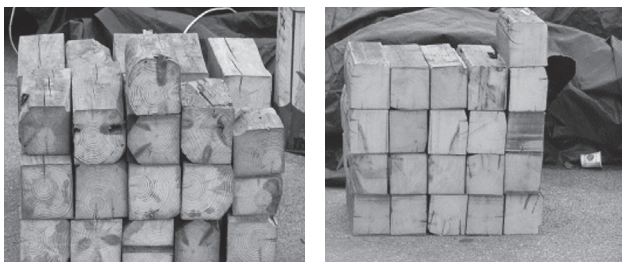
**Fig. 3.** The cross section cutting specimens of rafter members (Left: group I, Right: group II).

There were a total of 196 pieces as sample specimens. These 196 rafters were visually divided into two groups according to annual ring and cross-sectional features. (Group I: 99, group II: 97) Group I had straight and dense a grain of wood than that of group II. And group I had a narrow width of annual ring than that of group II. Also, group I showed a sudden transition of earlywood to late-wood and had a wide width than that of group II. Accordingly, group I had a coarse texture than that of

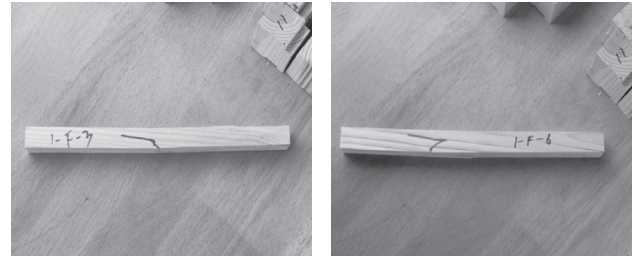
Fig. 5. Fracture mode of bending strength specimen for group 1.

Fracture modes of bending strength specimens are shown in Table 4, Fig. 5, Fig. 6, and Fig. 7. The main fracture mode of group 1 is the cross grain tension. The remaining fracture modes of simple tension, brash tension, and compression have the same proportion. In the case of group 2, the fracture modes are distinguished by a mixed mode rather than by one type. The most common case was that where a mixed fracture mode of com-

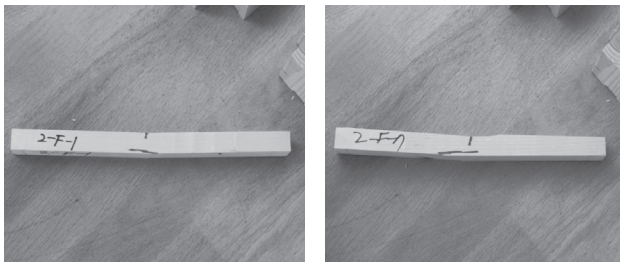
**Fig. 6.** Fracture mode of bending strength specimen for group 2.

pression and cross grain tension occurred simultaneously. The next most common case was that of a simple tension fracture mode.

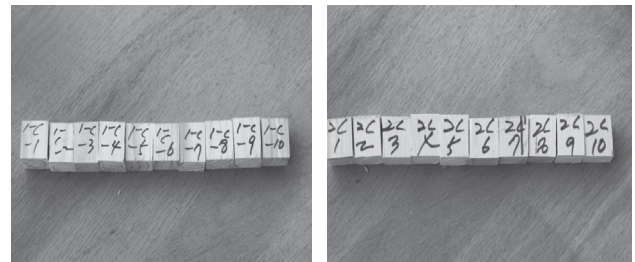
**Fig. 7.** Fracture modes of compressive strength specimens for groups 1 and 2.

The failure types for compressive strength are all crushing failure types with the exception of the splitting failure type for specimen 7 in group 2.
