# FATIGUE BEHAVIOR OF WELD ROOT CRACK AND STRUCTURAL RESPONSE IN ORTHOTROPIC STEEL DECKS

A Thesis Submitted  
In Partial Fulfillment of the Requirements  
For the Degree of  
**Doctor of Engineering**

to the  
DEPARTMENT OF URBAN AND ENVIRONMENTAL ENGINEERING  
GRADUATE SCHOOL OF ENGINEERING  
**KYUSHU UNIVERSITY**

Fukuoka, Japan  
September, 2017

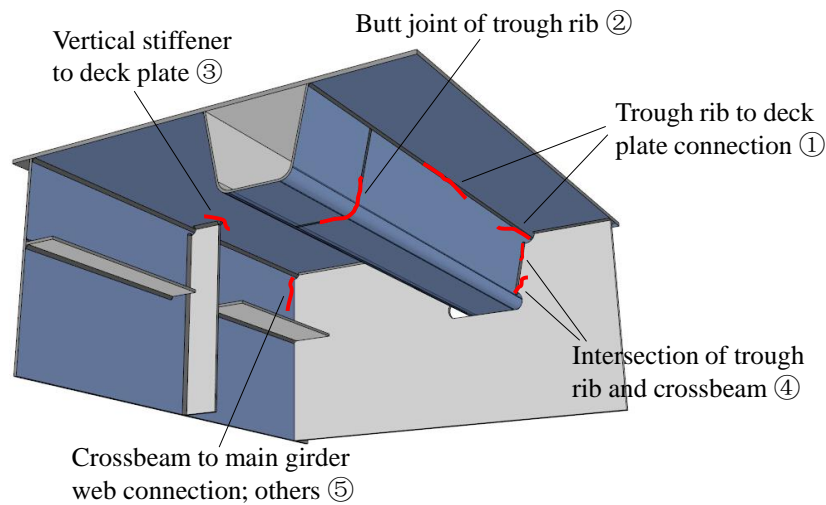
Figure 1.2 Typical fatigue cracks in orthotropic steel bridges

After 1975, the U-shape longitudinal rib was mainly used in OSD construction in Japan. For the bridge structure with U-ribs, the following typical fatigue cracks have been reported in recent years [15], as shown in Figure 1.2. These fatigue cracks mostly occurred at the welding connections between the ribs and crossbeams; the rib-to-deck welded joints; and the butt welds of trough ribs, etc. The proportion of typical crack types at the Metropolitan Expressway, Hanshin Expressway[18] and the statistical analysis on urban highway by Mori et al [14], as shown in Figure 1.3.

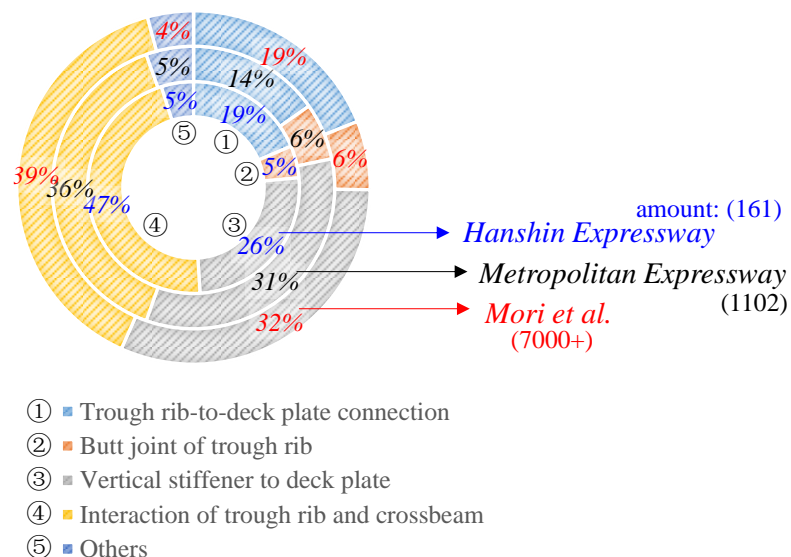
Figure 1.3 Occurrence proportion of typical fatigue cracks in Japan

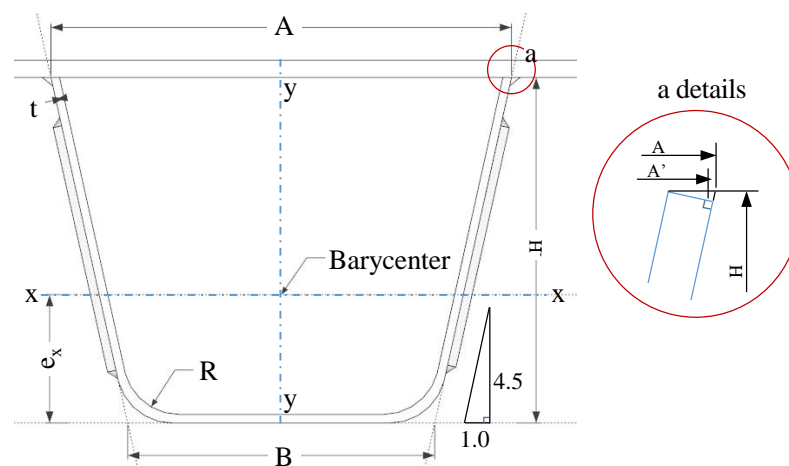
Figure 1.6 Typical shape of U-rib in orthotropic steel decks

recommendation by Japan Society of Steel Construction (JSS II 08-2006)[26], as shown in Figure 1.6.

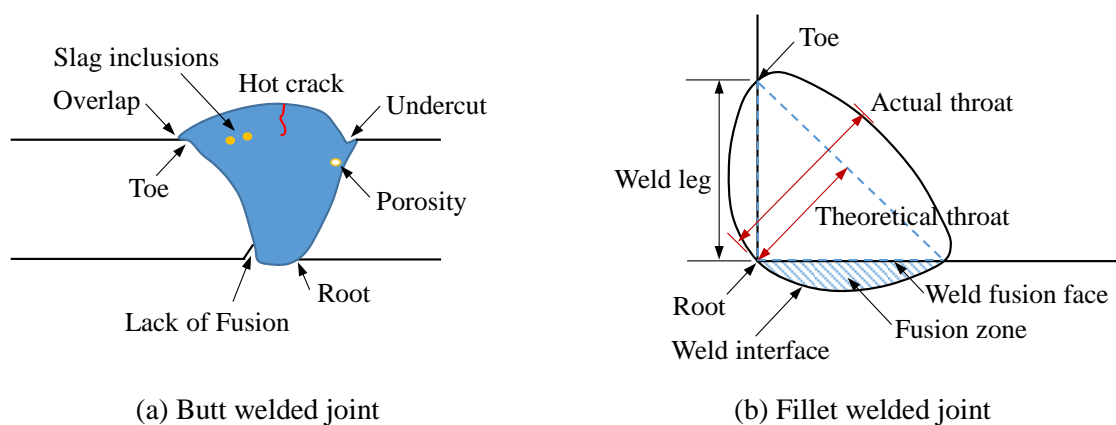
Figure 1.8 Cracks of butt weld and fillet welded joint

For a fatigue crack that initiates at the welded joint of OSD, such as weld root and propagates into the deck plate, it is nearly impossible to detect it in the early stage of propagation by visual inspection. The crack at root tip of butt weld and fillet welded joint as shown in Figure 1.8.

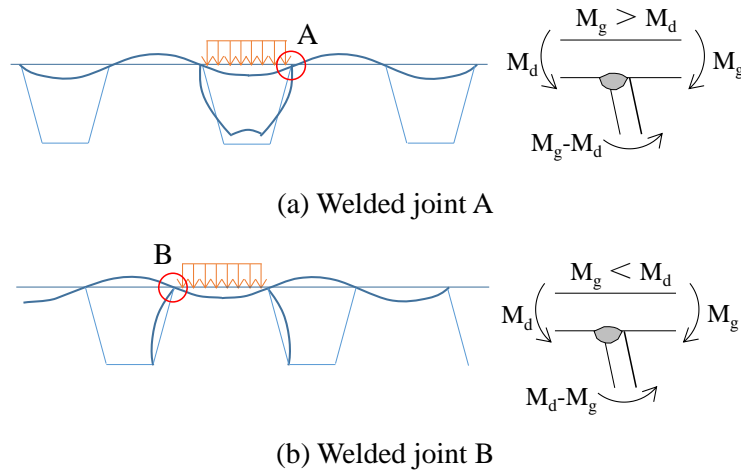
Figure 2.9 Local effects on rib-to-deck connection from wheel loading

The load transferred from the deck plate to the longitudinal ribs, and the local deformation of the deck plate from the wheel load results in transversal flexural stress in the deck and longitudinal rib. Transverse bending stress in deck plate, and local effects on ribs and rib to deck plate connection as shown in Figure 2.9.  $M_g$  is the moment in the deck plate in one rib,  $M_d$  is the moment in the deck plate between two ribs. As a result of transverse load distribution in the orthotropic deck, the ribs will experience local out-of-plane deformation causing transverse flexural stresses in the walls of the ribs.

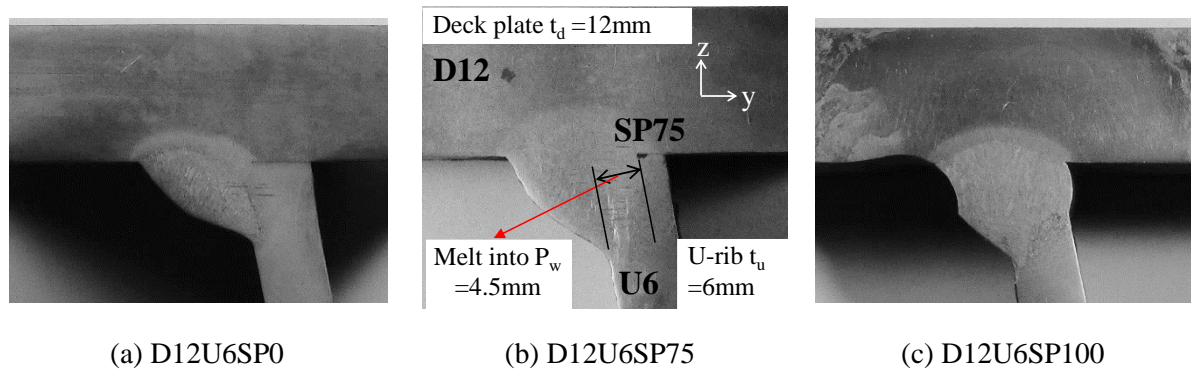
Figure 3.4 Weld joint photos of specimens in etching test

A total of 19 full-scale specimens were used in fatigue tests. The specimens were fabricated with 12, 14, and 16mm thick deck plates and 6 and 8mm thick U-ribs. The 12mm thick deck plate and 6mm thick rib are here referred to as D12U6 (the D and U values are the thicknesses of the deck plate and U-rib, respectively). The other combinations included D12U6, D16U6, D14U6, and D12U8. Three types of D12U6 specimens were fabricated, with 0%, 75%, and 100% weld penetration rates at the U-rib-to-deck connection, the photographs of the weld joints of the specimens after etching by a 5% nitric acid solution are shown in Figure 3.4. In the figure, the heat affected zone caused by the welding process can be observed. The welding area varies between the specimens with different penetration rates. The D12U8 specimens were fabricated with 50% penetration, and the D14U6 and D16U6 specimens were all fabricated with 75% penetration.

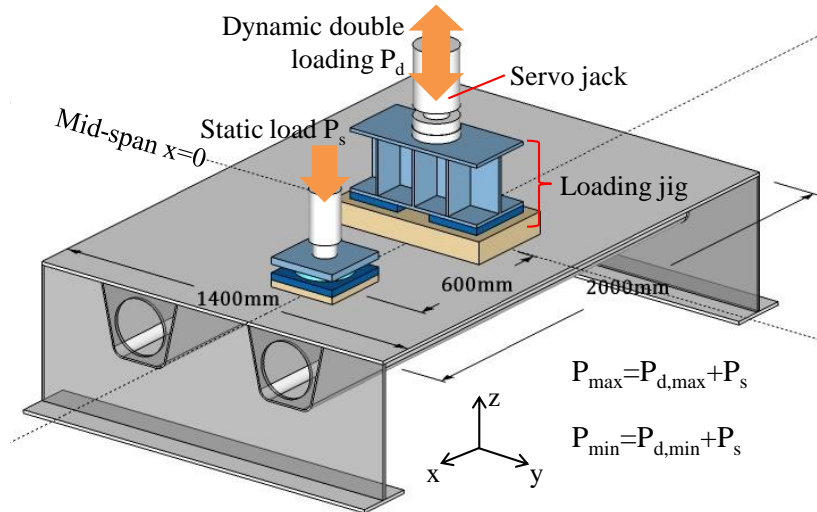
(a) Double-tire loading test

The test coordinates were set at the mid-span of a longitudinal U-rib ( $x=0$ ), and the static load side was the positive  $x$  direction. The blue line in Figure 3.5 (b) shows the target welded joint that was the focus of this study. The loading jig consisted of a loading brick, steel plate, and rubber plate. Double tire load was simulated by two 25mm-thick steel plates. The area size of tires are dependent on the pressure area of the actual tires 195mm×250mm [98], and there is a 130mm-width gap between the two plates. Below these steel load plates, the asphalt pavement of bridge was replaced with rubber plates, which edges were about 30mm beyond the borders of double tire. The rubber plate was used to ensure effective load dispersion, as shown in Figure 3.6. The properties of the rubber plates are summarized in Table 3.2 (b).

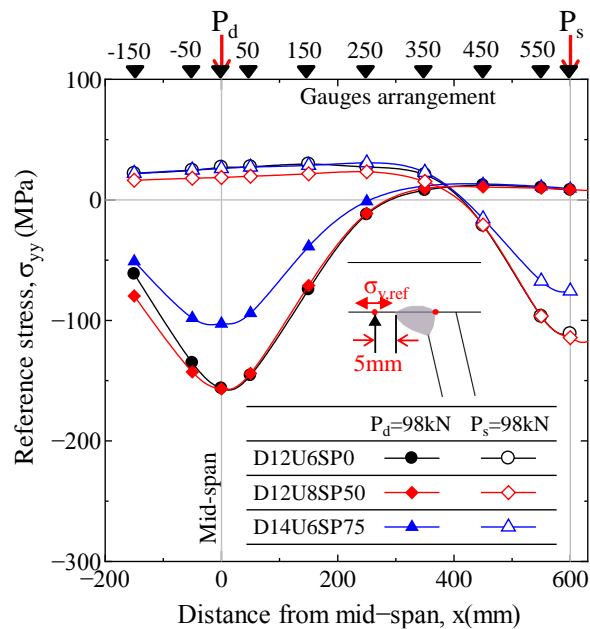
Figure 3.8 Reference strain distributions of static loading tests

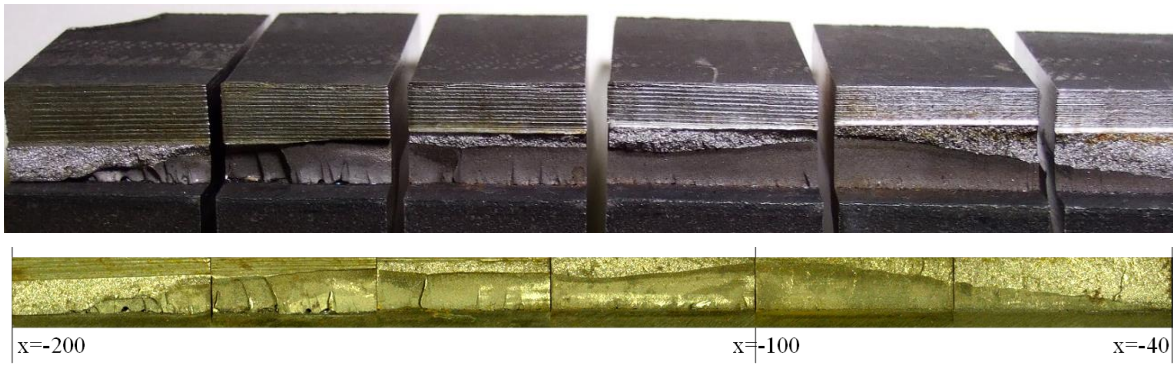
(a) Fracture longitudinal section of D12U6SP0-4 from -200 to -40 mm

The root crack fracture surface of D12U6SP0-4 in longitudinal is shown in Figure 3.13 (a). The fracture surface consists of some discontinuous fractures that could be multi-cracks initiated by the root crack and eventually forming a large crack. The corresponding crack patterns of other specimens by MPT inspection are shown in Figure 3.13.

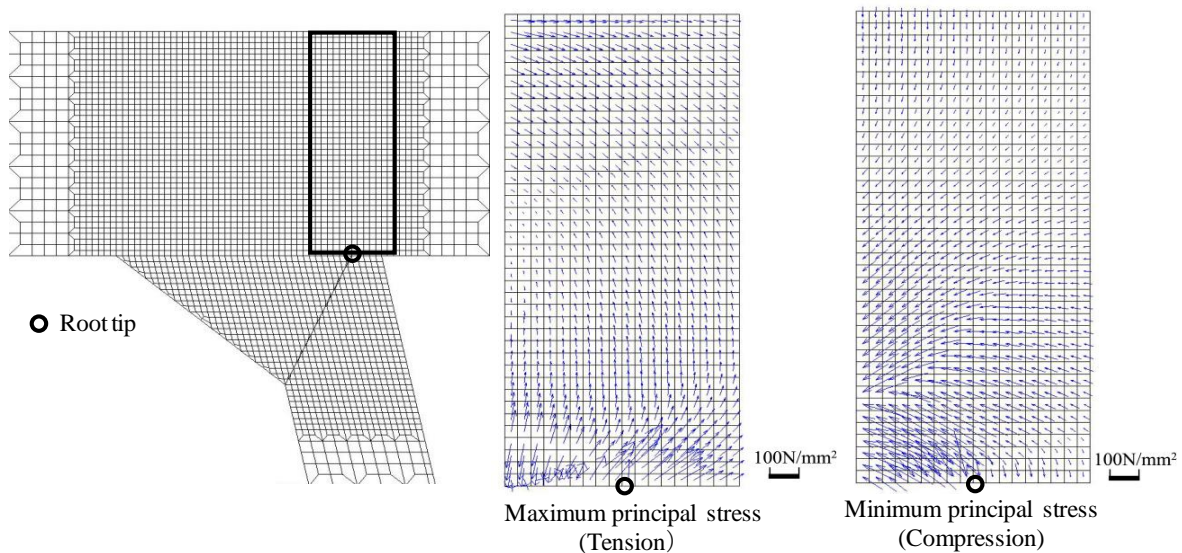
Figure 4.9 FE analysis on principal stress of D12U6SP75G0

Figure 4.9 shows the principal stress in the standard orthotropic steel deck (deck plate = 12 mm, U-rib = 6 mm, weld penetration = 75%, and root gap = 0 mm), which was calculated from the analysis results [27]. The tensile residual stress near the root tip was located at approximately 45° and was similar to the crack initiation and propagation in actual orthotropic steel decks. The tensile residual stress in the deck surface was slightly higher than that in the central part, and the angle of the principal stress was 45°. Thus, the principal stress was similar regardless of the thickness of the deck plate and U-rib, the weld penetration, and the root gap.

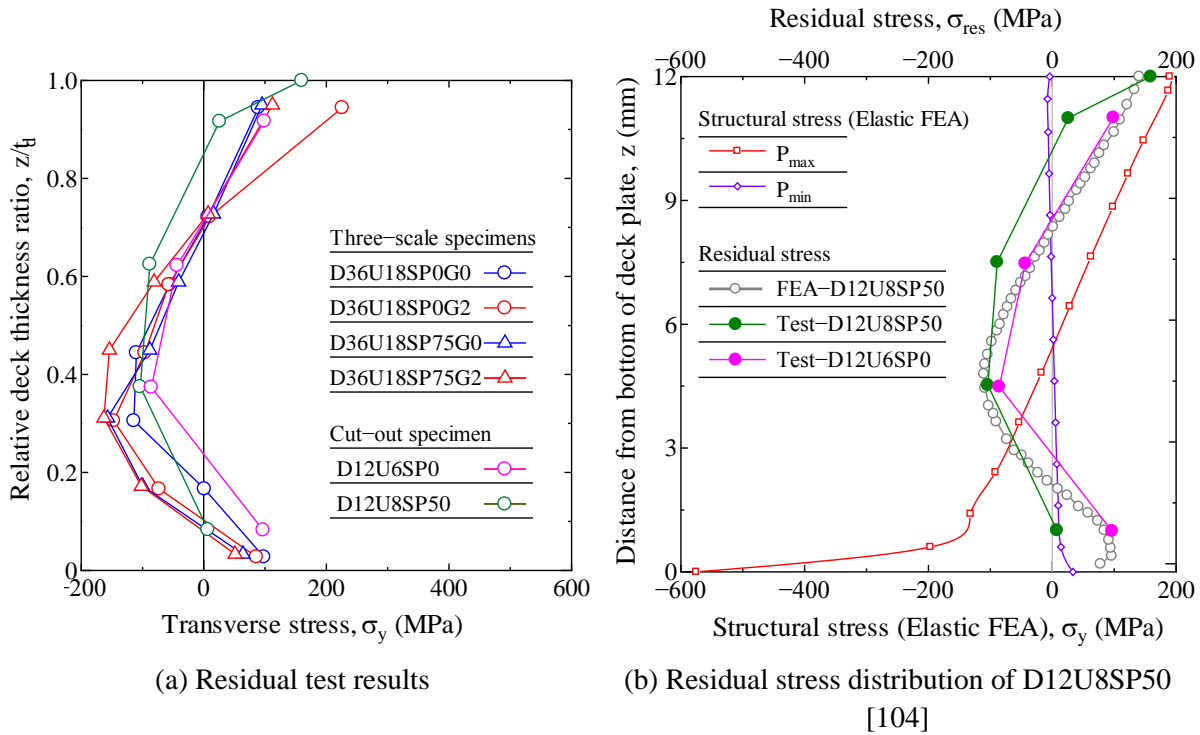
Figure 4.11 Residual stress distribution comparison

However, the residual tensile stress would be released after crack initiation and propagation. The structural stress distribution in z direction of deck plate was calculated according to the basic specimen, as shown in Figure 4.11 (b). It was compared with the FE and measured initial residual stress of this structural detail in deck thickness direction, the residual stress occurs could lead to increase the maximum tensile stress value of effective stress. Compressive stress areas of initial residual stress near the neutral axis ( $z=6\text{mm}$ ) also proved the tensile stress in crack top may be offset and lead to crack propagation stop.

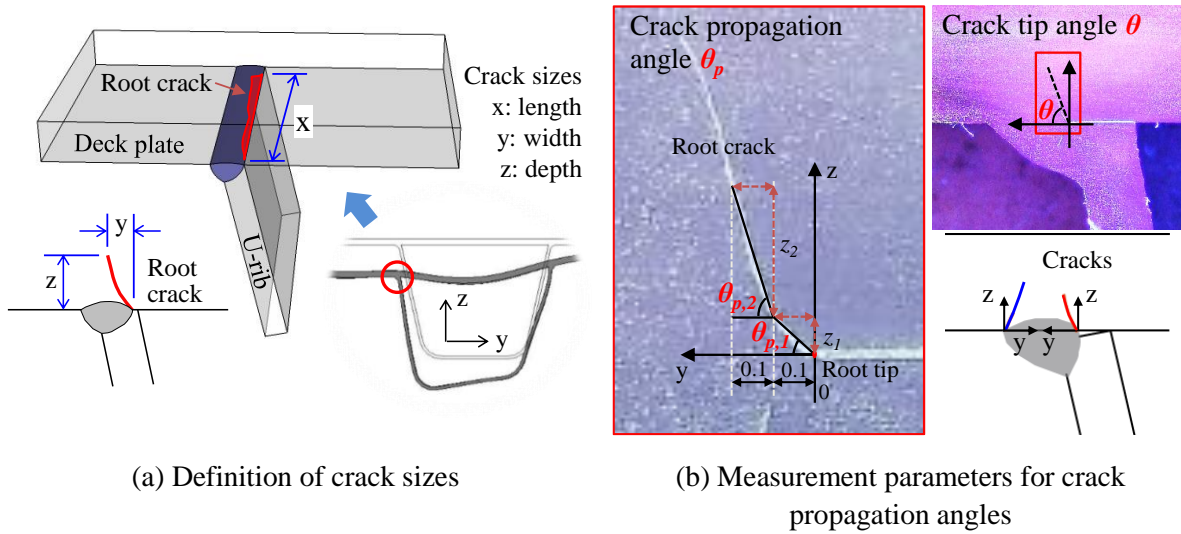
Figure 4.13 Definition of root crack parameters

crack propagation angle  $\theta_p$ . At the same time, the crack tip angle was defined as  $\theta$ , as shown in Figure 4.13 (b). The local coordinate origin was located at the crack initiation point.

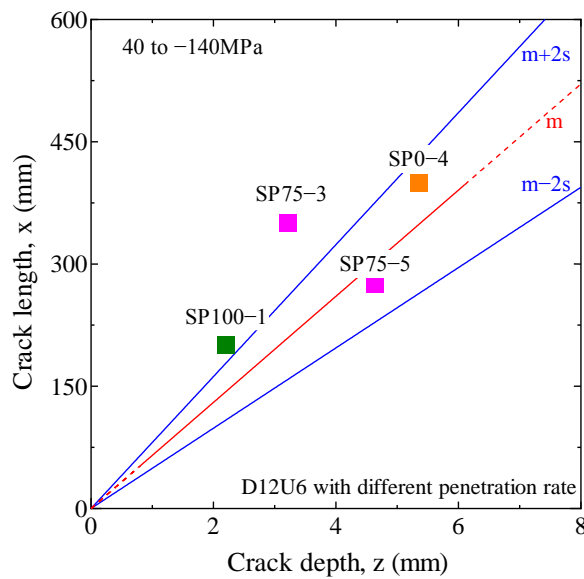
Figure 4.17 Relationship between crack depth and length (Effect of penetration rate)

Based on the calculated mean and confidence limits of Figure 4.14, the crack length and depth of specimens with a tested stress range of 40 to -140MPa, are plotted in Figure 4.17. It is obvious that both the crack depth and crack length decrease with an increase in the penetration rate in the case of a high stress ratio.

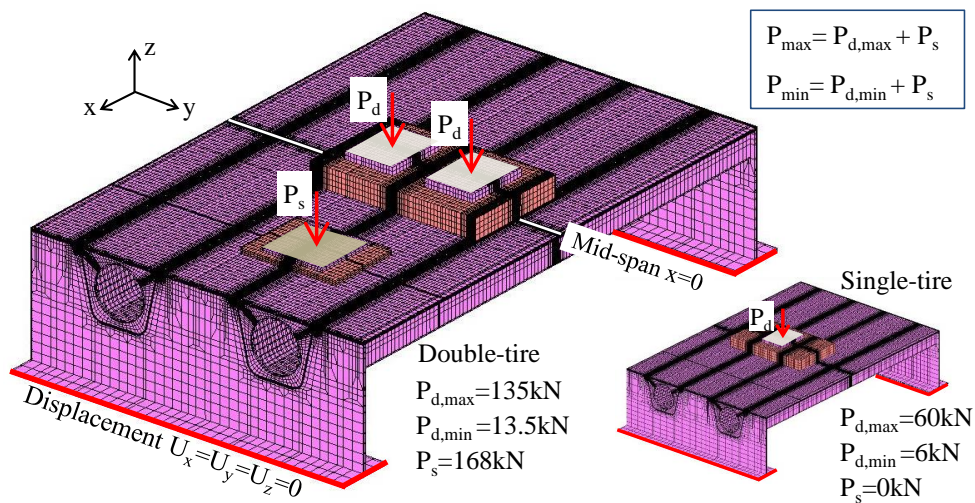
Figure 5.1 FE models and the loading conditions

Different plate thickness and penetration rates were considered, the boundary conditions of D12U6SP75 model were set as the same primary loading conditions of its corresponding specimen. In the presence of a flaw or slots at the root gap, the direction and value of maximum principal stress near root tip could be totally influenced [109]. There are linear and triangular shaped root gaps that exist in the tested specimens. In this study, elastic models were simulated with for the abovementioned two kinds of root gaps at partial joint penetration, hereafter referred to as “line-gap” and “tria-gap” models. The root gap shapes and welded joint dimensions were simulated as illustrated in Figure 5.2 (a, b).

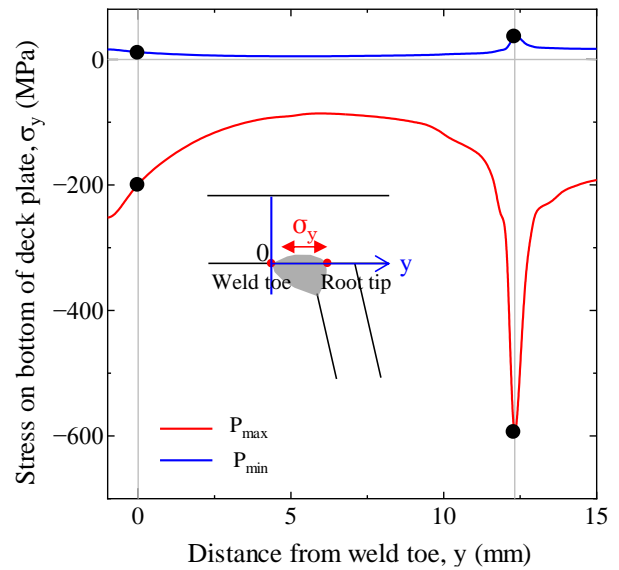
Figure 5.5 Stress distribution at welded joint of model D12U8SP50

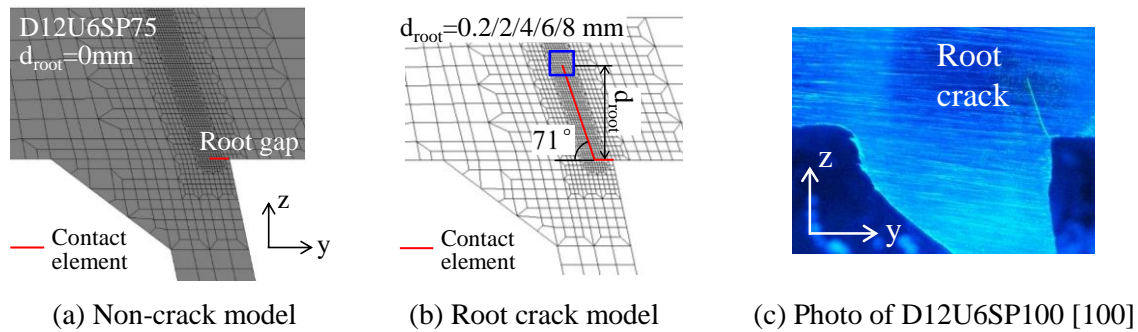
Figure 5.6 Definitions of FE Analytical model

To examine the stress response in rib-to-deck joint after the root crack occurred, artificial root cracks with projected depths of 0.2/2/4/6/8 mm that based on the root crack measurements of tested specimens, were simulated in FE models D12U6SP75, as shown in Figure 5.6. The finite element analyses were performed on the basis of the contact analysis model.

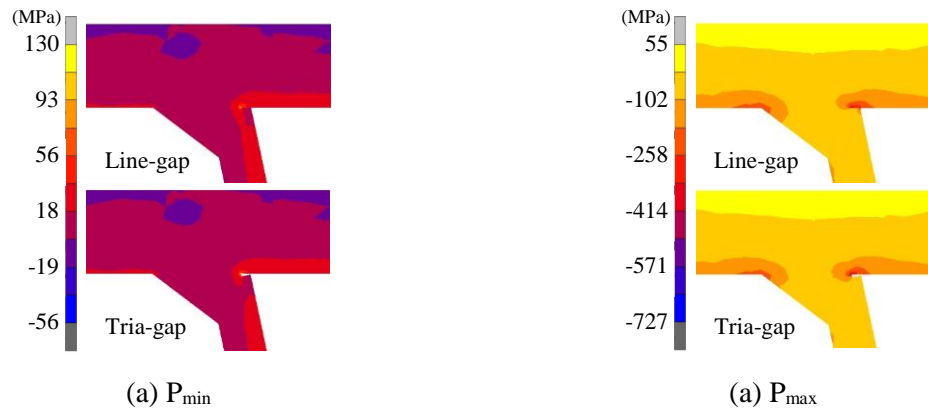
Figure 5.10 Major principal stress contours

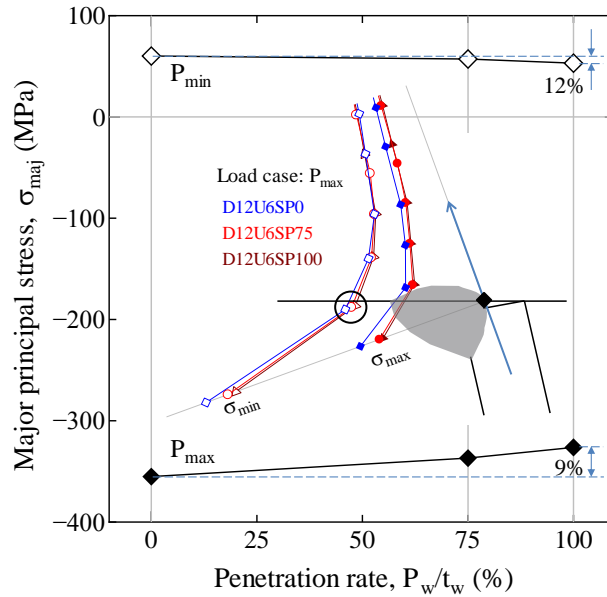
Figure 5.11 Effect of weld penetration rate on root tip stress of D12U6

No matter for U6 or U8 specimens, different penetration rate would lead to the stress range fluctuates at root tip. The tendency of penetration rate effect could also be changed by the geometry of root gaps. Therefore, the penetration rate could affect the fatigue life of the structure, up to a point. However, relative to the rib-to-bead crack, the larger penetration rate were not the crucial factor for rib-to-deck cracking.

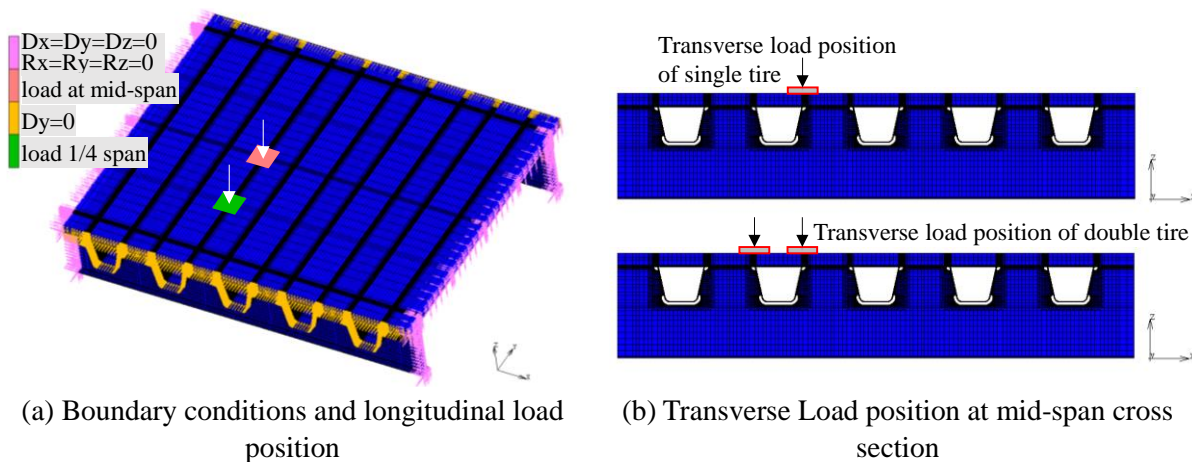
Figure 6.4 FE model of solid elements

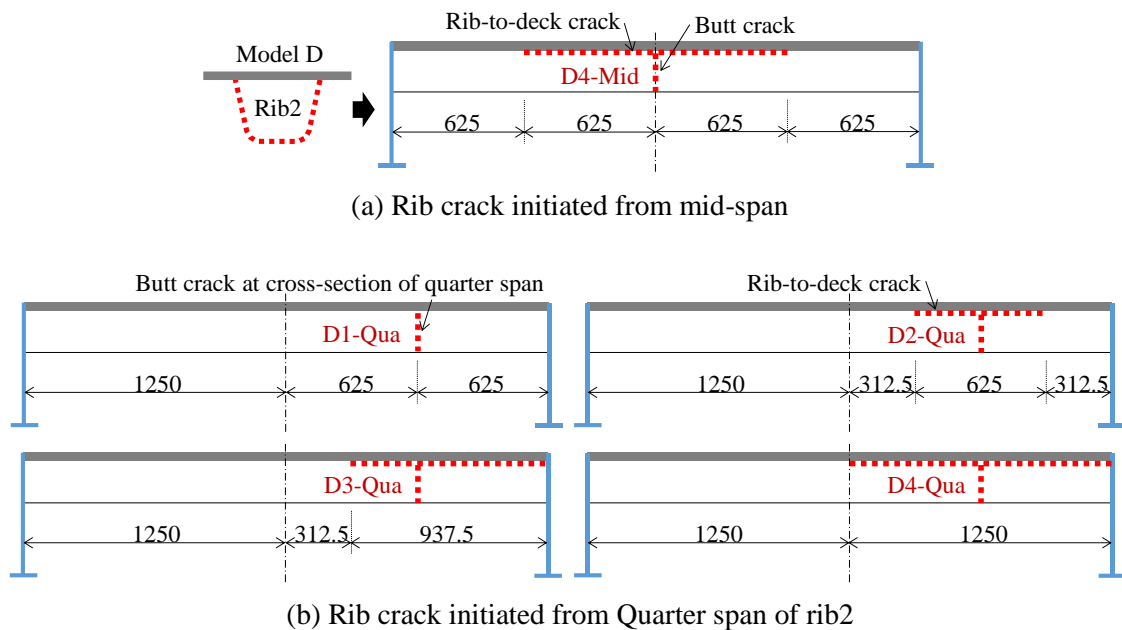
Figure 6.10 Images of artificial cracks in FE models (Unit: mm)

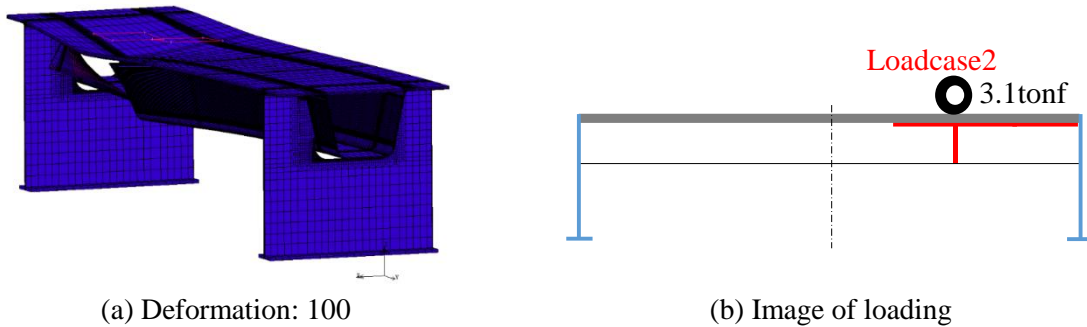
Figure 6.12 Deformation of D3-Qua model

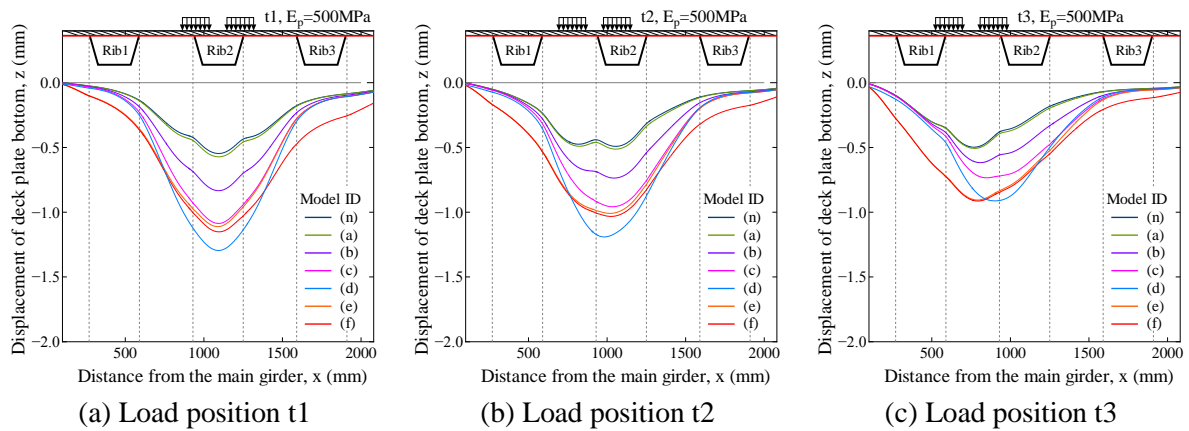
Figure 7.5 Deformation of the deck plate

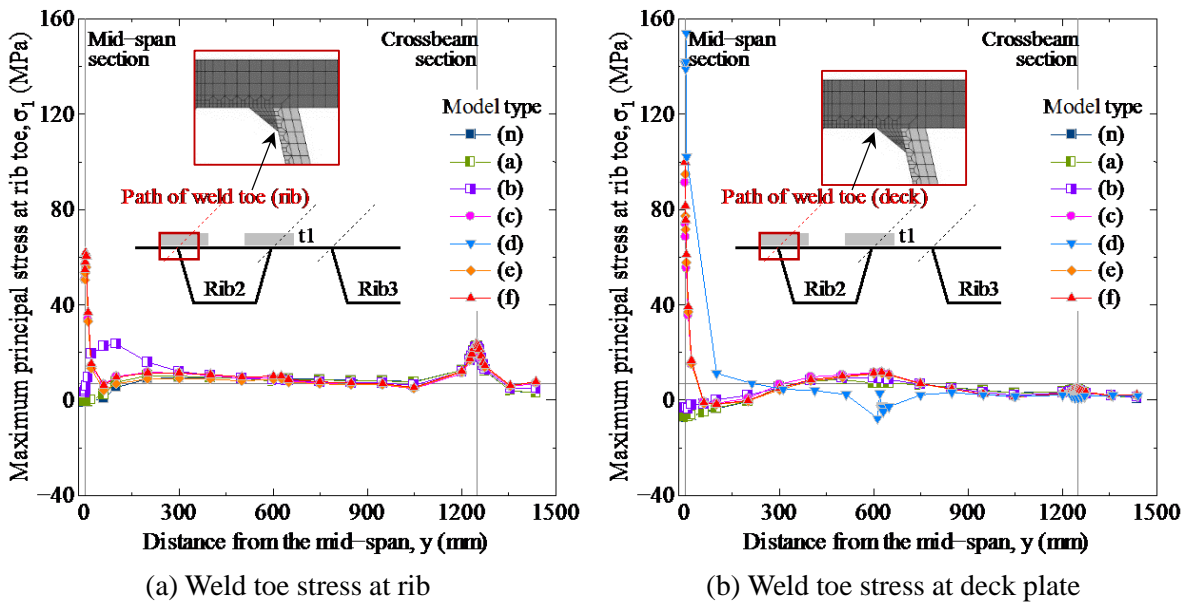
Figure 7.8 Stress distributions at rib-to-deck connections in longitudinal direction
