Erosion in the Western Middle Mountain Watersheds of Nepal : A Review

Erosion in the Western Middle Mountain Watersheds of Nepal: A Review

Prem P. PAUDEL*, Jagannath JOSHI* and Hiroshi OMURA**

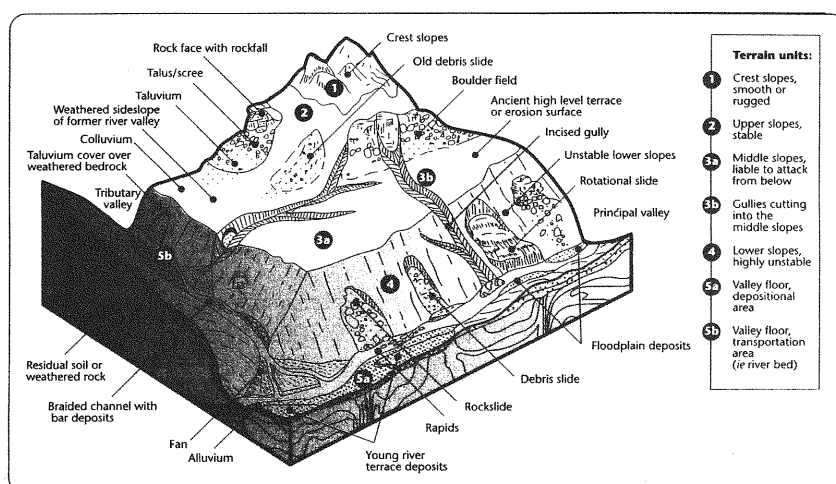
Fig. 1. Schematic cross-section of a typical mountain valley slope in the middle mountain (After Fookes *et al.*; 1985 and Transport Research Laboratory 1997).

common, while on the densely populated middle hill large number of slope failure occur frequently. The Siwalik region is unstable due to fragile geology, and the Terai region has flat plain with flood and sedimentation problem. Thus mountain slopes rarely achieve a truly straight profile because of above mentioned different features as well as variations of rock type, structure and weathering environment. The history of Himalayan geo-morphology is one of a continuous succession during periods of rapid adjustment towards a more stable state i.e. slope angle have been reduced. In the present landscape of the middle mountains five different principle slope elements are identified and they are ridge top of 15° – 45° , upper slope of 15° – 25° , mid slope of 20° – 30° , lower slope of 30° – 45° , and river valley of 0° – 15° (Howell 1999). The schematic cross section of a typical mountain valley slope of the middle mountain is shown in Figure 1.

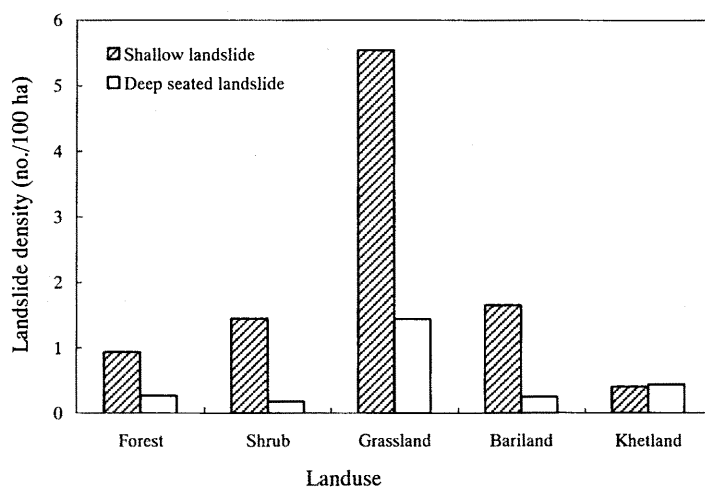
Fig. 3. Density of landslides by landuse type.

The landslides occurred in the watersheds are classified as shallow type and deep seated one. The former one has a scale within a depth of 1.0 m to 3.0 m and affected area size is 100–3000 m². The latter is deeper than 3.0 m and of more than 3000 m². Landslides in each watershed is listed in Table 1. Concerning about the density per 100 ha by land use type is the largest at grassland with 6.98, followed by Bari land with 1.90, shrub with 1.63,

forest with 1.20 and Khet land with 0.85 (Figure 3). In terms of slope, the density is greatest at more than 30° slope category (Figure 4). One of the probable reason for higher number of landslide density in grassland is due to thick soil cover, low vegetation coverage and shallow rooting system. The density of landslide in Parbat south watershed is highest among others. This might be due to deeply weathered bed rocks eroded by undercutting effect of Argaudi stream. An example of a deep seated landslide is shown in Photo 1.

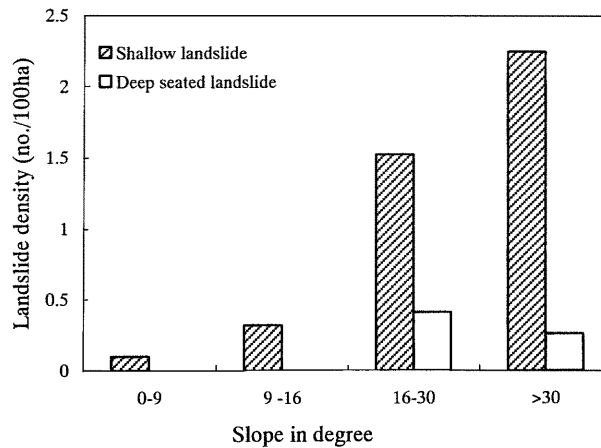
Fig. 4. Density of landslides by slope category.

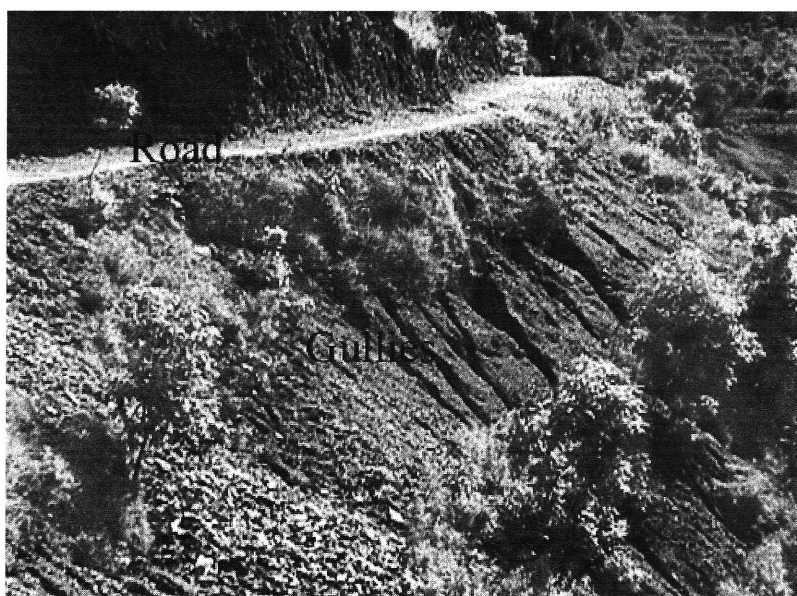
Photo. 2. V shape gully formation on filled bank slope formation below the road.

The gully erosion has occurred mainly due to an increase of surface run-off because of over-grazing, improper farmland management, construction of trails and rural roads without side drainage. It looks more serious in cultivated land. There are so many gullies in the watersheds most prominent areas are in Kaski North and Parbat south area. The conditions of gullies are presented in Table 2, where the shape of gullies depends on soil properties and direction of flow of water in the ground. The U shape gully is formed if the resistance of the subsoil against erosion is equals with that of the top soil. On the contrary V shape gully is formed if the subsoil is more resistive than the top soil (HMG/JICA 1998a). The view of gully formation in filled bank slope is shown in Photo 2.

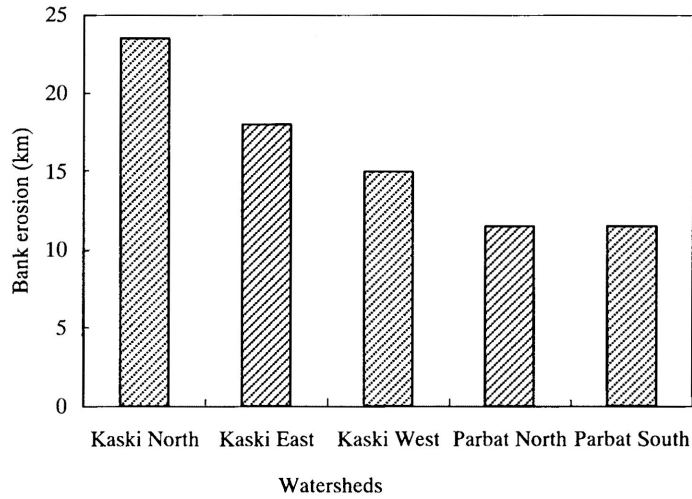
Fig. 5. Condition of bank erosion at both sides of streams.

mainly during monsoon season. The bank erosion on both sides of the streams of each watershed is shown in Figure 5. The erosion in Kaski North watershed is highest. It might be due to activities of major tributaries like Bijayapur stream, Kali stream, and Bhoti streams. A typical example of bank erosion is shown in Photo 3.

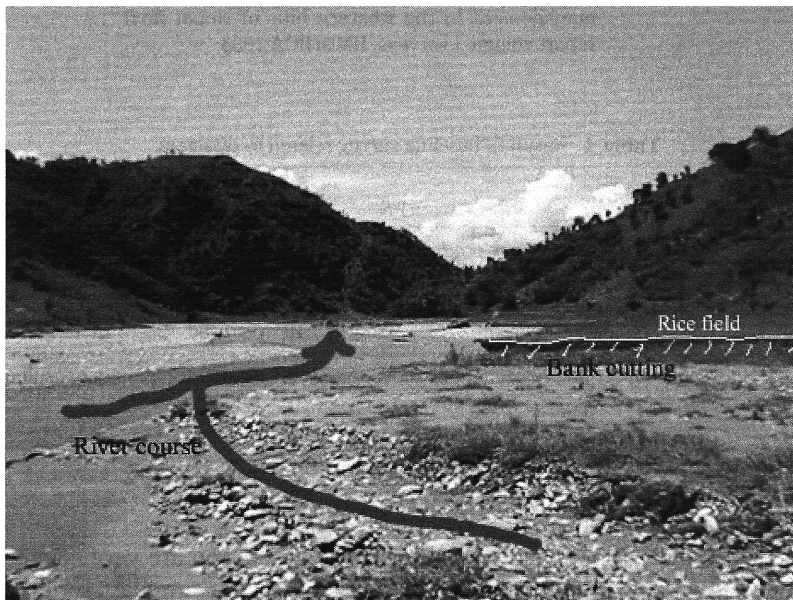
Photo. 3. View of Bank cutting by Bijayapur stream in Kaski North Watershed area.
