Stability of Deep Underground Openings through Large Fault Zones in Argillaceous Rock

Abstract: The stability of underground openings is pivotal to sustainable safe mining in underground coal mines. To determine the stability and tunneling safety issues in 800-m-deep underground openings through large fault zones in argillaceous rocks in the Guqiao Coal Mine in East China, the pilot industrial test, laboratory experimentation, and field measurements were used to analyze the large deformations and failure characteristics of the surrounding rock, the influence factors of safe excavation and stability of underground openings, and to study the stability control countermeasures. The main factors influencing the stability and tunneling safety include large fault zones, high in situ stress, poor mechanical properties and engineering performance of the argillaceous rock mass, groundwater inrush and gas outburst. According to the field study, the anchor-ability of cables and the groutability of cement-matrix materials in the argillaceous rock in the large fault zones were extremely poor, and deformations and failure of the surrounding rock were characterized by dramatic initial deformation

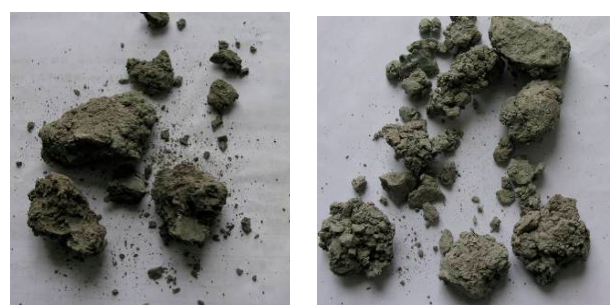
**Figure 12.** Weathering and disintegration of saturated argillaceous rock.

As shown in Figures 11 and 12, argillaceous rock specimens were in full argillization after one day with water immersion, except Specimens 4 and 6, indicating that argillaceous rock containing substantial amounts of water-sensitive clay minerals will undergo evident softening, argillization, swelling, dissolution, and weakening when in contact with water and will easily disintegrate and weather after air drying. The experimental results show that the argillaceous rock, in the south underground openings through large fault zones, is hydrophilic swelling soft rock, sensitive to disintegrating and weathering, with a high erosion rate. Groundwater seepage and construction water should be a focus during excavation and support.
