Stability of Deep Underground Openings through Large Fault Zones in Argillaceous Rock

Abstract: The stability of underground openings is pivotal to sustainable safe mining in underground coal mines. To determine the stability and tunneling safety issues in 800-m-deep underground openings through large fault zones in argillaceous rocks in the Guqiao Coal Mine in East China, the pilot industrial test, laboratory experimentation, and field measurements were used to analyze the large deformations and failure characteristics of the surrounding rock, the influence factors of safe excavation and stability of underground openings, and to study the stability control countermeasures. The main factors influencing the stability and tunneling safety include large fault zones, high in situ stress, poor mechanical properties and engineering performance of the argillaceous rock mass, groundwater inrush and gas outburst. According to the field study, the anchor-ability of cables and the groutability of cement-matrix materials in the argillaceous rock in the large fault zones were extremely poor, and deformations and failure of the surrounding rock were characterized by dramatic initial deformation

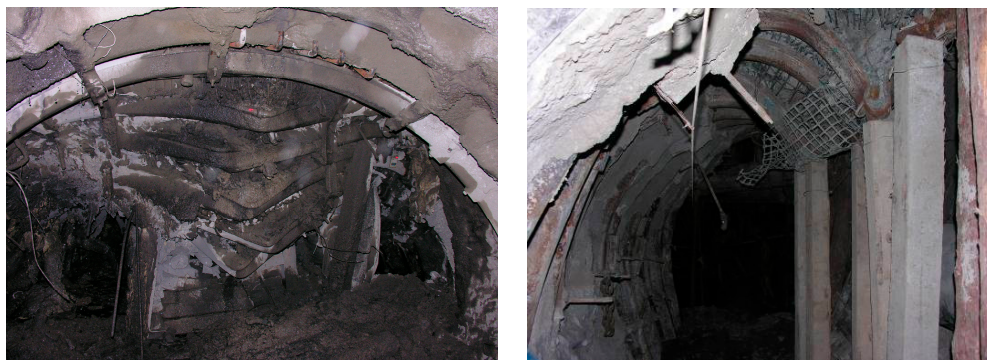
Figure 3. The debris flow and roof collapse at the tunneling face near fault FD108.

The roof collapse occurred in the south rail underground opening under support Scheme 1 when the tunneling face reached fault FD108. Scheme 5, including the 8 m-long borehole pre-grouting and pilot heading method, was then used in the south rail underground opening from fault FD108 toward the south. Nevertheless, the southern roof collapse occurred again when Scheme 5 was used as the tunneling face approached the G5 + 53 m area in the south haulage underground opening. The roof collapse in the south underground opening is shown in Figures 3 and 4.

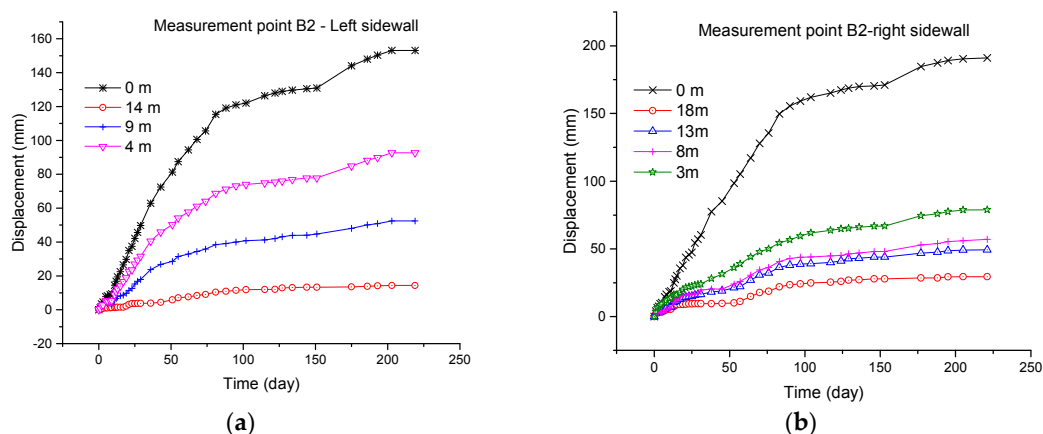
Figure 9. Displacements of deep surrounding rock at measurement point B2, 19 m away from fault FD108-1: (a) left sidewall; and (b) right sidewall.

The absolute displacements of the 4 m-deep point, 9 m-deep point, and 14 m-deep point within the left sidewall were 93, 52, and 14 mm, respectively, which accounted for 61%, 34%, and 9% of the total displacement of 153 mm between 0 m and the 21-m-deep point, respectively (Figure 9a). The absolute displacements of the 3 m-deep, 8 m-deep, 13 m-deep, and 18-m-deep points within the right sidewall close to the south haulage underground opening were 79, 57, 49, and 29 mm, respectively, which accounted for 41%, 30%, 26%, and 15% of the total displacement of 191 mm between the 0 m and the 25 m-deep point, respectively (Figure 9b).

The displacements were mainly concentrated in the area from the surface (0 m) to 8–9 m deep in the surrounding rock mass. More precisely, the displacement within the 0–9 m-deep rock mass (101 mm = 153 mm – 52 mm) occupied 66% of the total (153 mm) of the left sidewall. Similarly, the displacement within the 0–8 m-deep rock mass (134 mm = 191 mm – 57 mm) accounted for 70% of the total (191 mm) at the right sidewall. Therefore, the deep holes post-grouting should be used to improve the strength and intactness of 8–9 m-deep surrounding rock mass.

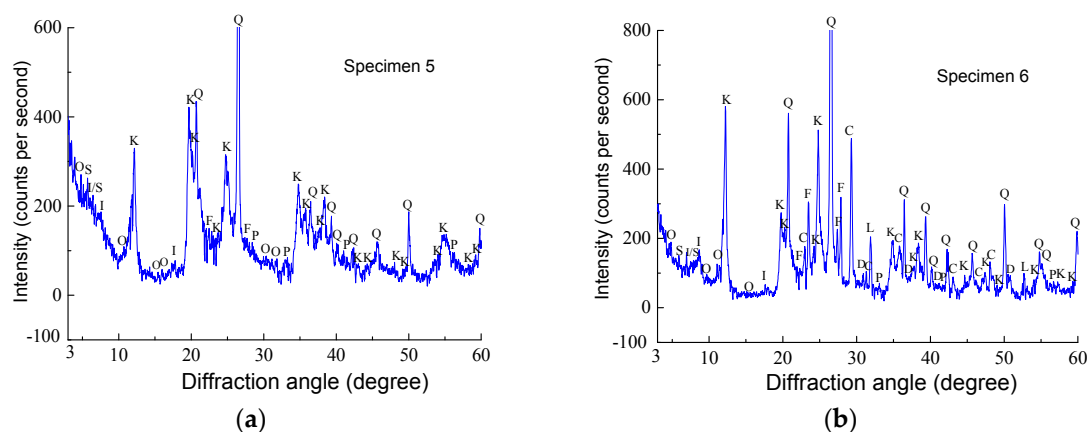
Figure 10. X-ray diffraction patterns of specimens: (a) Specimen 5; and (b) Specimen 6.

The Illite, Smectite, and Illite-Smectite interstratified minerals content in Specimens 4, 5, and 6 were 27%, 25.8%, and 26.7%, respectively. The kaolinite content in Specimens 4, 5, and 6 was 56.1%, 55.9%, and 45.2%, respectively. Therefore, the rock surrounding the south underground openings through the large fault zones consist of more than 70% clay minerals. The argillaceous rock contains substantial amounts of water-sensitive clay minerals and undergoes argillization when it is subjected to water.

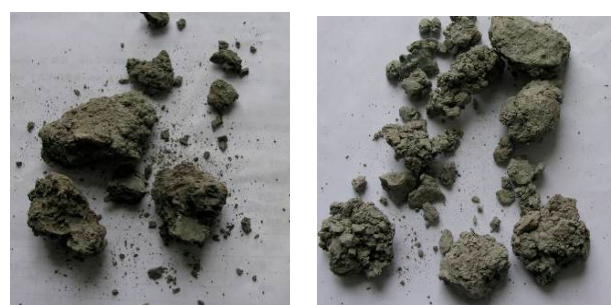
**Figure 12.** Weathering and disintegration of saturated argillaceous rock.

As shown in Figures 11 and 12, argillaceous rock specimens were in full argillization after one day with water immersion, except Specimens 4 and 6, indicating that argillaceous rock containing substantial amounts of water-sensitive clay minerals will undergo evident softening, argillization, swelling, dissolution, and weakening when in contact with water and will easily disintegrate and weather after air drying. The experimental results show that the argillaceous rock, in the south underground openings through large fault zones, is hydrophilic swelling soft rock, sensitive to disintegrating and weathering, with a high erosion rate. Groundwater seepage and construction water should be a focus during excavation and support.

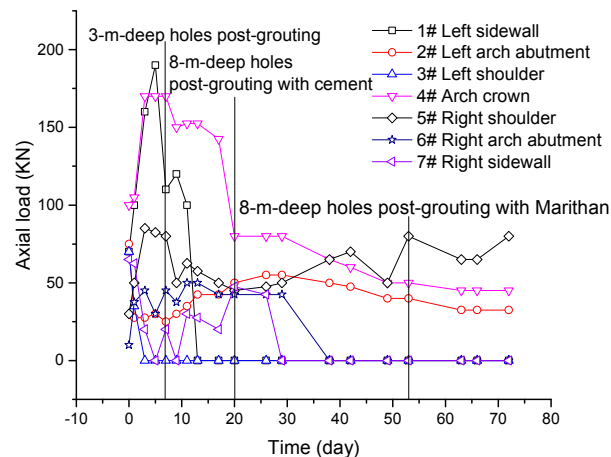
Figure 15. Axial loads of cables installed before shotcrete and 3 m-deep holes post-grouting during re-excavation.

Figure 15 presents the curve of the axial loads of cables at SJ52 + 92 m during re-excavation when cable installation occurred before shotcrete and 3 m-deep holes post-grouting. The axial loads of cables first increased but then suddenly decreased. The axial loads of the cables underwent plummeting and unloading phenomena. The anchor-ability of cables within argillaceous surrounding rock was extremely poor.

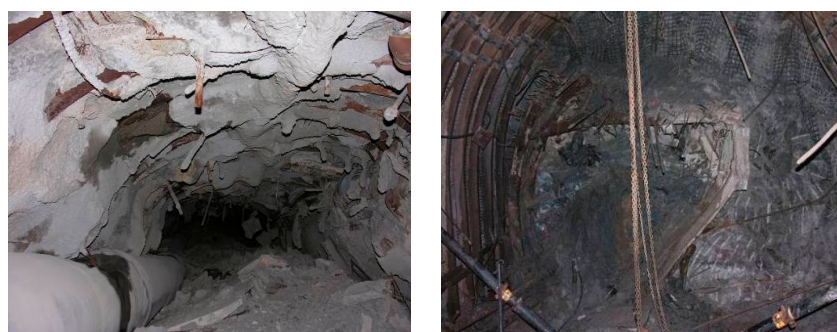
Figure 18. Failure of the deep underground openings through large fault zones in argillaceous rock.

The deformations and failure of the deep underground openings before re-excavation were extremely serious (Figure 18).

The areas of the residual cross-sections were less than 4 m². Most cross-sections of the deep underground openings in the large fault zones were closed. The underground opening was re-excavated by hand air drill. The optimized support measures during re-excavation are illustrated as follows.

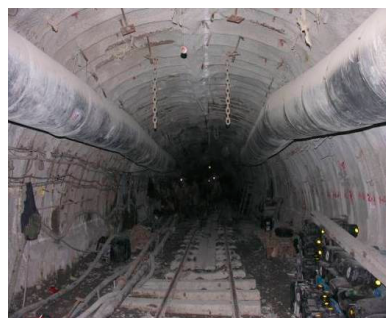
Figure 26. Support effect after 8 m-deep holes post-grouting with Marithan®.

A total of 158 days later, according to Figure 25, the creep rates of sidewall-to-sidewall, roof-to-floor, the left sidewall, the right sidewall, the roof, and the floor were 0.36 mm/day, 0.71 mm/day, 0.21 mm/day, 0.14 mm/day, 0 mm/day, and 0.71 mm/day, respectively. The total corresponding displacements were 413 mm, 1142 mm, 257 mm, 156 mm, 3 mm, and 1139 mm, respectively. In addition, the displacements showed asymmetry during re-excavation. The displacements of the left sidewall (257 mm) and the floor (1139 mm) were much larger than those of the roof and the right sidewall, which represented 62% and 99% of the roof-to-floor (1142 mm) and sidewall-to-sidewall (413 mm) deformations, respectively. Compared to the displacements during the pilot excavation, the displacements decreased considerably during re-excavation. Compared with the displacements of sidewall-to-sidewall (1852 mm) and roof-to-floor (3259 mm) at measurement point C7 during the pilot excavation, the displacements decreased considerably by 78% and 65%, respectively, during re-excavation. The support effect is shown in Figure 26.
