# DURABILITY STUDY ON 150 MPa HIGH STRENGTH MORTAR WITH MICRO FIBER AND CRACKS UNDER CHLORIDE ENVIRONMENT FROM THE VIEWPOINT OF STEEL CORROSION

Loke Yen Theng, Hidenori Hamada, Yasutaka Sagawa, Daisuke Yamamoto, Hirotaka Hazehara\*, Tadaaki Nozawa\*\*, Yuki Kobayashi\*\*

## Background

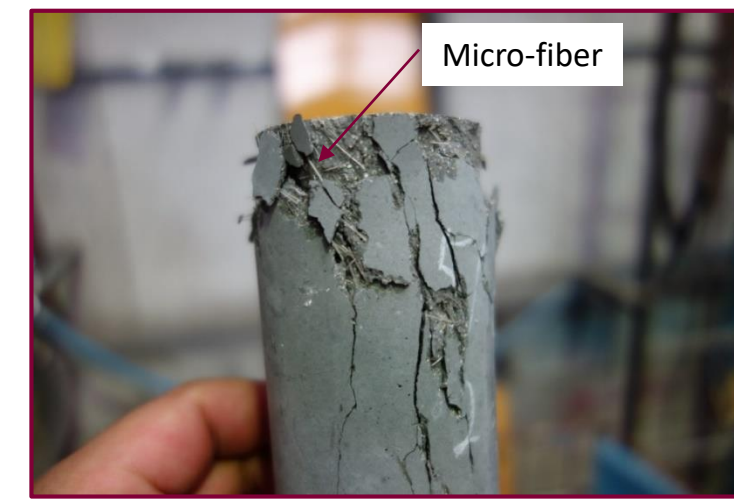
Micro fiber used in high strength mortar

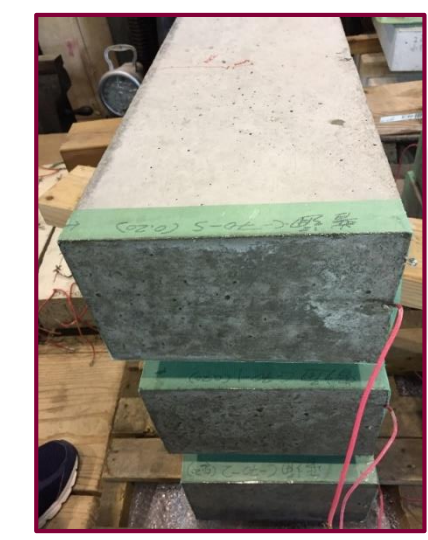
Both ends coated with epoxy

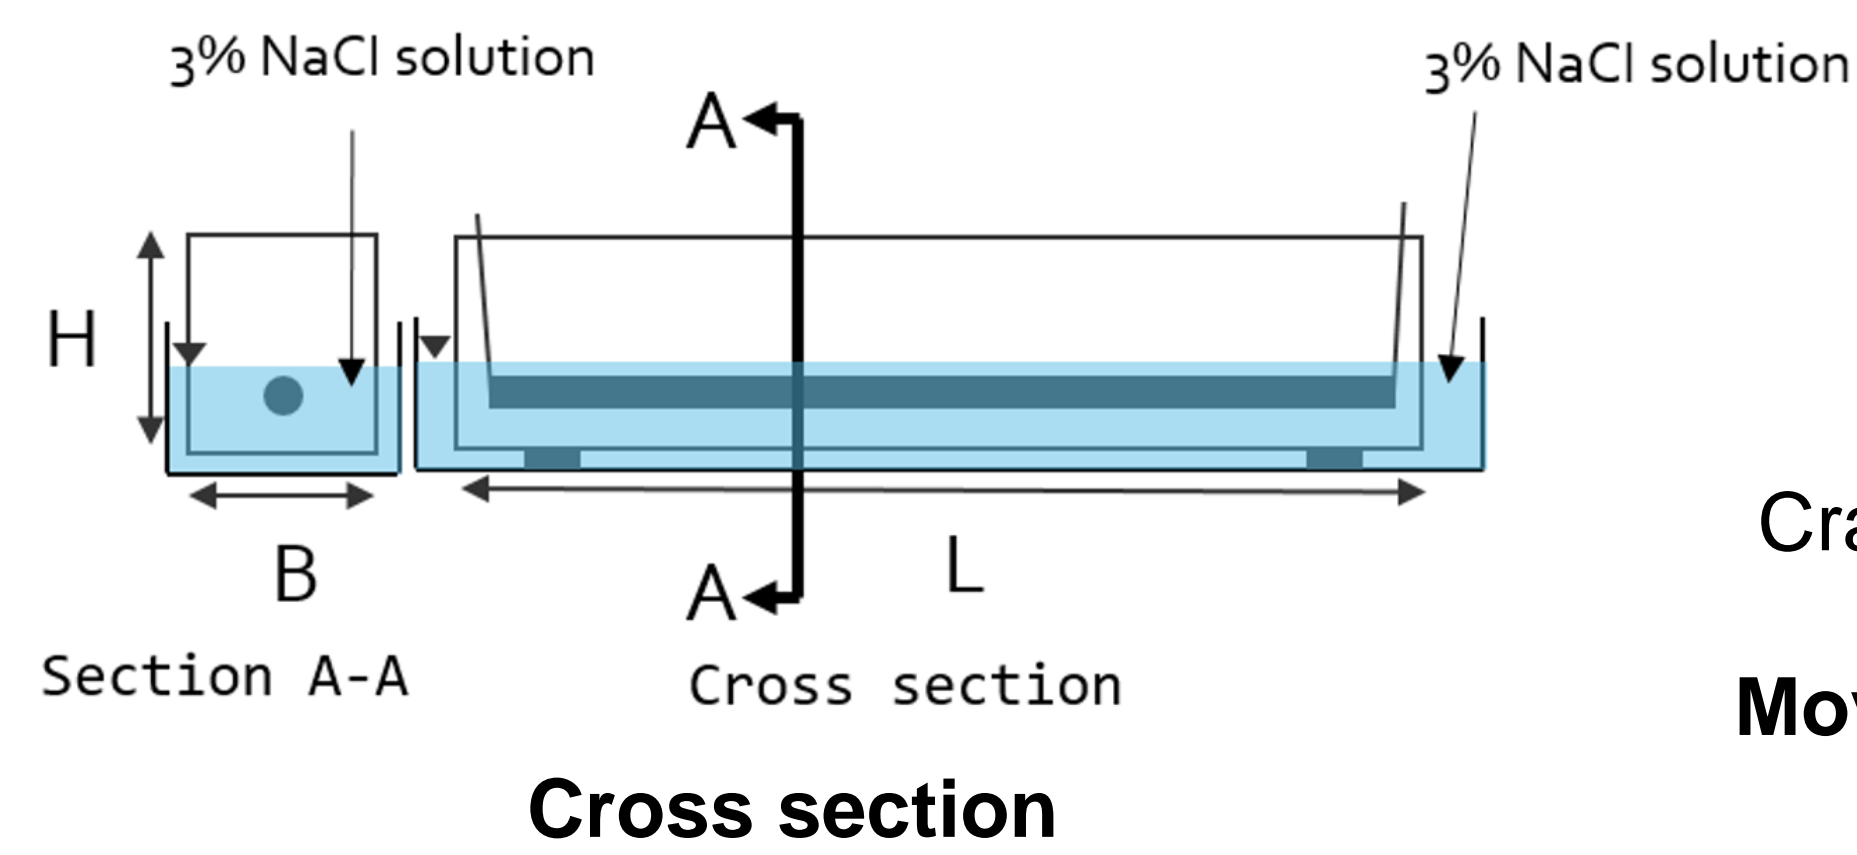
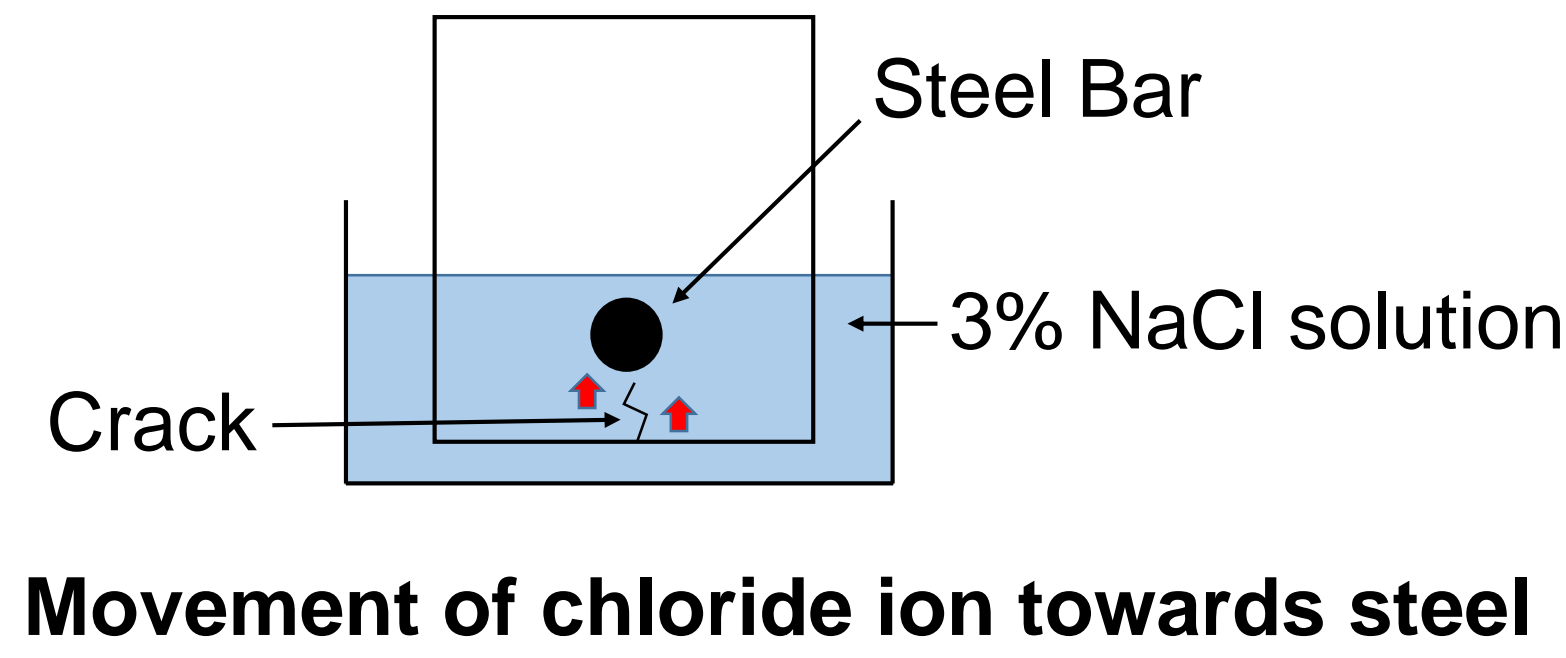
Parameters	150	30 (OPC)
Strength (N/mm <sup>2</sup> )	150	30 (OPC)
Cover Depth (mm)	40 and 20	70 and 40
Crack Width (mm)	0 ~ 0.46	0 ~ 0.26
Bar Size (mm)	16	16
No. of Bar	1	1

Size : 150mm(B) x 150mm(H) x 490mm(L)  
\*150mm(B) x 250mm(H) x 690mm(L)

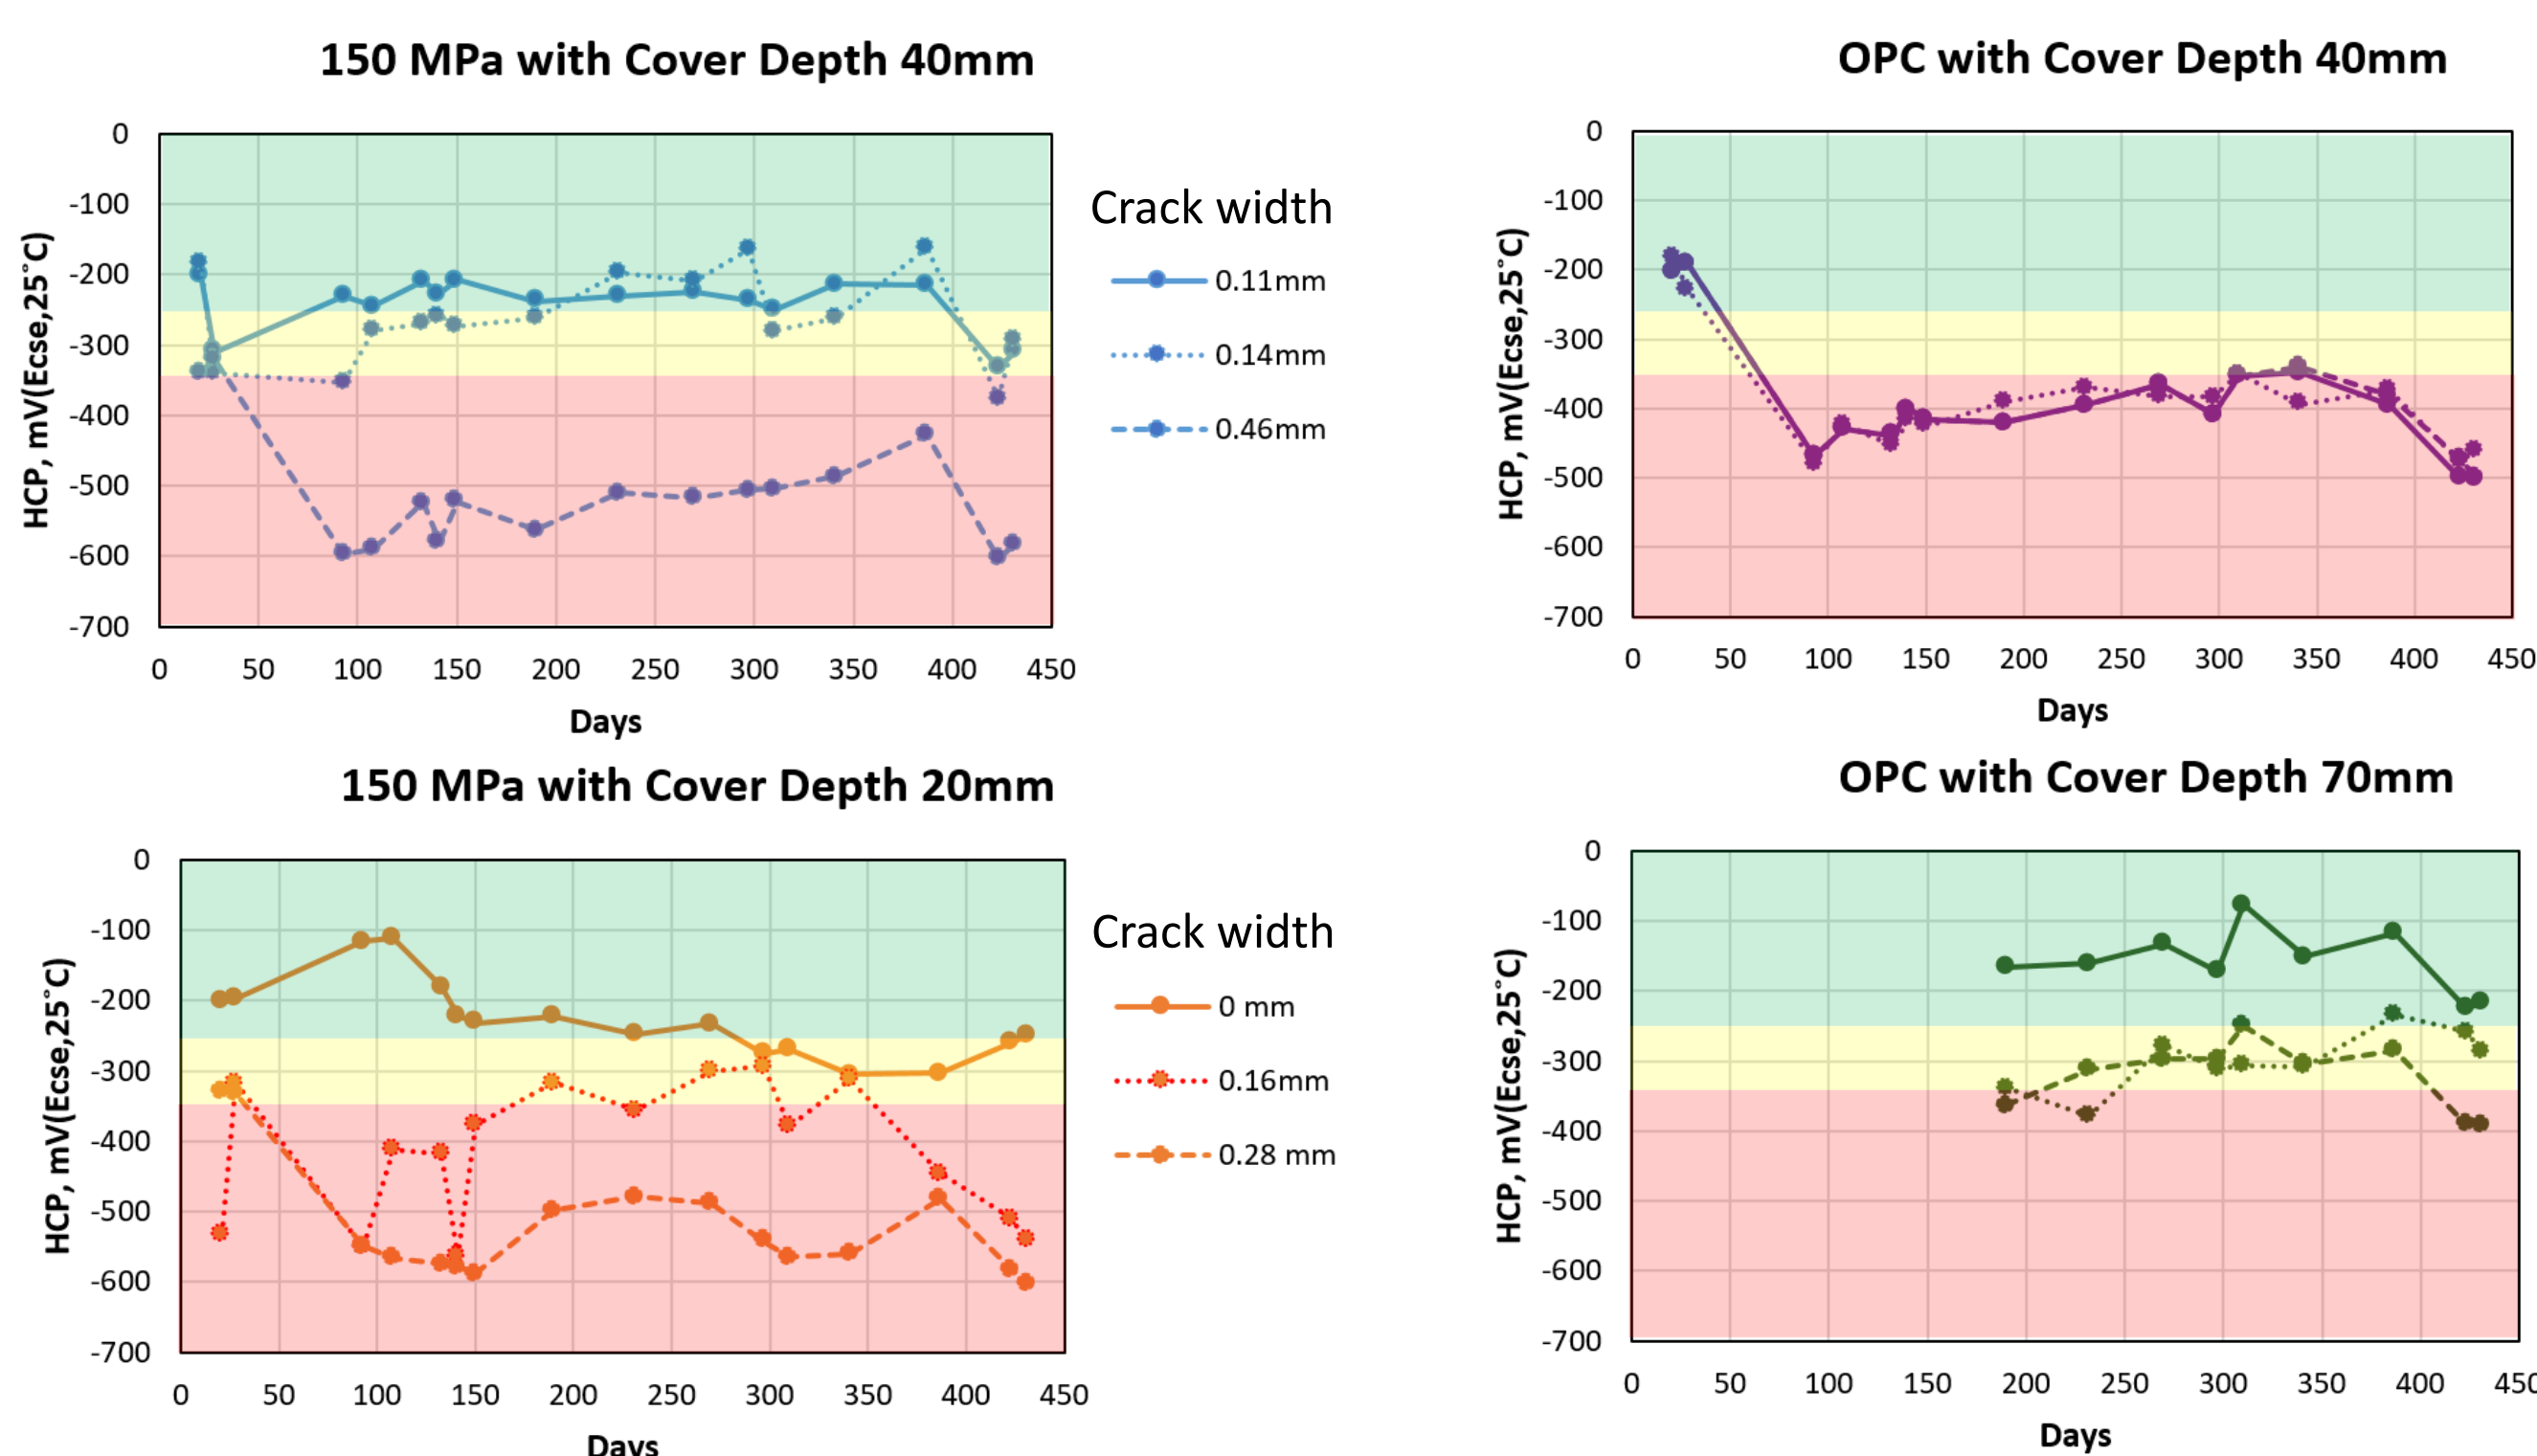
### Half-cell Potential (mV)

- Half-cell potential measurement : Identify the potential corrosion of steel
- Polarization resistance : Measure rate of corrosion of steel
- Passivity grade : Classify the passivity film of steel

Measurement up to 431 days  
Applied silane coating on 387 days

Corrosion ( $E_{cse} < -350mV$ )    Uncertain ( $-350mV \leq E_{cse} < -250mV$ )    No Corrosion ( $-250mV \leq E_{cse}$ ) (ASTM C876-09)

20mm cover depth is acceptable with crack width less than 0.12mm. Repair works is necessary for crack width more than 0.12mm.
