RESISTANCE AGAINST FATIGUE LOADING OF PRECAST PC DECK SLAB WITH THE IMPROVED LOOP JOINT

Shigetada Hatakeyama¹, Shinichi Hino², Hidenori Hamada³, Yuji Sato⁴, Syusaku Kawabe⁵, and Mamoru Masaki⁶

Keywords: Loop joint, Precast PC deck slab, Wheel moving load test

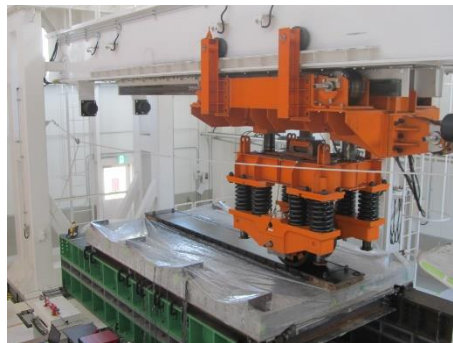
Photo 2. Wheel moving load test machine.

The test was conducted using a wheel moving load test machine shown in Photo 2. The iron wheel of the test machine having a diameter of 0.7m and a width of 0.5m supplies reciprocating motion. The maximum load during running was 490kN. The reciprocation speed was a maximum of 15 reciprocations / minute, and the test was performed at a speed of 10-15 reciprocations / minute.

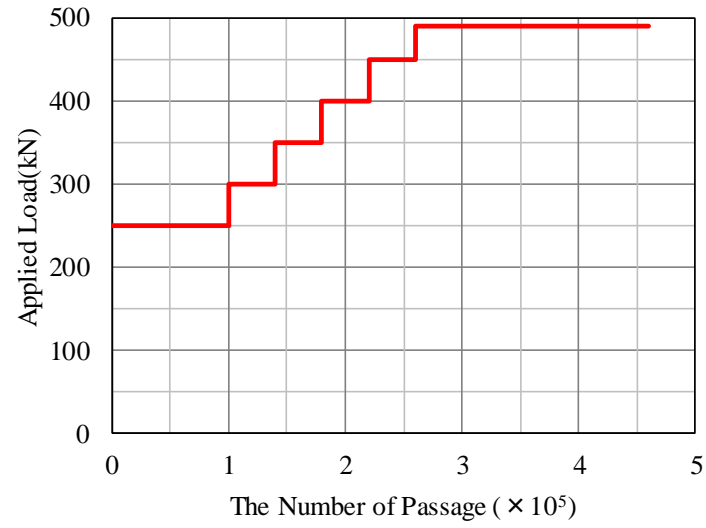
Figure 4. Load step diagram.

The support condition was simple support with a span length of 2,500 mm, and the load travel repeatedly within the range of 500 mm in width and 3,000 mm in length (shown by the red dashed line in Figure 2). Figure 4 shows the load step diagram. In this test, 250 kN x 100,000 times were conducted referring the paper [3] to investigate the durability equivalent to 100 years. After that, a water filling test was conducted to check water leakage from the joint between the precast part and the in-situ part. The water filling test is shown in Photo 3. In the water filling test, the water depth was 10 mm and the water was left for 6 hours. After the water filling test, the water was removed, and the load was increased by 50 kN for every 40,000 times as shown in Figure 4 to investigate the fatigue fracture properties of the specimen. The load was increased upto 490kN which is the maximum load of the machine. The total number of loadings at each loading stage is 460,000. The number of converted loading time N_{eq} running under this condition is approximately 440 billion times calculated from Eq. (2).

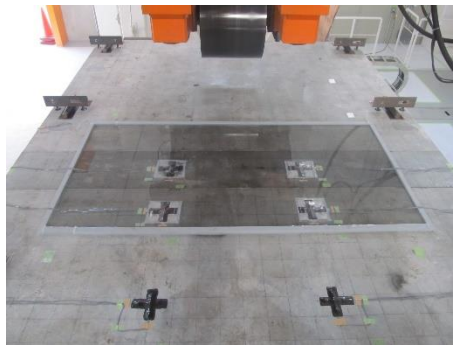
Photo 3. Water filling test.

level difference in the vertical direction occurred during each run due to the impact of the wheel load. On the other hand, paying attention to the fatigue durability of $250\text{kN} \times 100,000$ times that is equivalent to 100 years in Figure 8 (a), the largest crack width was 0.07mm , which was very small. In the water filling test after $250\text{kN} \times 100,000$ times, no water leakage from the joints on the lower surface was confirmed. Therefore, it is considered that it has fatigue durability equivalent to 100 years.

As a result of a wheel moving load test, sudden increases in vertical deflection, joint opening, and rebar strain were not observed at the load step ($250\text{kN} \times 100,000$ times) that caused damage equivalent to 100 years on an actual bridge. Moreover, there was no water leakage from the bottom surface of the deck slab by the water filling test.

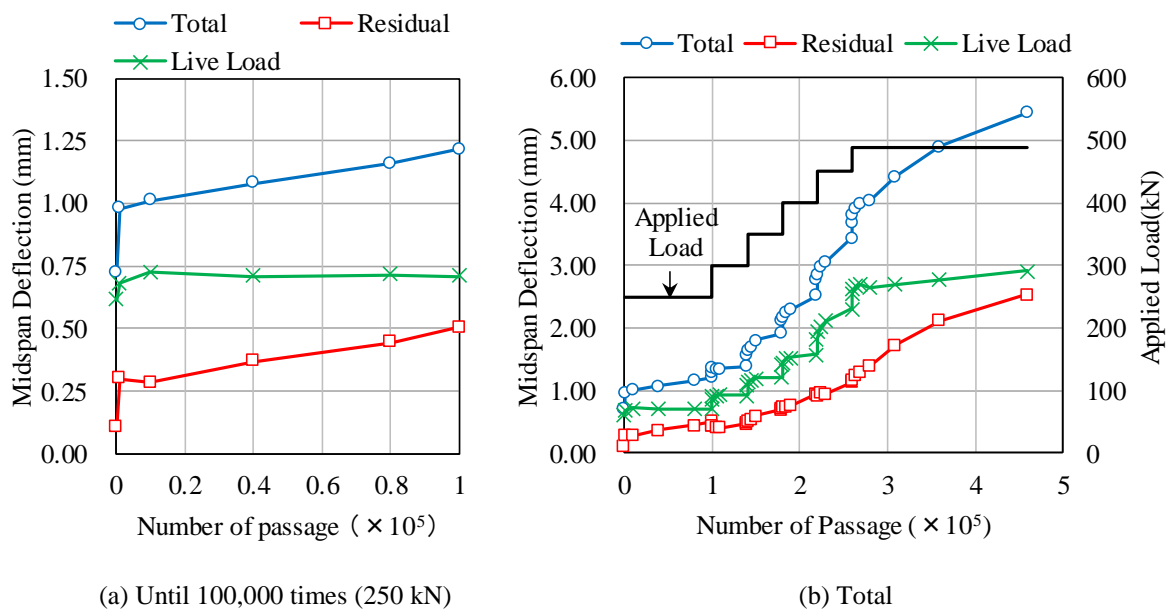
Figure 6. Changes of midspan deflection.

Figure 6 shows the changes in deflection in the center of the slab. Figure 6 (a) shows the details of 250kN x 100,000 times, which is equivalent to 100 years, and Figure 6 (b) shows results in total load steps. The live load deflection δ_{live} is calculated by Eq. (3)

Where δ_{total} is total deflection which is measured by LVDT at the maximum load in each load stage, $\delta_{residual}$ is residual deflection which is measured at unloading. Total deflection and residual deflection gradually increased with increasing loading, and the deflection after 490kN tended to increase more than before. On the other hand, the live load deflection was almost constant at any load stage. The same tendency was observed at the other LVDTs, and drastic changes in deflection due to the loop joint were not observed.

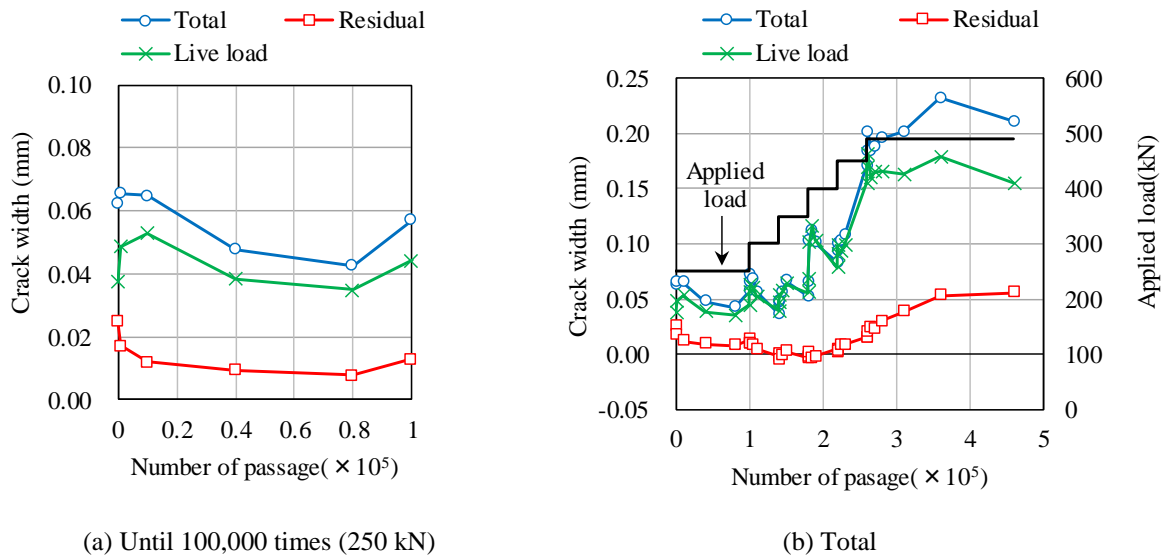
Figure 8. Changes of crack width between deck slab and in-situ part.

Figure 8 shows the changes of crack width between PC deck slab and in-situ part. The figure shows the values below the loading point, which showed the largest value among all six locations. The display format of each value is the same as in Figure 6. As shown in Figure 8 (b), crack width at each load stage fluctuated and did not show a constant value, unlike the case of deflection. It can be inferred that a small

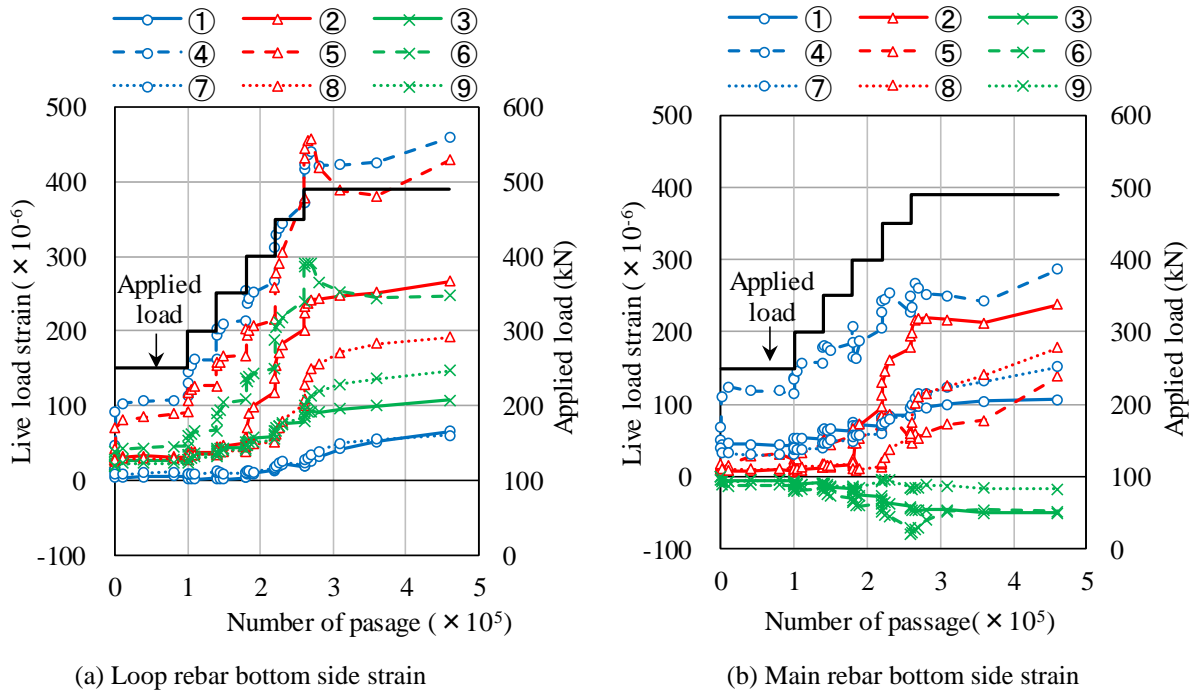
Figure 9. Strain of reinforcing bar.

Figure 9 (a) and (b) show the strain on the lower side of the loop reinforcing bar, and the strain on the lower side of the main reinforcing bar, respectively. The numbers in the graph correspond to Figure 5, and the strain indicates the live load strain. The live load strain ε_{live} is calculated by Eq. (4)

Where ε_{total} is the total strain which is obtained at the maximum load at each load stage, and $\varepsilon_{residual}$ is the residual strain which is obtained at unloading. As shown in Figure 9 (a), the strain generated in the loop rebar tends to increase as it gets closer to the in-situ part, and in particular, No.4 just below the loading point shows the largest value. For gauges No.3, 6, and 9, the strain showed compression. This is thought that negative bending occurs at this position due to the support conditions of the slab. Looking at the transition of strain upto 100,000 times, no sudden increase in strain is confirmed. In the main rebar shown in Figure 9 (b), the strain tends to increase at the center position of the span (No.4, 5, and 6), which is considered to be the same as the normal slab behavior. Comparing gauges No.1–3, and No.7–9 located 450mm away from the center of the span, all showed almost the same strain up to a loading load of 350kN. On the other hand, after 400kN, paying attention to No.2 and 8, the strain has a difference of about 50×10^{-6} . This is thought to be due to the difference in the progress of cracks on the bottom of the slab. Even in the main reinforcing bar, no sudden increase in strain was observed up to 100,000 times.
