MECHANISM OF LARGE-SCALE FLOWSLIDES DUE TO THE 2018 SULAWESI EARTHQUAKE, INDONESIA

ROHIT DIVYESH MOHANBHAI

A Thesis Submitted
In Partial Fulfilment of the Requirements
For the Degree of
DOCTOR OF ENGINEERING

to the
DEPARTMENT OF CIVIL AND STRUCTURAL ENGINEERING
GRADUATE SCHOOL OF ENGINEERING
KYUSHU UNIVERSITY
August, 2021

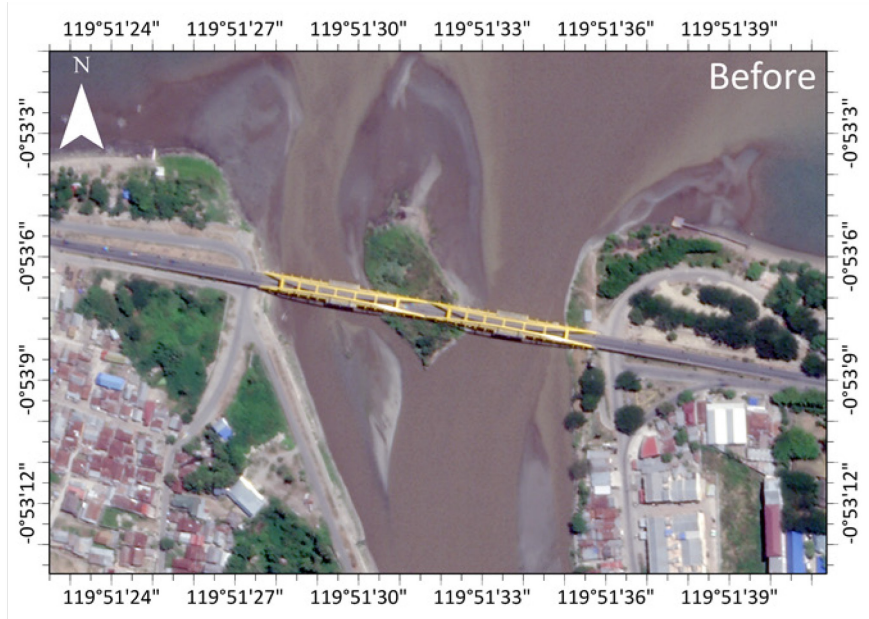
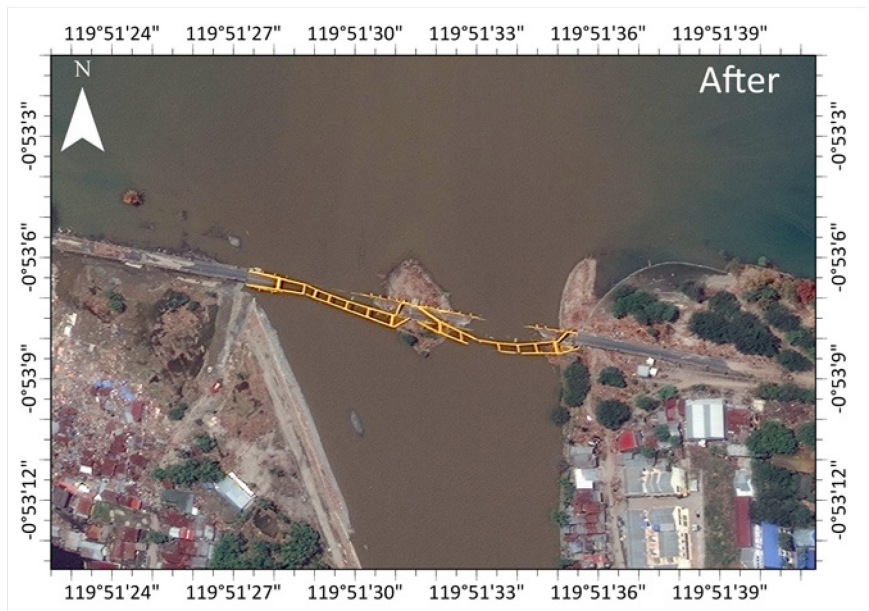
Figure 1.2 The Yellow Ponulele bridge, Palu: (a) Before (September 28, 2018) and after (October 1, 2018) satellite image (modified from BNPB ArcGIS Map service) and (b) Actual picture of the damaged bridge from the site.

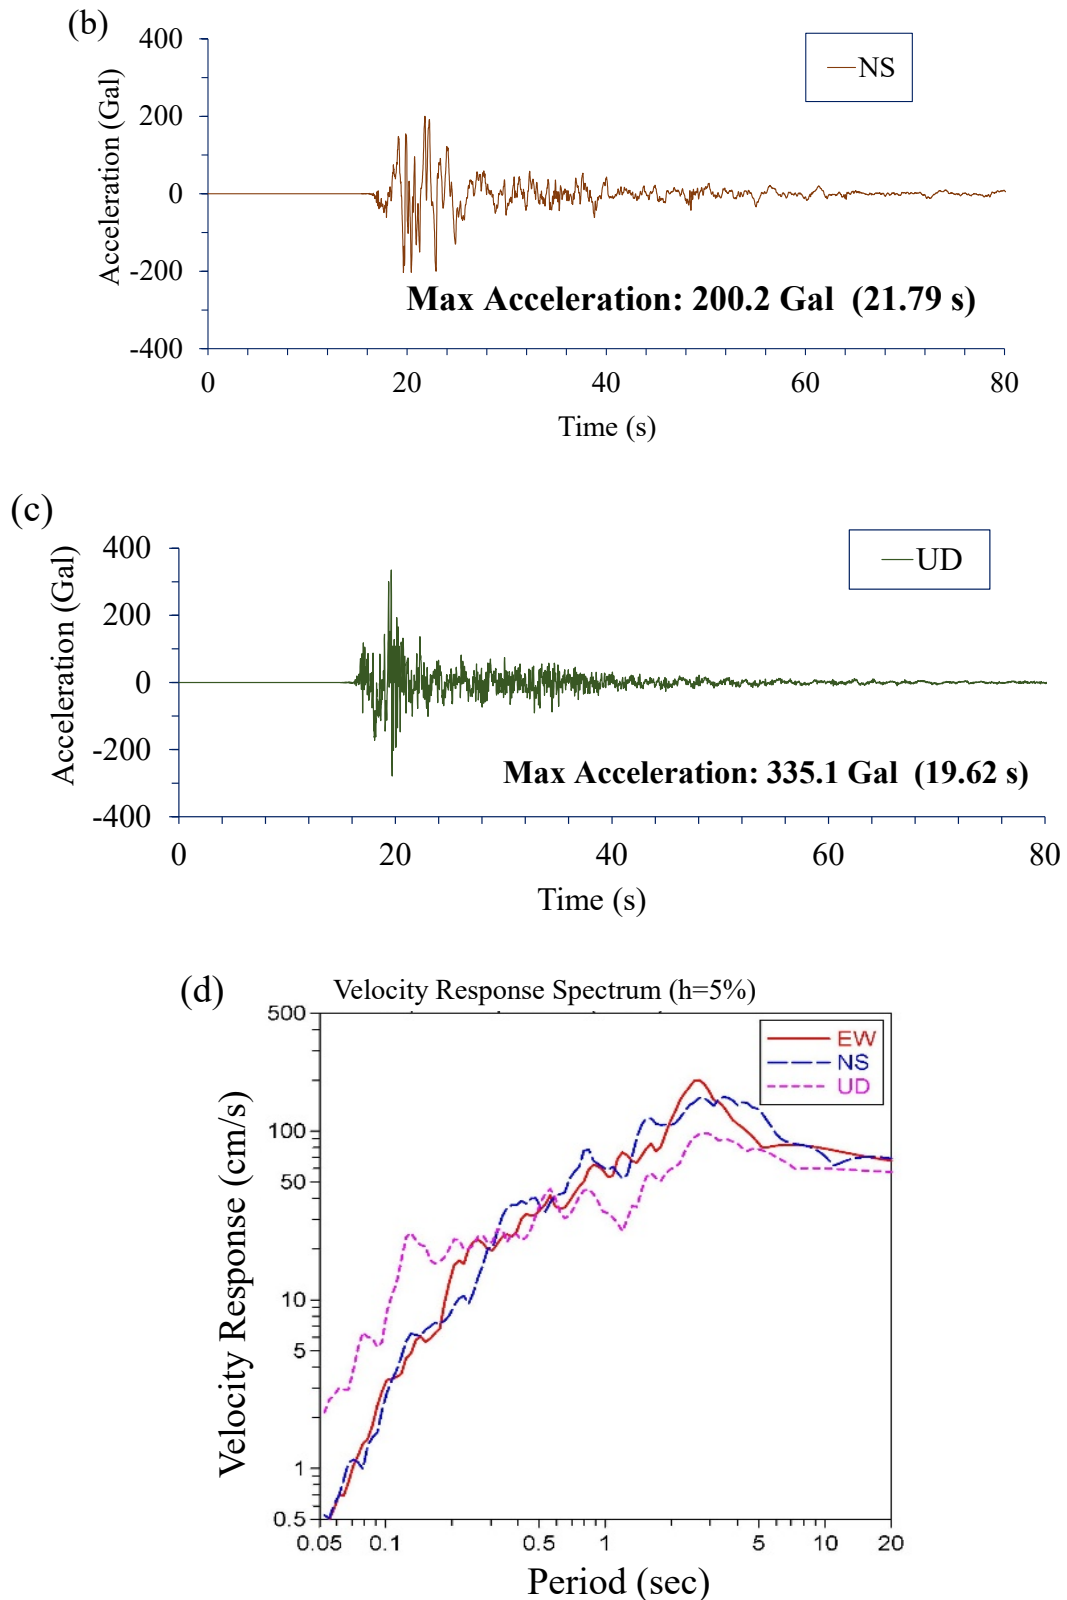
Figure 1.7 Time history of motions at strong ground motion station near Balaroa (a) E-W (b) N-S (c) U-D components and (d) Velocity responses (Adopted and modified from the data in JICA Report, 2019).

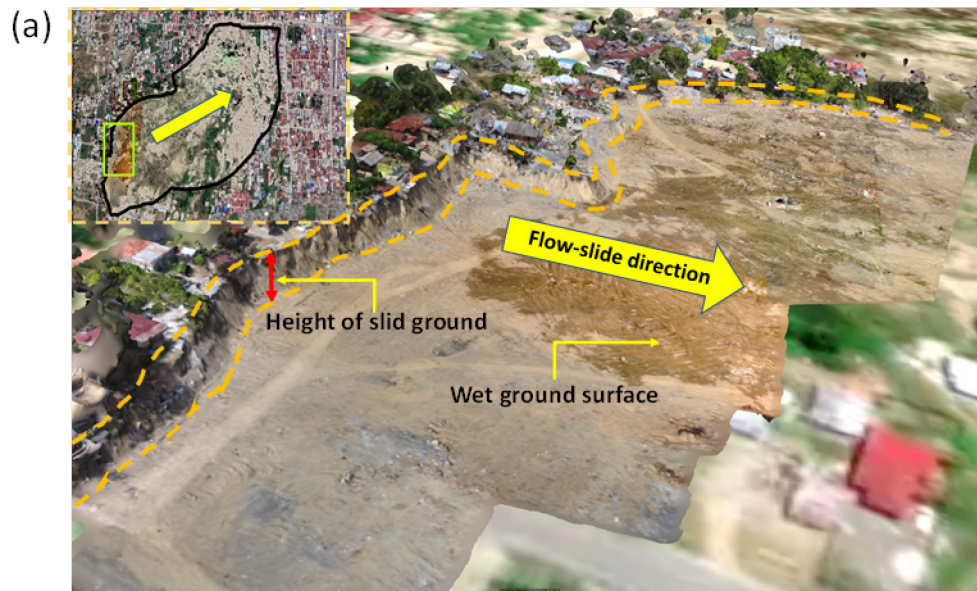
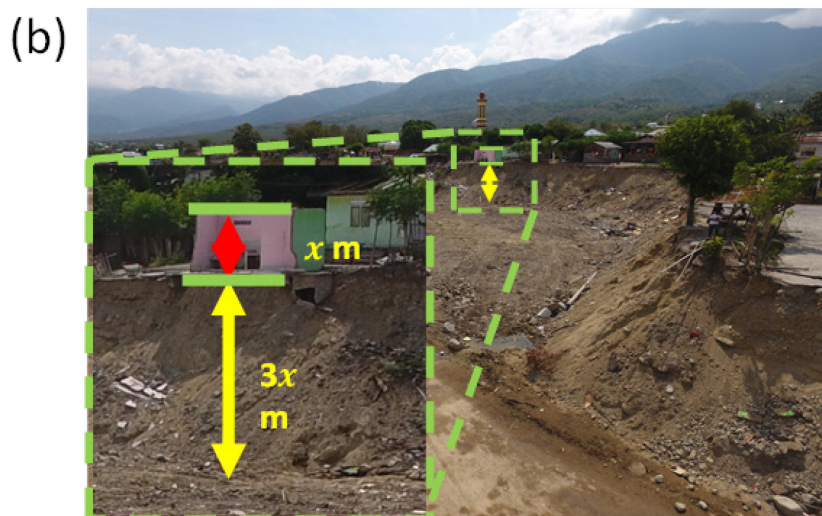
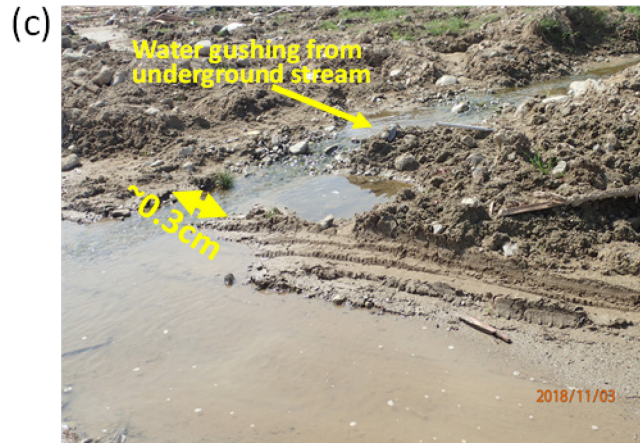
Figure 2.4 Site investigation results from Balaroa: (a) 3D model generated from drone survey. (b) extent of vertical ground displacement and (c) water gushing from underground stream (Survey done on November 3, 2018).

ground displacement could be ascertained from Figure 2.4 b, in which the height of the vertical soil profile near the crown appears to be around than 3 times the normal ground level structures present on the edge from visual observation. The height of the partially demolished housed is assumed as $1N$, where N is in meters. The vertical reduction in ground elevation seemed to be around 3 times ($3N$) the height of the house. Furthermore, the site had a very shallow water table which was almost at the surface as observed by the authors during the survey. This could be confirmed by the presence of natural ground water gushing out from the debris (Figure 2.4 c). Furthermore, it confirms the theory of presence of an artisan aquifer by Kiyota et. al., (2020).

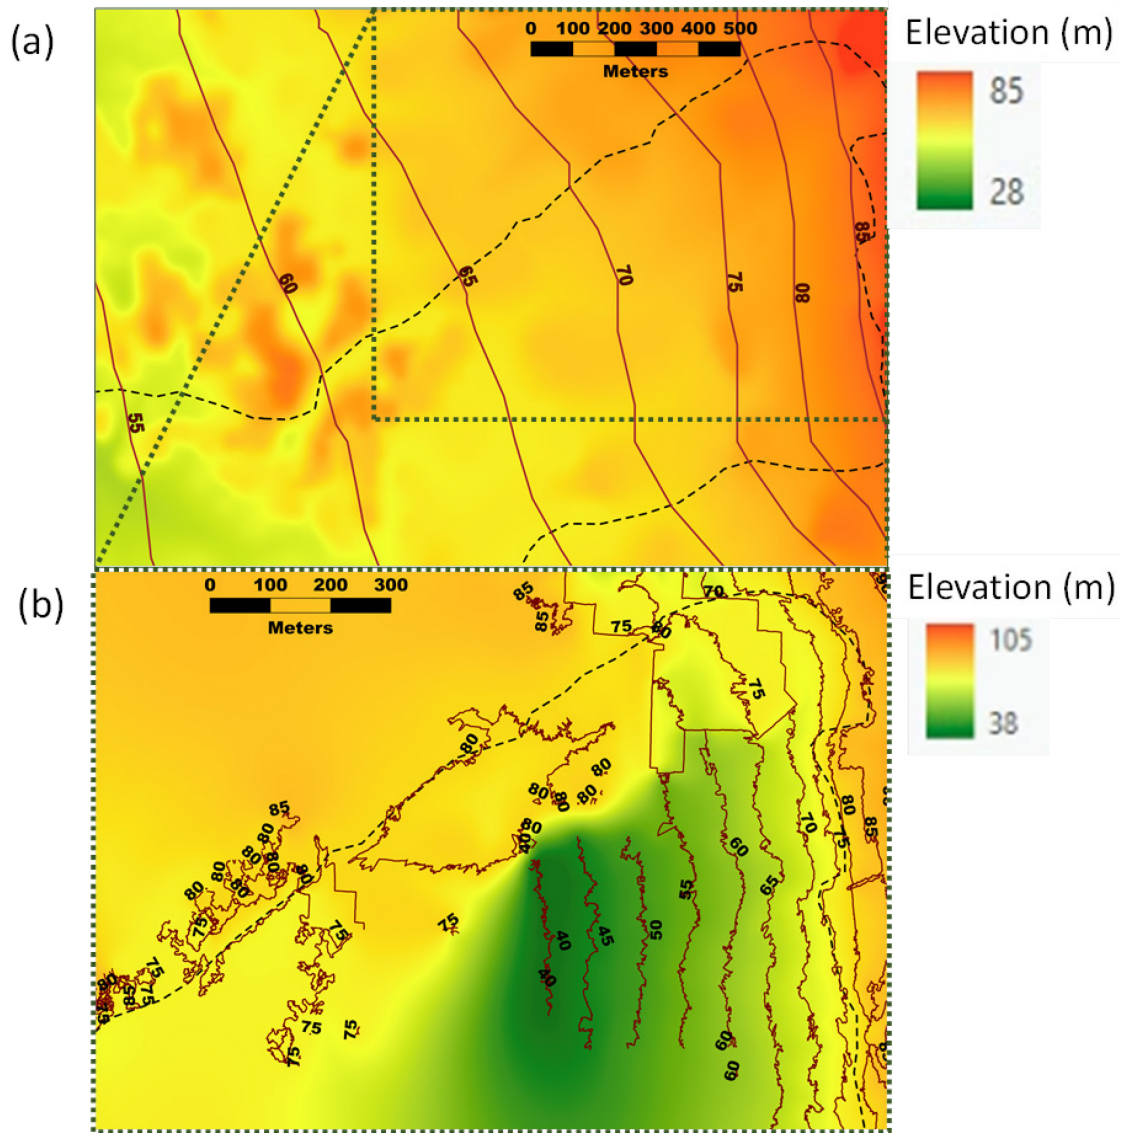
Figure 2.8 Raster elevation profile of the Jono Oge flow-slide site: (a) before earthquake and (b) after the earthquake (Survey performed on 2/11/2018).

Furthermore, the geomorphological change to the site was evaluated from the pre- and post-earthquake terrain elevation profile of the area (Figure 2.8 a and b). The pre-earthquake elevation profile was obtained from the open access DEMNAS data source of Geospatial Information Agency (BIG) of Indonesia, while the post-earthquake elevation data was obtained from the Digital Elevation Model (DEM) generated from drone image analysis conducted. In Figure 2.8 a, the profile has a gentle slope with consistently decreasing elevation profile while in Figure 2.8 b, a sudden sump is observed in the tension zone from where the ground sliding occurred. While an increase in elevation can be seen in the downstream side, which is due to the accumulation of the debris and soil blocks along with humping of ground due to forward thrust provided by the slide.

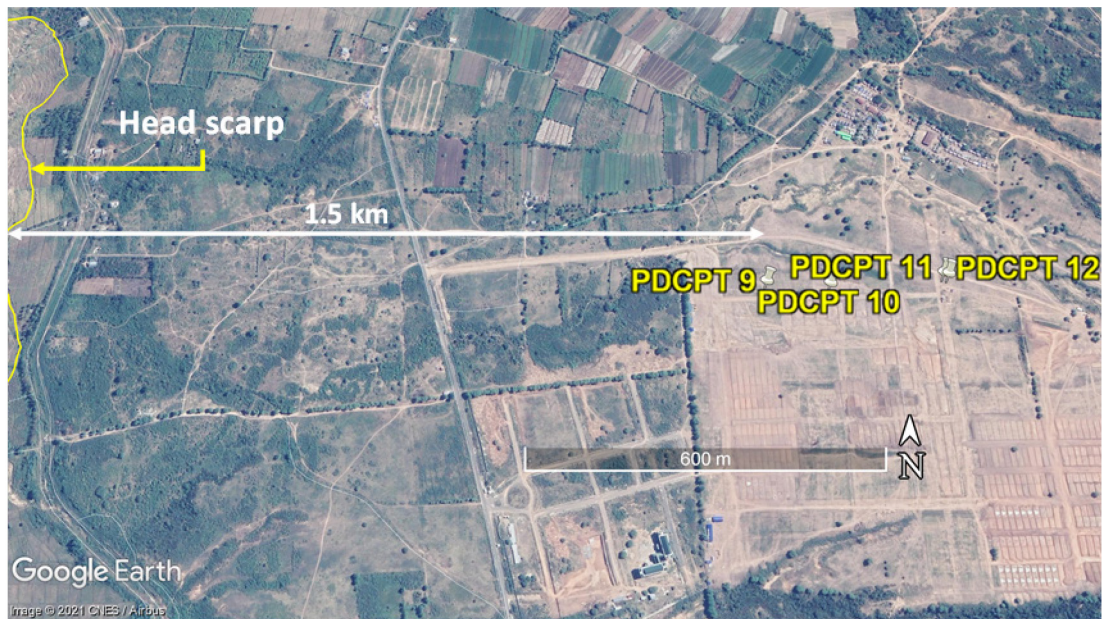
Figure 2.10 Locations of the PDCPTs conducted in the un-failed area, upstream of Jono Oge flowslide site (modified from Google Earth).

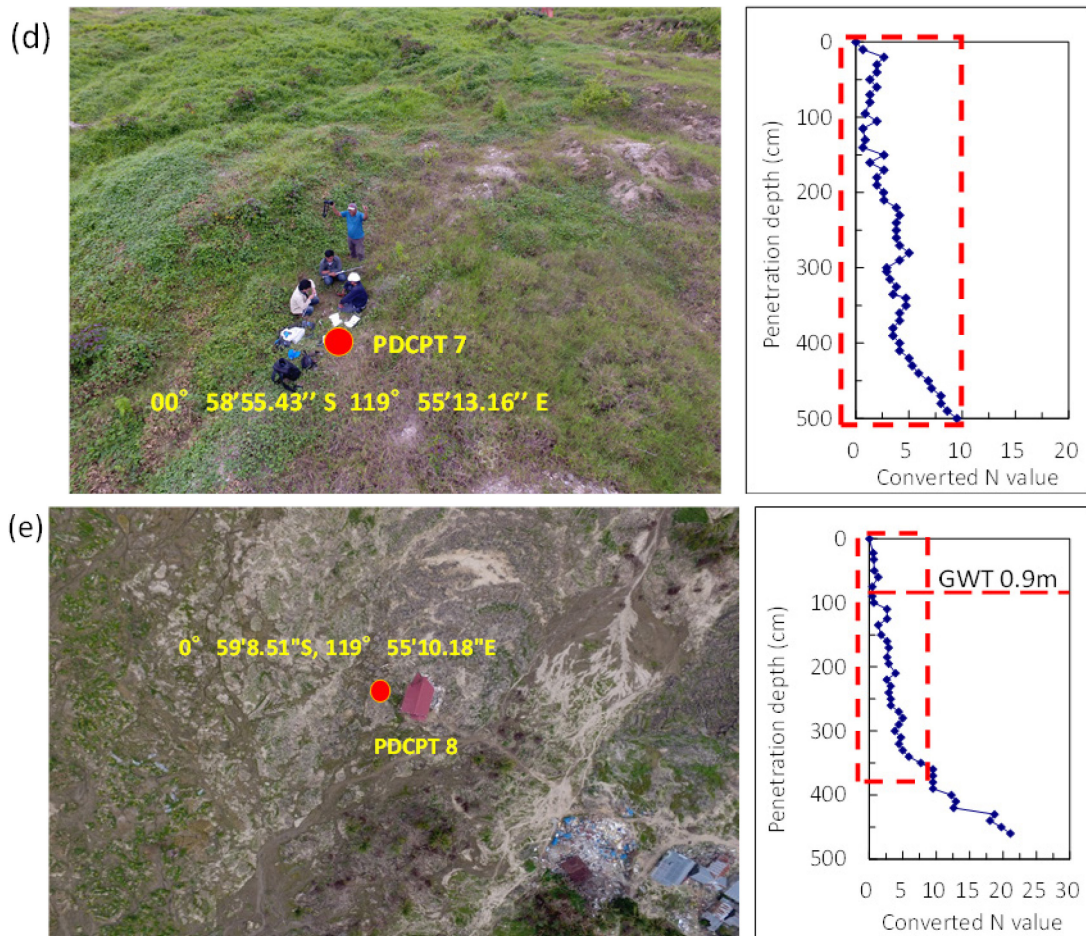
Figure 2.14 Drone imagery of locations of PDCPT and N_{SPT} versus depth values (a) PDCPT4 (b) PDCPT5 (c) PDCPT6 (d) PDCPT7 and (e) PDCPT 8.

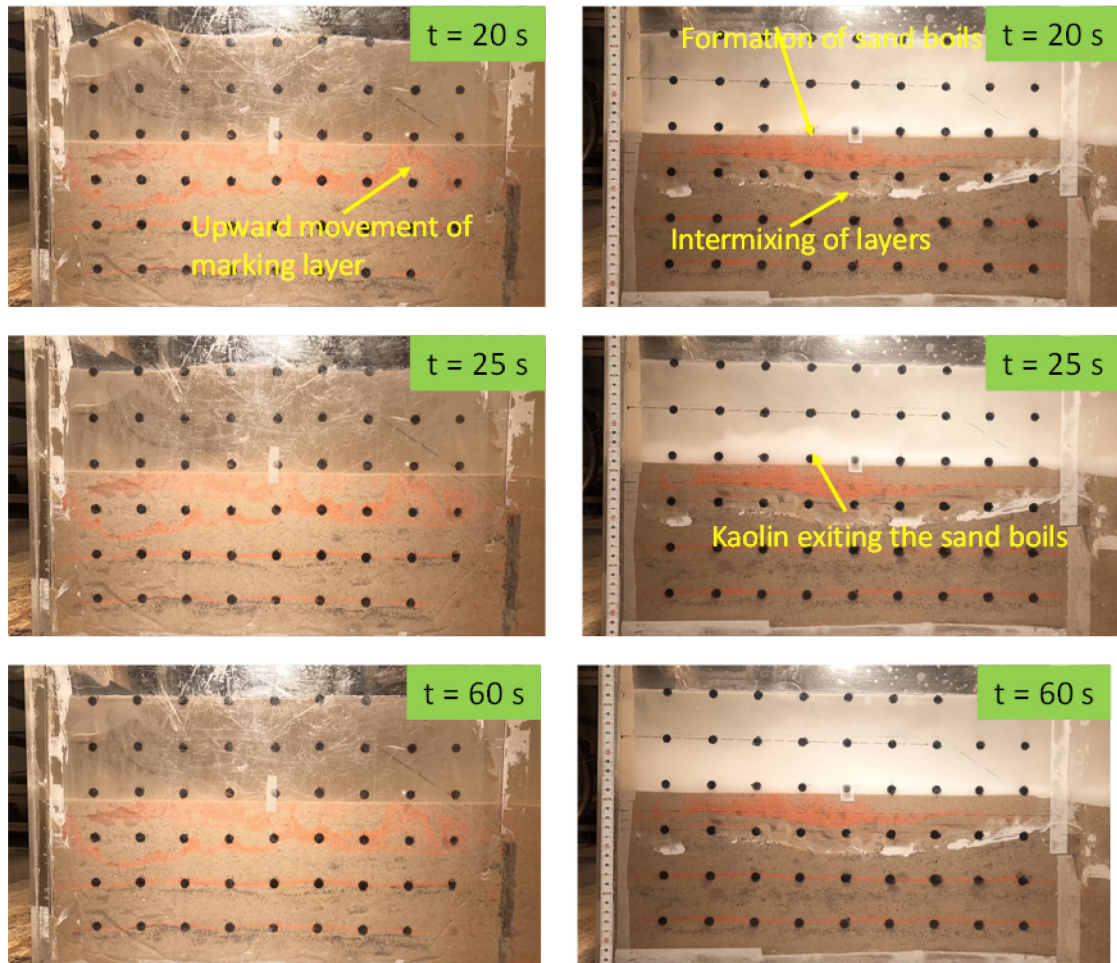
Figure 3.6 The deformation of soil surface and layers relative to elapsed time and the formation of sand boils.
