## Effective Use of Sacrificial Zinc Anode as a Suitable Repair Method for Severely Damaged RC Members Due to Chloride Attack

In many cases, the repair strategy by using sacrificial anodes for cathodic protection in real RC structures requires additional zinc anodes after several years due to the decreasing protective area. This experimental study evaluates the effectiveness of time lag application of sacrificial anode cathodic protection applied to RC beam specimens that deteriorated severely due to chloride attack. In the experiment, sacrificial anodes and cathodic protection (SACP) were applied to 41-year-old RC beam specimens exposed to natural marine environments in which the embedded steel bars were significantly corroded. The repair work was performed in three stages. Instant-off and rest potential tests of steel bars were conducted periodically to demonstrate the time-dependent depolarization value. In the first stage, a polymer-modified mortar as a patch repair material was cast to replace the concrete in the middle tensile part with small sacrificial anodes embedded in the mortar. After the protective current reaches an equilibrium state, the sacrificial anodes are disco

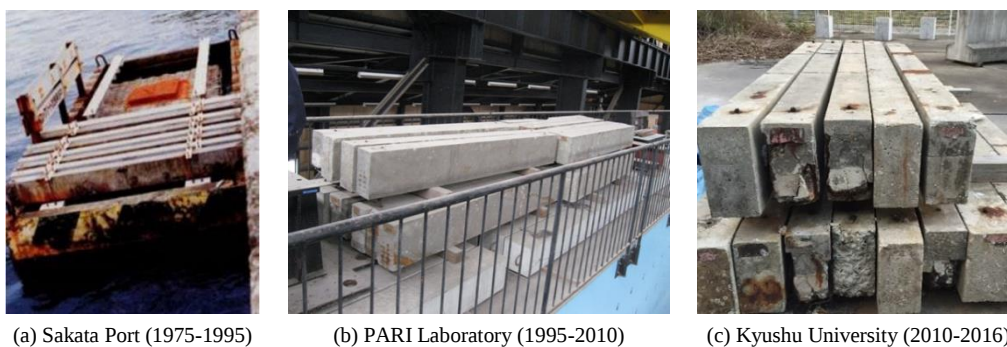
**Figure 3. Exposure conditions**

Ordinary Portland cement (OPC) was used in the original old concrete. The specific gravity and fineness modulus of aggregates are summarized in Table 1. The concrete mix proportion is presented in Table 2. The specimens were moisture-cured for a day and demoulded before being air-cured in a laboratory. The specimens were exposed to natural marine environments, a tidal zone for 20 years from 1975 to 1995 at Sakata Port in Yamagata Prefecture, Japan. In 1995-2010, the specimens were kept and sheltered from the rain at the Port and Airport Research Institute (PARI) laboratory, Yokosuka, Japan [42, 43], then moved to the Kyushu University outside exposure site, Fukuoka, Japan. The exposure conditions until 41 years are displayed in Figure 3.
