# Non-Destructive Testing of Hydraulic Cylinder Excavator Bucket and Failure Analysis

出版情報 : Proceedings of International Exchange and Innovation Conference on Engineering & Sciences (IEICES). 11, pp.955-959, 2025-10-30. International Exchange and Innovation Conference on Engineering & Sciences

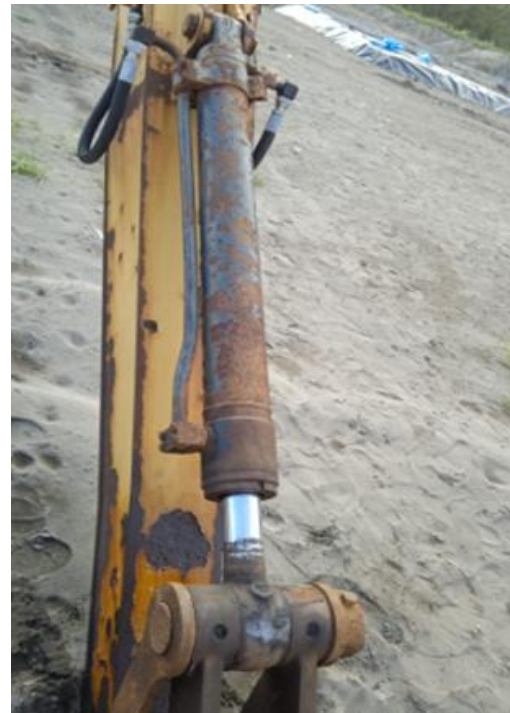
The results of bucket cylinder observation on the cylinder area using visual and dye penetrant tests revealed corrosion on the housing and cylinder rod. The damage was caused by dirt friction between the rod and the seal in the housing cylinder, which eroded the chrome layer. The frequent exposure of the rod to seawater and river water led to the peeling of the chrome layer on the cylinder rod, as shown in Figure 3 and 4.

Fig. 3. Corrosion part on the cylinder tube of the housing.

2. The dirty and wet condition of the cylinder led to oxidation of the metal, causing corrosion in the housing area and peeling of the chrome layer on the rod.

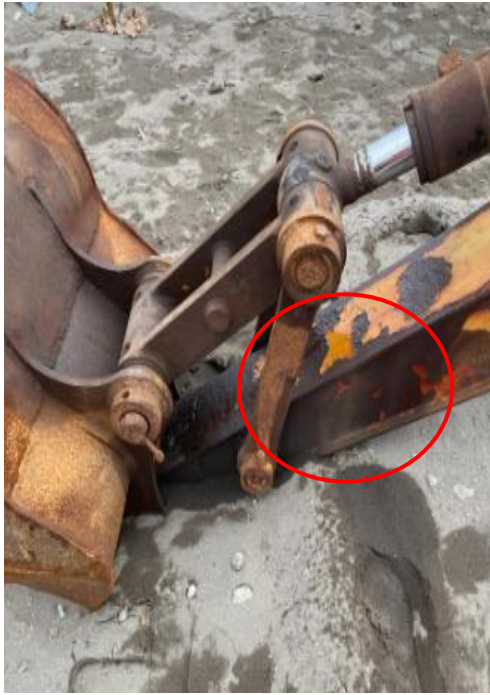
Fig. 4. Condition of the bucket cylinder housing with the hydraulic oil leak.

1. The cylinder component material was damaged due to friction between the cylinder and materials being transported, such as sand, soil, mud, and water. This friction caused scratches on the cylinder rod, and dirt buildup led to friction with the cylinder seal, resulting in seal damage and oil leakage.

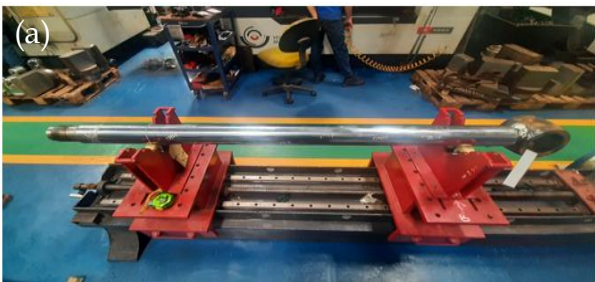
The results of the used hydraulic oil sampling showed that visually, the oil had already changed in color, and there was a change in the viscosity value of the tested oil. The hydraulic oil used was Turalik 52 (ISO VG 68). The viscosity result was below the standard limit, measured at 41.63°C, compared to the minimum-maximum standard range of 61.41–75.05°C. There are some causes of hydraulic oil viscosity drop such as prior to the unit's breakdown, the unit operated under a high workload, with the excavator operator running the machine at high engine speeds, which caused a temperature rise in the hydraulic oil system, and contaminants such as dust, dirt, or other chemicals entered the hydraulic oil, reducing its viscosity. Figure 5 and 6 shows the measurement inspection of the cylinder rod and damage inspection in various conditions, respectively.

Fig. 5. Inspection of the cylinder rod in (a) dimensioning, (b) surface area with experienced pitting corrosion, (c) a peeling chrome layer, and (d) the results of the measurement of 64.96 mm diameter and 1080 mm rod length.

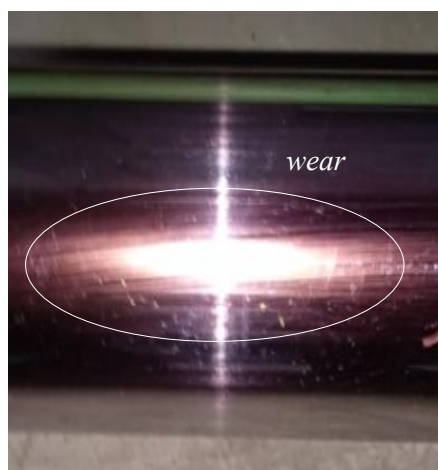
Fig. 6. Damage inspection of the cylinder rod condition in (a) experiencing wear on the surface, (b) experiencing corrosion, pitting, and peeling chrome layer, (c) normal condition or there is no wear, corrosion, and scratch on the surface.

To prevent damage to the bucket cylinder, a daily inspection check sheet is made, to find out the condition of the cylinder whether it is in good working condition or not, and if there is damage to the cylinder after a visual inspection is carried out, then a record is made to facilitate the implementation of the maintenance schedule. This inspection check sheet aims to make it easier for excavator operators and excavator mechanics to monitor the performance and physical condition of the bucket cylinder.
