出版情報：九州大学工学紀要. 67 (4), pp.191-197, 2007-12-20. 九州大学大学院工学研究院  
バージョン：  
権利関係：

## **SIMS Analysis of Hydride in Commercially Pure Titanium**

### **Abstract**

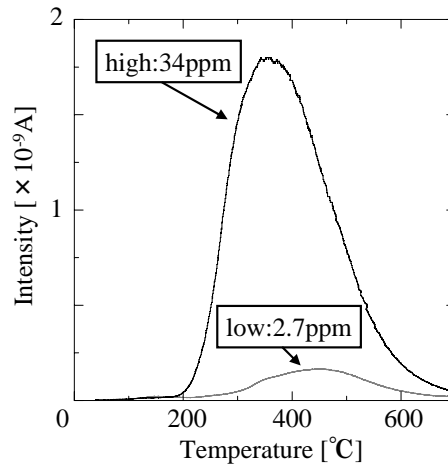
**Figure 1** shows thermal desorption spectrometer (TDS) profiles of hydrogen for two kinds of annealed material. Disk plates for TDS measurement were cut out from the materials. The disk plate has a diameter of 8 mm and a thickness of 0.8mm. The material annealed in air contains 34 ppm hydrogen but the material annealed in a vacuum contains 2.7 ppm hydrogen.

**Fig. 1** TDS profiles for both materials. High: higher hydrogen content material. Low: lower hydrogen content material. Rate of temperature rise is 0.17°C/s.

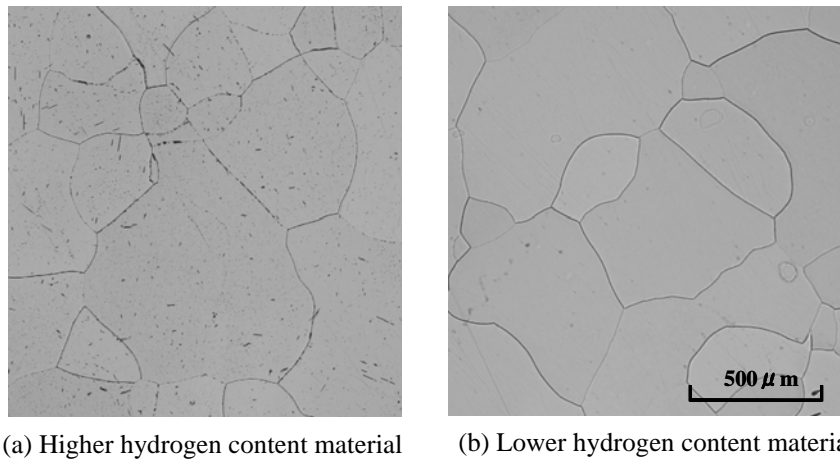
**Figure 2** shows photographs of microstructure of annealed materials. The average grain sizes of both kinds of materials are the same: about 300  $\mu\text{m}$ . There are acicular precipitates that seem to be hydrides in the high hydrogen material. This material was analyzed by SIMS.

**Fig. 2** Microstructure of materials.

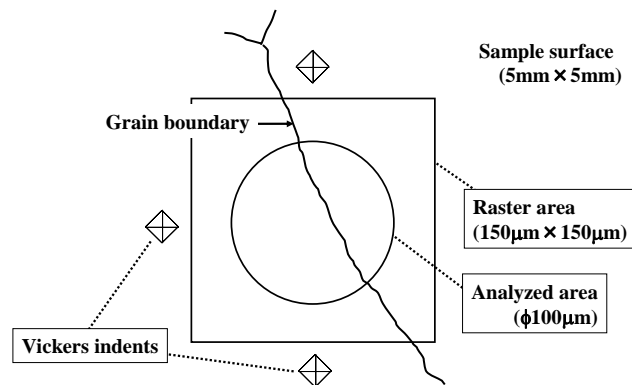
**Figure 3** shows the relationship between the indentations and the positions of the detection area. **Figure 4** shows depth profiles for  $^1\text{H}$  and  $^{48}\text{Ti}$  obtained by SIMS. Secondary ion counts of  $^1\text{H}$  and  $^{48}\text{Ti}$  reached the steady state after 1,000 seconds. Therefore, it was considered that the contamination layer of the sample had been sufficiently removed. Then the two-dimensional distribution of hydrogen was analyzed in the same area.

**Fig.3** Illustration of detection area for SIMS.

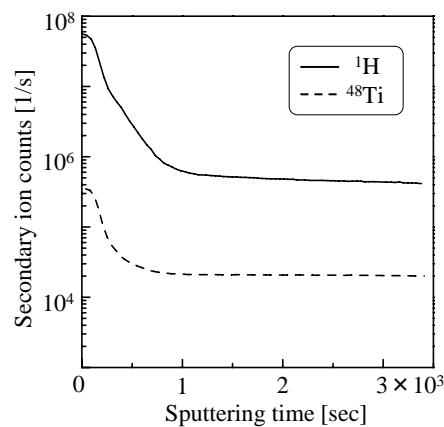
**Fig.4** SIMS depth profile for H and Ti.

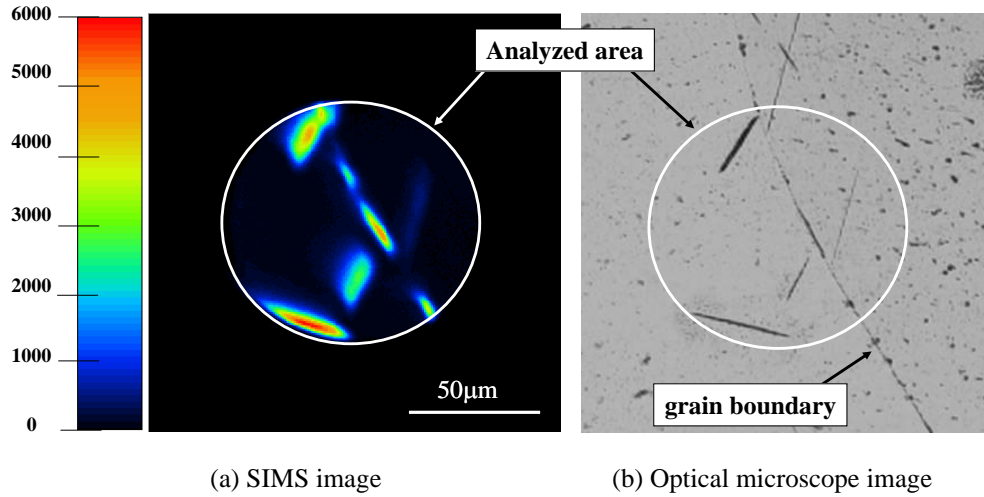
**Figures 5** (a) and (b) show an optical microscope image and an SIMS map for hydrogen near a grain boundary, respectively. The distribution pattern detected a large number of counts on the SIMS map of  $^1\text{H}$  corresponding to the distribution pattern of black needles and the grain boundary in the optical microscope image. This implies that the needles in the grain are  $\gamma$  hydrides<sup>9</sup>. **Figures 6** (a) and (b) show similar images to **Fig. 5**, but hydrides detected only at the boundaries. **Figures 7** (a) and (b) show optical microscope images of the observation area before and after SIMS analysis shown in **Fig. 5**, respectively. The sputter rates of two adjacent grains seemed to be different from each other. However, **Fig. 7** (c) shows that the step of the grain boundary is small and the intensity of  $^1\text{H}$  along the grain boundary is not constant. In addition, the solubility of hydrogen into titanium is low. On any case, the intensity of edge effects is not very high. Therefore, high-intensity sites along the boundary are also thought to be hydrides.

**Fig. 5** SIMS analysis of higher hydrogen content material.

Hydride is reported to be brittle, and harder than the base material<sup>4)</sup>. In addition, expansion during hydride formation<sup>5)</sup> causes the stress in base material. Hydrides shown in **Fig. 5** and **6** are considered to inhibit slip inside the grain and near the grain boundary.

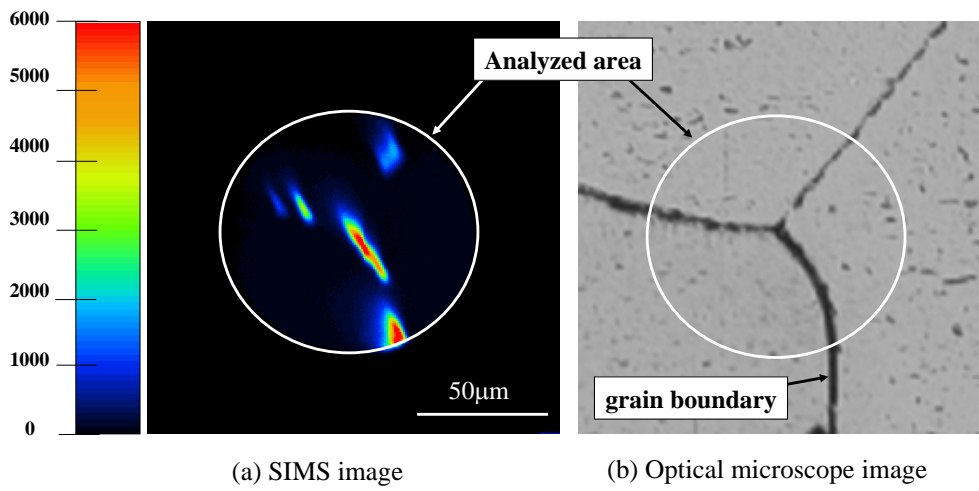
**Fig. 6** SIMS analysis of higher hydrogen content material.

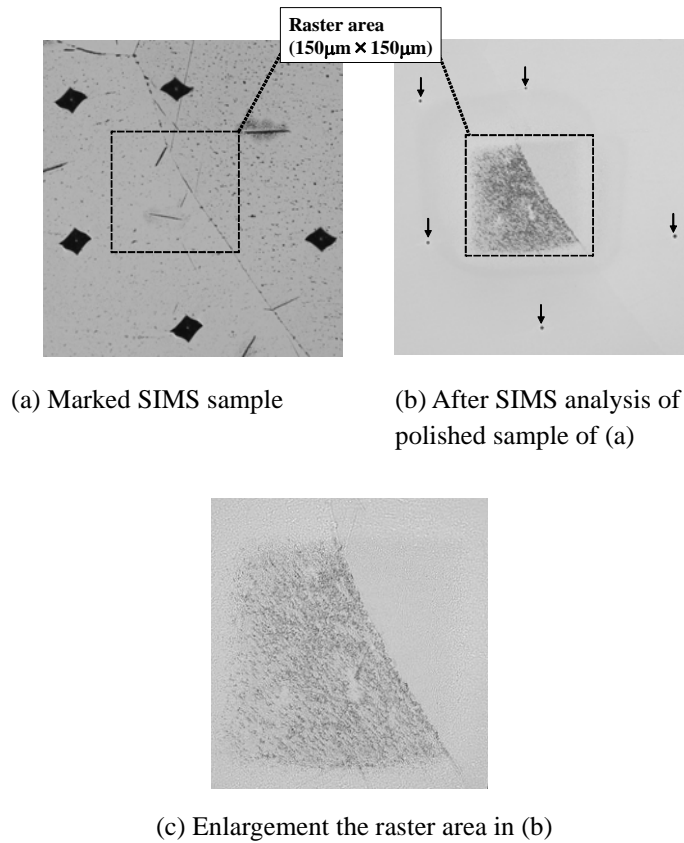
**Fig. 7** Change in surface morphology near the grain boundary before and after SIMS analysis. Arrows indicate Vickers indents after polishing sample in (a).
