## Unzen Volcano : the 1900-1992 eruption

## 11. Debris Flows in Mt. Fugen

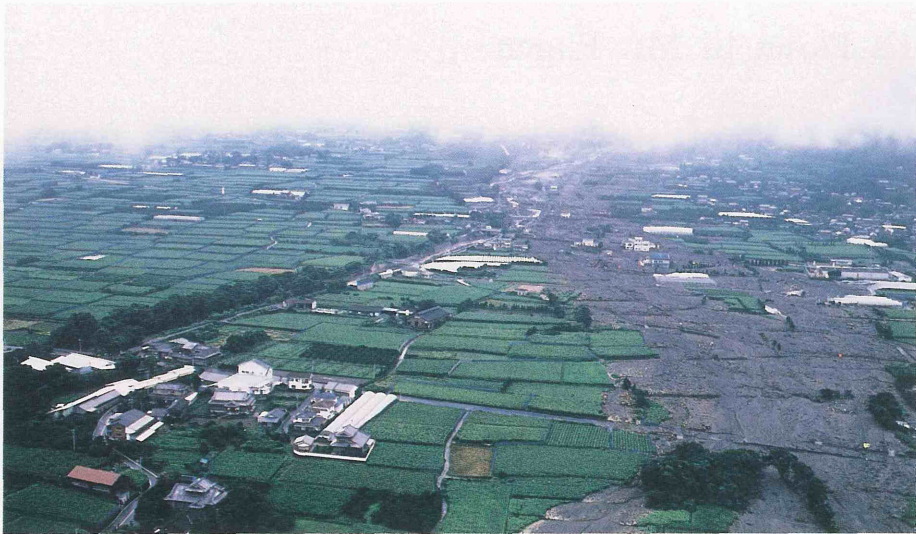
Fig. 11-1. Debris flow flooded into the protected low land on June 30. About 130 houses were broken. (by Hirano, July 2, 1991).

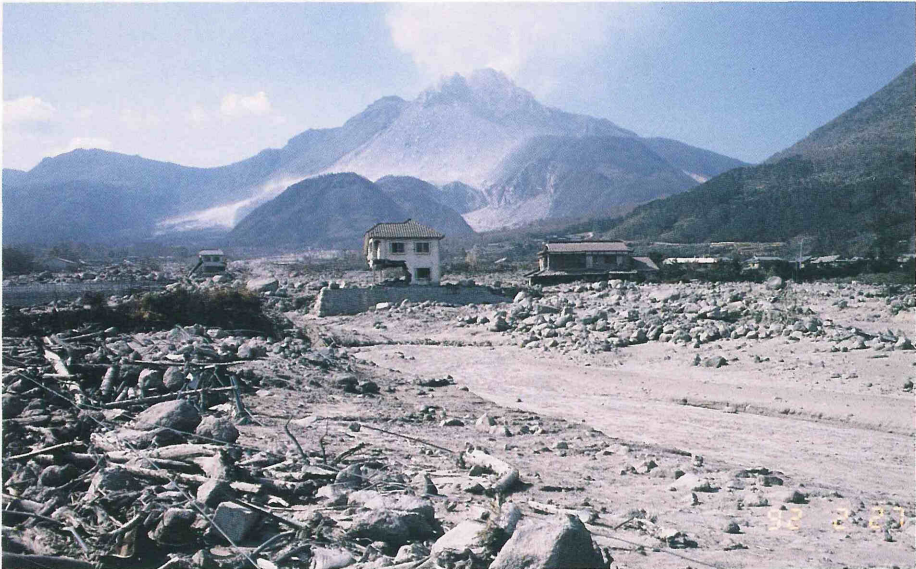
Fig. 11-2. Broken houses by the debris flow on 30 June. Houses have been still left broken in the limited-entry zone. (by Hirano, 22 February 1991).

On the same day, 30 June, a debris flow occurred in the Yue River, too, and caused damage in Ariake town (Fig. 11-2). The debris flow swelled with a lot of dead trees, blocked the bridges and flooded. Despite the larger scale of debris flow, damage was comparatively small, because the rain was heavy but brief and because there were a small number of houses in that area; one person was slightly injured and nine houses

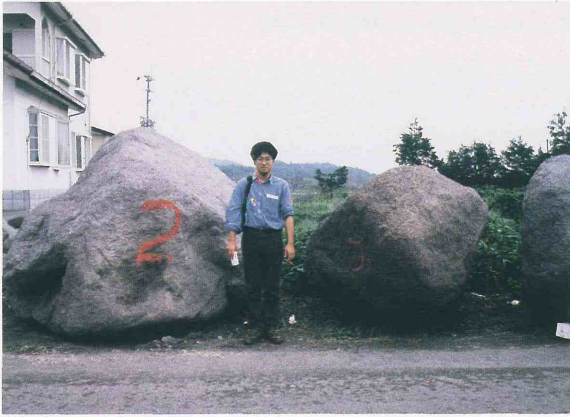
Fig. 11-3. Large blocks of rock brought by the debris flow of May 15 at the lower reach of the Mizunashi River. (by Hirano, 24 May 1991).

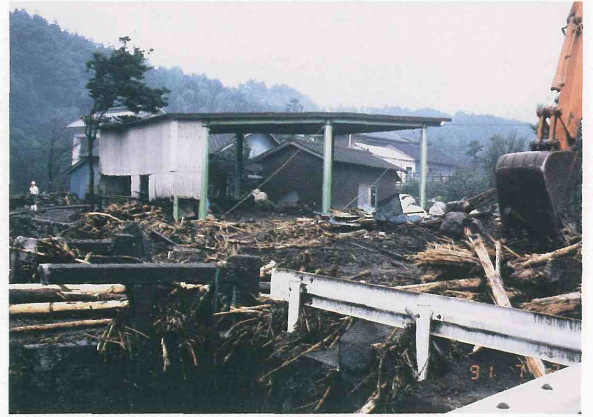
Fig. 11-4. A house broken by the debris flow of June 30 at the Yue River. (by Hirano, 2 July 1991 ).

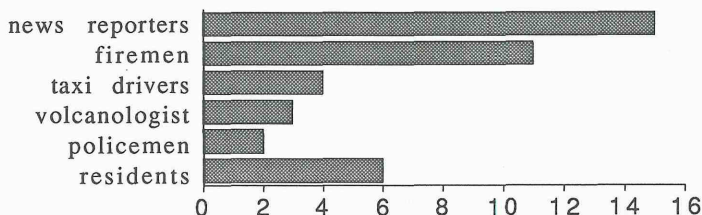
Fig. 11-5. The constituents of victims by the pyroclastic flow on 3 June 1991.

Figure 11-5 indicates the details of 41 lost lives due to the pyroclastic flow by the end of July (The Nagasaki Newspaper Documents, 1991. The total number of casualties finally reached 43). It is remarkable that there were so many loss of lives from the TV teams and firemen

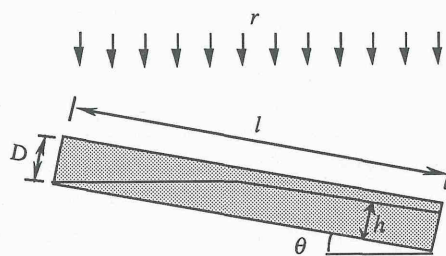
Fig. 11-6. Schematic sketch of a slope.

According to the experimental results (Hirano et al., 1977), debris flow occurs when surface flow appears on a slope due to the heavy rainfall. The criteria of the surface flow is given as follows. On a slope shown in Fig. 11-6, the momentum and continuity equations of subsurface flow are expressed as

where  $\lambda$  is the porosity,  $h$  is the depth of the flow,  $t$  is time,  $\theta$  is the angle of slope,  $\nu$  is the velocity of the flow,  $x$  is the coordinate taken in the downstream direction,  $r$  is the rainfall intensity, and  $k$  is the hydraulic conductivity.

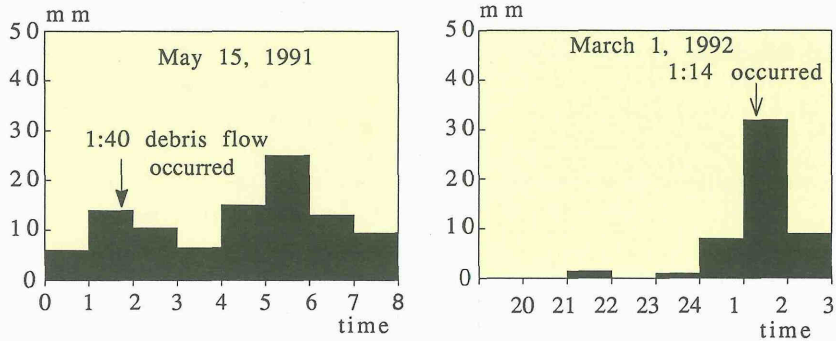
Fig. 11-7. Hyetograph at Unzen Meteorological Observatory.  
(The debris flow occurred in the Mizunashi River)

Figure 11-7 shows hyetographs recorded at the Unzen Meteorological Observatory when debris flows occurred on 15 May 1991, and on 1 March 1992, respectively. In both cases, debris flows occurred between the first and second hours after it began to rain. This shows that debris flows can occur even without the precursory rainfall.

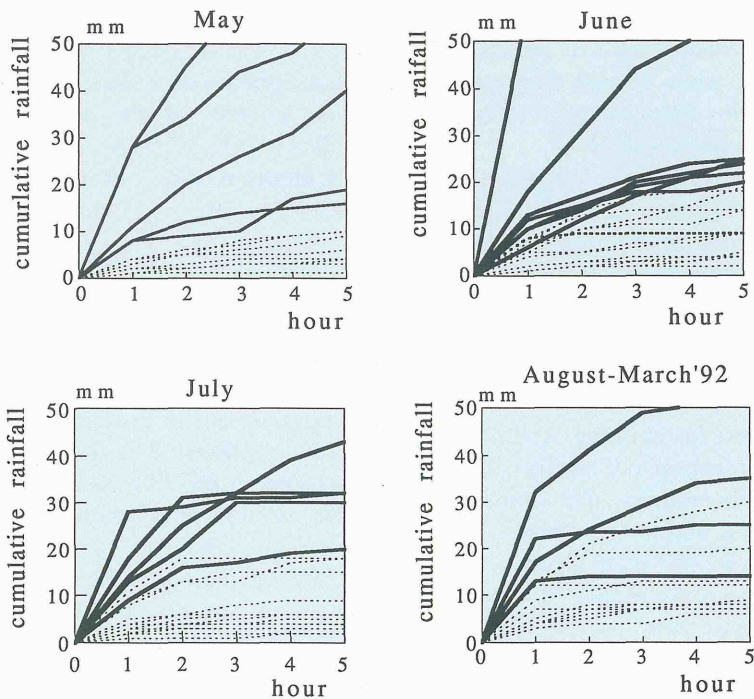
Fig. 11-8. Cumulative rainfall at Unzen Meteorological Observatory.  
(Solid lines: debris flow occurred; dotted lines: not occurred)

Figure 11-8 shows the cumulative amounts of rainfall against cumulative durations, for both cases with and without debris flows. The figure represents the following facts; (1) the time of concentration is estimated to be about an hour on average, (2) the occurrence of debris flows is possible when the amount of rainfall exceeds 7

mm / hr, and (3) debris flows will definitely occur for the rainfall over 15 mm / hr. At Sakurajima Volcano, which has been active in this 20 years, debris flows have been generated by rainfall with the amount of 7 to 13 mm over a period of forty minutes. By comparison, we can conclude that the debris flows in the Mizunashi River show the typical property of volcanic debris flow caused by a small amount of rainfall.
