Unzen Volcano : the 1900-1992 eruption

19. Earthquake Observations at Mt. Mayuyama

Hajime TSUTSUMI, Toshihiko ASO, Shoichi KITAGAWA¹, and Kiyoshi UNO²

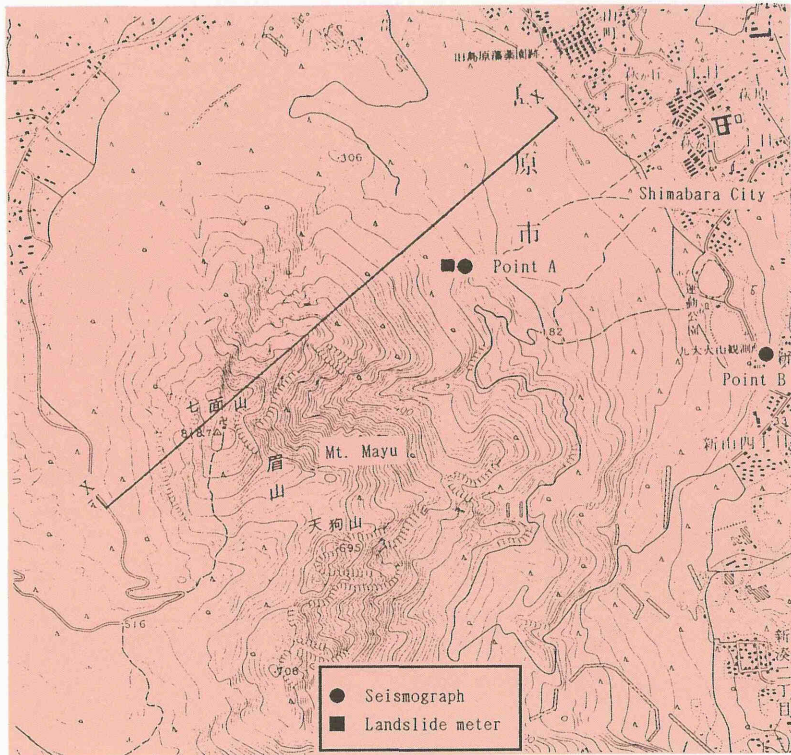
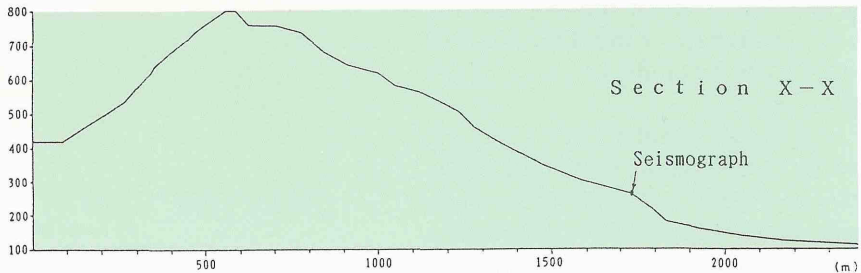
Fig. 19-1. Planimetric map and observation points.

We are making earthquake observations at two locations shown in Fig. 19-1. One (Point B) is the Shimabara Earthquake and Volcano Observatory of Kyushu University, and the other (Point

A) is located on the northeast mountainside of Mt. Mayuyama, where a landslide is most likely to occur in future. Observations at Point A is for investigations of the earthquake behaviour at Mt. Mayuyama, and those at Point B for analyses of seismic waves through the mountain bedrock. One set of seismographic instruments can measure accelerations in three dimensions at the same time and this system can cover wide ranges of acceleration, frequency and strains. We located a landslide meter near Point A, which consists of three steel wires about 40 meters long and measures strains at the surface of the slope. The measurement interval is two hours and a trigger is set for the sudden changes above $\pm 25 \mu$ due to earthquakes. Data obtained from the seismographs and the landslide meter have been sent to Kyushu University by an extensive digital line and analyzed.

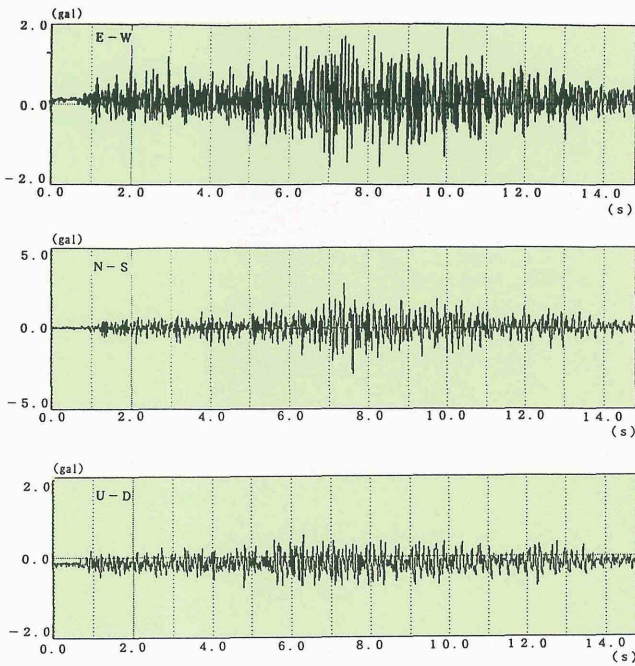
Fig. 19-2. Time history of observed earthquake.

Figure 19-2 shows the time history of the above earthquakes measured at Mt. Mayuyama. The maximum acceleration was 2.5 gal in the N-S direction. Figure 19-3 presents the power spectrum, showing the frequency characteristics of seismic motion at Mt. Mayuyama. Data obtained from the landslide meter does not show significant strains of the slope even during the earthquake.

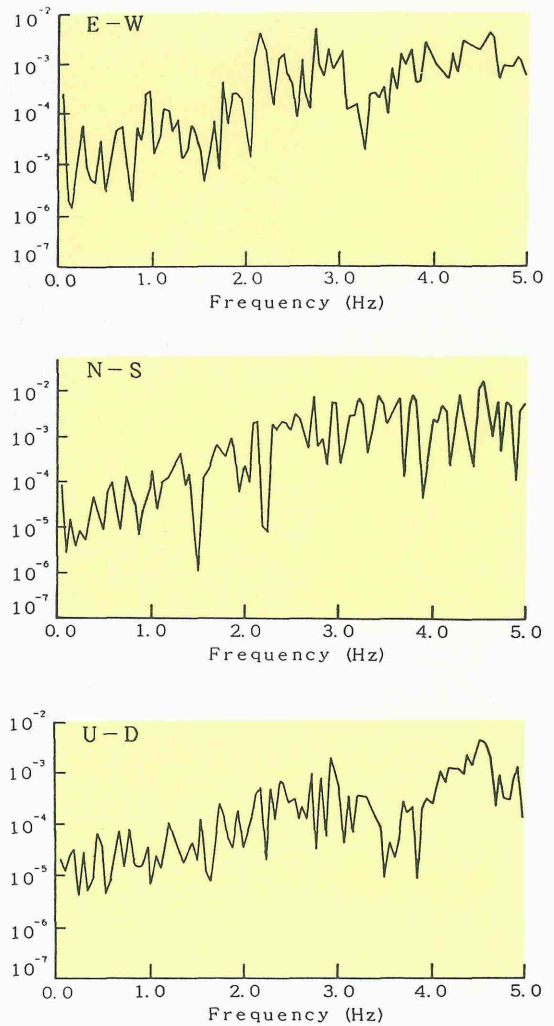
Fig. 19-3. Power spectrum of observed earthquake.

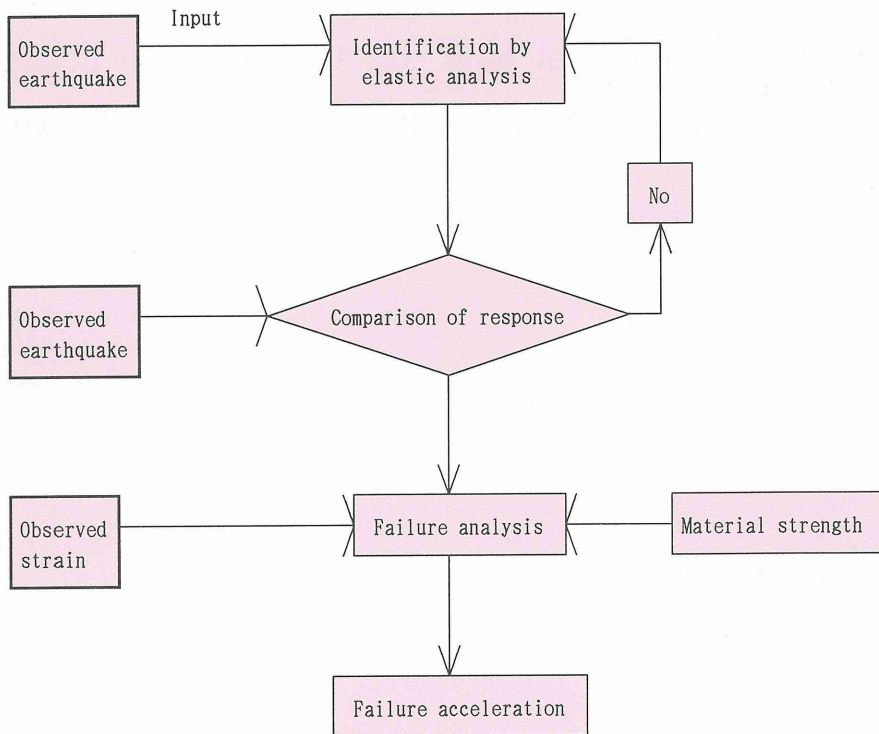
Fig. 19-4. Analysis procedure.

To examine the possibility of the slope failure at Mt. Mayuyama, it is important not only to continue the observations of earthquakes and landslides, but also to study the dynamic characteristics of Mt. Mayuyama. There is little information concerning the geological data and material properties of this slope. However, dynamic failure analysis can be improved and reinforced, if combined with observed seismic data. We will present here one possible process for failure analysis, which is schematically

outlined in Fig. 19-4.

We will model the slope of Mt. Mayuyama as an assemblage of many "elements" for computation by means of finite element method. Definition of such elements depends on an elastic material behaviour, a damping factor, and so on. The mechanical responses of these elements to the earthquake can be computed based on data of the seismic waves through the bedrock obtained at Point B. Comparing the acceleration recorded at Point A with the computed accelerations, we can get useful information to improve computational parameters describing mechanical properties of the elements. Repeating this procedure

will enable us to precisely estimate the soil profile and dynamic characteristics of the slope in the linear range. If the strength of the slope material can be known by some methods, we can compute failure acceleration.
