Analysis of Small Spalling Mechanism on Hot Rolling Mill Roll Surface

Abstract

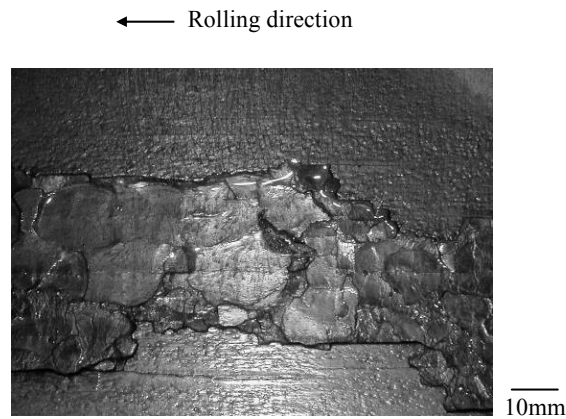
Figure 1 shows the small spalling which exists on the hot rolling mill roll surface after 1.75×10^5 cycles. The roll diameter is 410mm. The finish processing of the roll surface was carried out by a grinding machine and surface roughness of the roll was Ra 1.0μm.

The crack depth is 1 - 2mm from the roll surface, and the size of the small spalling is about several mm - 10mm in the rotation's direction. Each small spalling connection to the rotation's direction was observed. The Hertzian pressure of P_0 = 1747MPa and contact half-width of c = 6.2mm were obtained from the rolling condition based on the elastic calculation. **Figure 2** shows the cross sectional observation of the small spalling site of the actual hot rolling mill roll. Some cracks perpendicular to the roll surface were observed, and one crack, which grew in the roll circumferential direction, was observed.

Fig.1 Small spalling of the hot rolling mill roll.

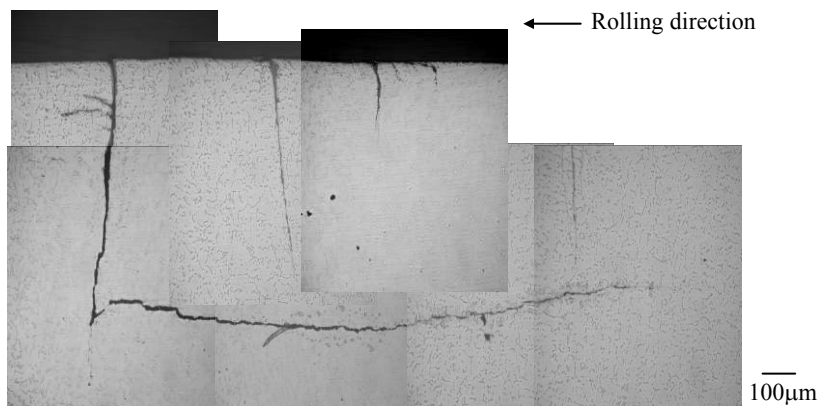
Fig.2   Cross section of the actual hot rolling mill roll.

During rough rolling and finish front rolling, when the roll surface is rapidly cooled during rolling, cracks are initiated by tensile stress which act on the roll surface[3,4]. The tensile stress of the roll surface causes the perpendicular crack initiation on the roll surface. The observed crack shown in **Fig.2** has a shape similar to that reported in the literatures[3,4].

Due to the rolling mechanical loading, the perpendicular crack seems to grow in the circumferential direction. The perpendicular crack is closed by the Hertzian pressure, because the stress field of the Hertzian contact region is compression[5]. When liquid from the outside does not enter to the crack surface as in a perpendicular crack, the crack shifts to a Mode II crack growth without causing Mode I crack growth[3]. The circumferential crack observed in **Fig.2** is thought to grow by the Mode II loading.

When the crack length was considered a = 0.8mm was observed in **Fig.2**, and the friction coefficient was found to be f = 0.1, the Mode II stress intensity factor range, $\Delta K_{II} = 17.5\,\mathrm{MPa}\sqrt{\mathrm{m}}$, was obtained. The friction coefficient f = 0.1 referred to the literature[13] measured the friction coefficient in the rolling actually. The $\Delta K_{II} = 17.5\,\mathrm{MPa}\sqrt{\mathrm{m}}$ value obtained by the calculation exceeded $\Delta K_{IIth} = 16.0\,\mathrm{MPa}\sqrt{\mathrm{m}}$ of the specimen in **Fig.8**, and it satisfied the circumferential Mode II fatigue crack growth conditions.

When the circumferential the Mode II fatigue crack grew under the condition at ΔK_{II} = $17.5\,\mathrm{MPa}\sqrt{\mathrm{m}}$, Mode II fatigue crack growth rate $da/dN \approx 5.00\mathrm{x}10^{-5}$ mm/cycle was obtained from **Fig.8**. The circumferential crack length is 1.8mm in **Fig.2**. The life for the circumferential crack growth in **Fig.2** was estimated to be about $3.60\mathrm{x}10^4$ cycles. The hot rolling mill roll in **Fig.2** passed through $1.75\mathrm{x}10^5$ cycles, and small spalling was observed even during the 10^4 cycles (no crack growth was observed). The small spalling life is about $2.00\mathrm{x}10^5$ cycles, if the small spalling size is considered to be about 10 mm in **Fig.1**, and it approaches the phenomenon observed in the actual hot rolling mill roll. The circumferential crack growth length of **Fig.1** and **Fig.2** is different. If the circumferential crack started to grow, when the hot rolling mill roll started to use, there is the difference between the small spalling life prediction from **Fig.1** and the small spalling life prediction from **Fig.2**. Because the crack growth starting to the circumferential direction is uncertain, the estimation in the detailed crack growth life by the confirmation of the conversion of the perpendicular crack to the circumferential crack is required.

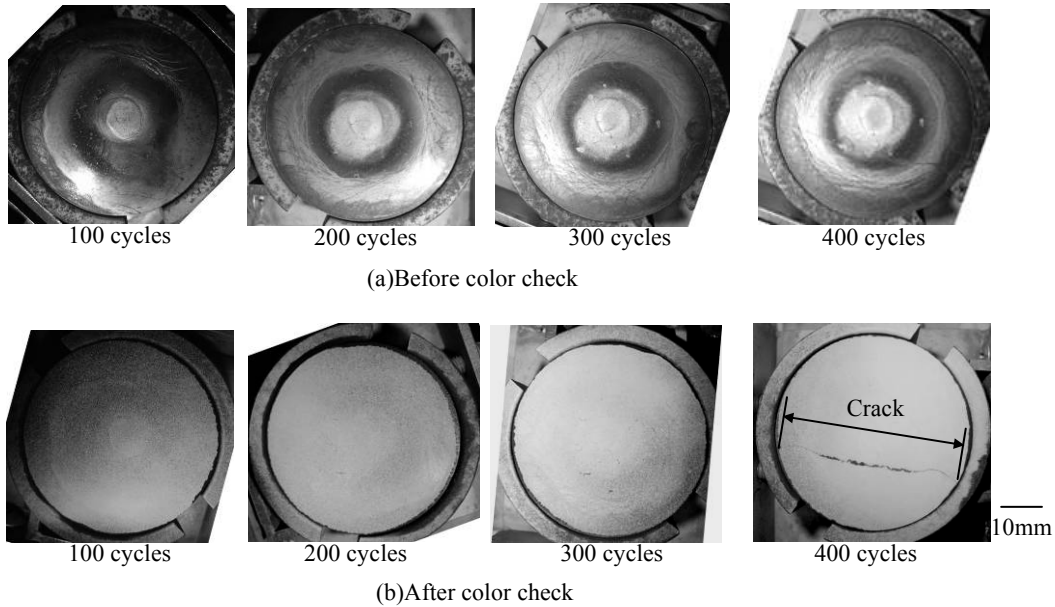
Fig.4 Specimen surface after thermal cycle test.

Figure 4 shows the surface state of the specimens after the thermal cycle test. The crack initiation was observed on the specimen surface after the thermal cycle test of 400 cycles.

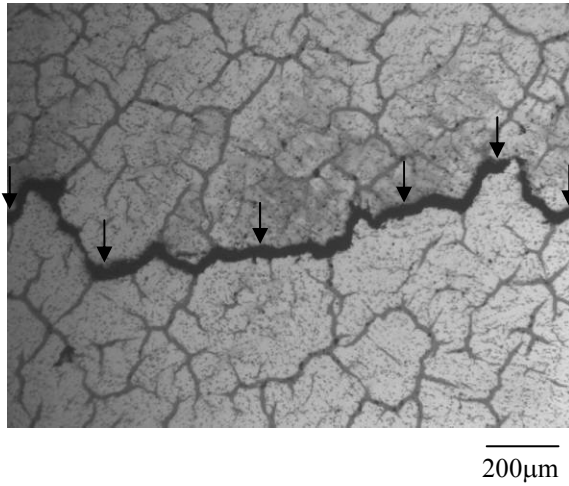
Figure 9 is a photograph around the crack in the specimen surface observed after 400 cycles during the thermal cycle test. The crack growth was observed along the pattern of the black network. **Figure 10** shows the result of the analysis of this black network by EDX (Energy Dispersive X-ray spectroscopy). **Figure 10** shows the result of the oxygen analysis, and it was confirmed that oxygen existed in the black network. The oxide was generated, because the black network was a boundary of the dendrite, and the boundary is easy to be corroded in comparison to the matrix. **Figure 11** shows the result of EDX analysis and the position is different from the **Fig.10**. There are element peaks such as Fe, O and V. The compound oxide seems to have been formed. The Vickers hardness of the black network and the matrix was measured. The sizes of the indentations were about 25 μm under the load condition of 0.2kgf. As a result of the measurement, The Vickers hardness of the black network and the matrix were 680 and 460, respectively. The hardness of the black network is higher than that of the matrix. Based on this result, the black network becomes brittle due to the formation of the oxide.

**Fig.9** Crack on the thermal cycle specimen surface.   **Fig.10** Result of oxygen analysis on the specimen surface by EDX.

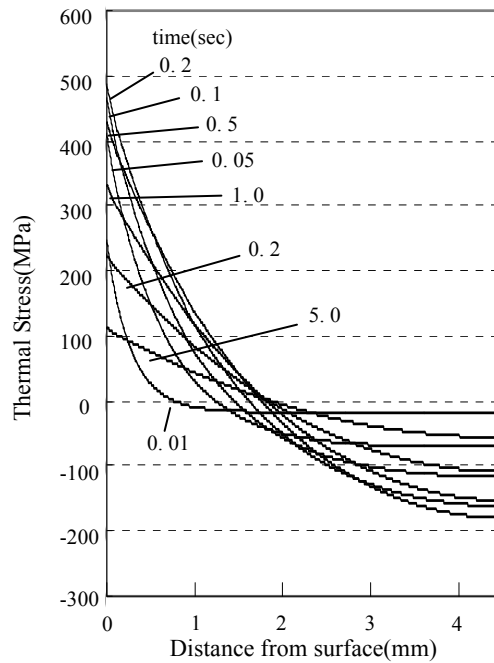
Fig.19 FEM analytical result of the thermal stress[11)].

Verification on the condition of the crack initiation of the small crack origin was then carried out. Based on the calculation by the authors[11], in the specimen of the same material, the largest thermal tension stress, which acts on the surface of the specimen, was about 500MPa after 0.2 seconds from the starts of cooling from 600°C. The Mode I stress intensity factor K_I was calculated using the following equation by considering the effect of the inclusion, when the small crack (the overall length $2a = 2.5mm$) as in **Fig.13** was initiated by the effect of the oxide during the thermal cycle. The effect by the sliding in actual hot rolling was not considered, because the contact area between the rolled steel and the hot rolling mill roll was far from a cooled area of the roll surface.
