Optimalization of Outpit Dump at Asam-Asam Open Pit Coal Mine, PT Arutmin Indonesia

Budi Sulistianto[*1], Tri Karian[*1], Kardiansyah[*2], Syarif Hidayatullah[*2], Sudirman Widhy[*2]

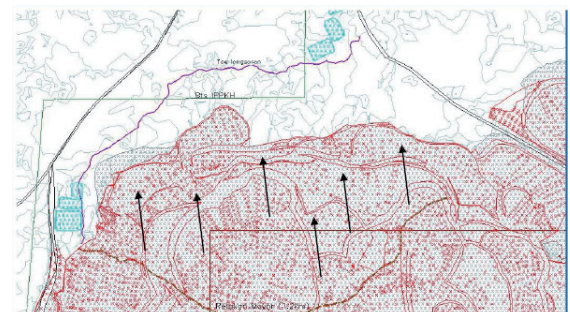
One of overburden dumping area in Asam-Asam site is outpit dump DH 1-2 (OPD DH 1-2). This overburden dump height is around 25 meter. Failure has occurred in this overburden dump on March 2012 as shown in Fig. 2. Currently, PTAI is planning to continue coal mining operation in Pit 1-2 DH. Since an optimization of hauling distance is needed, the availability of OPD DH 1-2 is very important for pit 1-2 DH dumping area. Therefore, a geotechnical study has to be conducted in order to characterized the cause of failure occurred in OPD pit 1-2 DH and to guarantee that OPD pit 1-2 DH can be used for further dumping activity.

Fig. 2 OPD pit 1-2 DH and direction of failure.

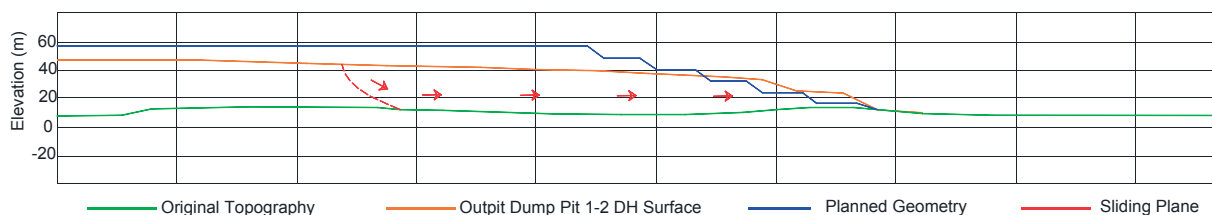
Material of OPD Pit 1-2 DH is overburden from Pit 1-2 DH which mudstone and sandstone are dominated. It is calculated from surveying that approximately 6 million cubic meter material is slide with around 400 m width and 900 m length. Geometry of sliding area is shown in

The type of failure is predicted as a composite failure consists of plane failure and circular one, and the sliding plane based on field observation is represented by the dash line in Fig. 3. It is also known that dumping activity is carried out by using free dump technique without a proper compaction in some of OPD Pit 1-2 DH.

Fig. 3   Geometry of failure at OPD pit 1-2 DH.

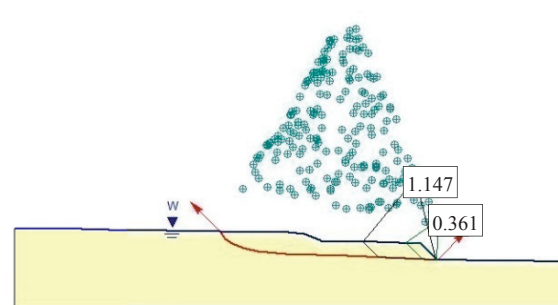
Based on the result of analysis, it can be known that a failure occurs only at the front side of OPD Pit 1-2 DH. Providing that front side material moving forward after failure occurred, stability analysis can be conducted by omitting front side material as shown in Figs. 6 and 7. It can be seen the large failure at material pile was induced by the failure of front side material.

Fig. 6   Result of outpit dump failure analysis by omitting the front side material (SF = 1.147).

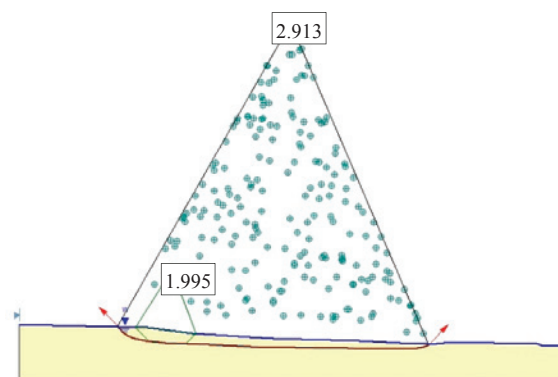
By using surface condition after failure and using the same sliding plane, post failure analysis is then conducted in order to know the stability of outpit dump after failure. Result of analysis can be seen in Fig. 8. From the result of post failure analysis it can be known that post failure at OPD pit 1-2 DH is in stable condition. However, in order to obtained higher certainty of stability, resloping is still conducted. Fig. 9a shows the actual field condition of OPD Pit 1-2 DH after resloping activity is conducted

Fig. 8   Result of OPD pit 1-2 DH failure analysis at block 10 after failure (SF=1.995).

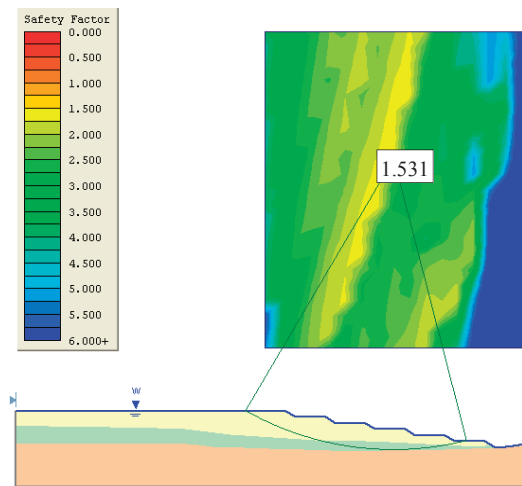
Fig. 10 Result of optimized OPD pit 1-2 DH at section 3 for circular sliding analysis (SF=1.53).

For optimizing the mining activity, OPD Pit 1-2 DH is still needed as a short range dumping area. In order to optimize OPD pit 1-2 DH after failure, Post failure analysis with the addition of another dumping material from pit 1-2 DH is carried out. Optimization of post failure OPD pit 1-2 DH is carried out by adding dumping material until the overall slope height is 60 meter and angle of 10^o while the single slope height is 10 meter and angle of 35^o with failure material act as base of Optimized OPD Pit 1-2 DH model. Figs. 10 and 11 show the result of optimized OPD Pit 1-2 in Section 3 for circular sliding analysis and composite sliding analysis. The same analysis is conducted for OPD pit 1-2 DH in section 5. The result is shown in Fig. 12.

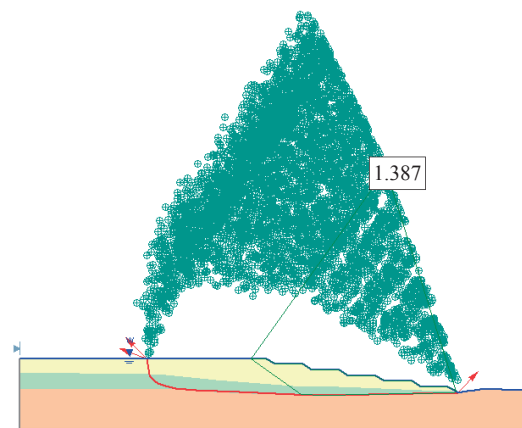
Fig. 11 Result of optimized OPD pit 1-2 DH at section 3 for composite sliding analysis (SF = 1.38).

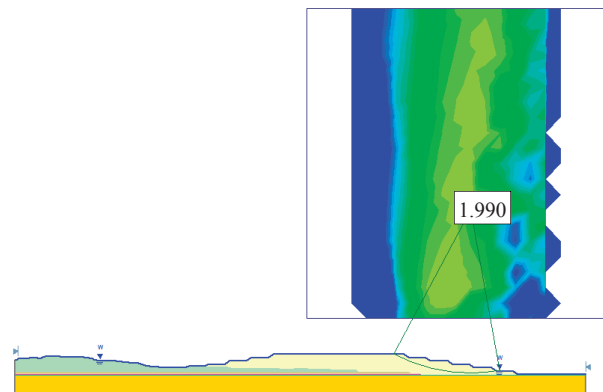
Fig. 12 Result of optimized OPD pit 1-2 DH at section 5 for circular sliding analysis (SF=1.99).

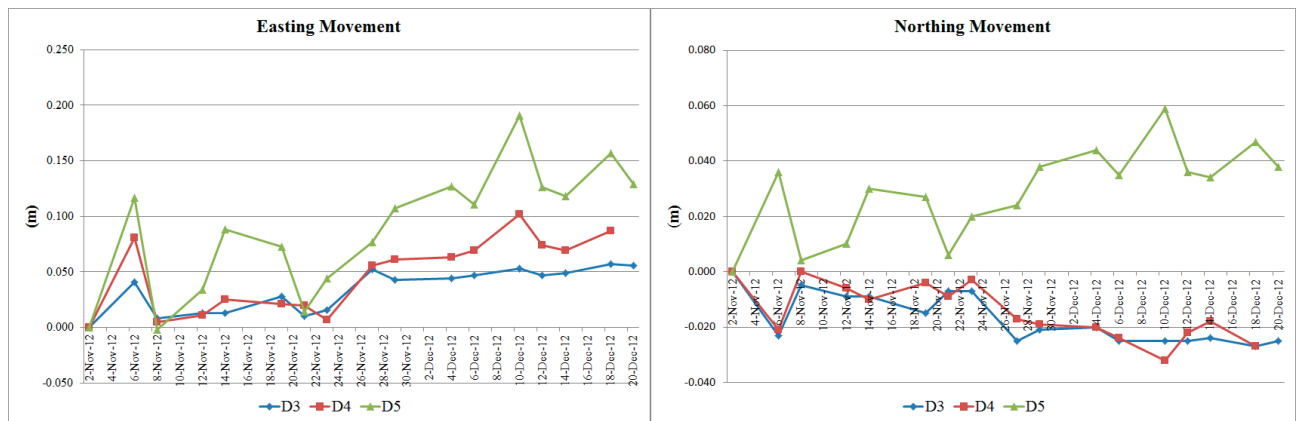
Fig. 16 Monitoring point in OPD pit 1-2 DH.

afety dumping operation, after re-sloping the dumping material pile at failure area, PTAI has installed some monitoring point as shown in Fig. 16 which is monitored continuously.

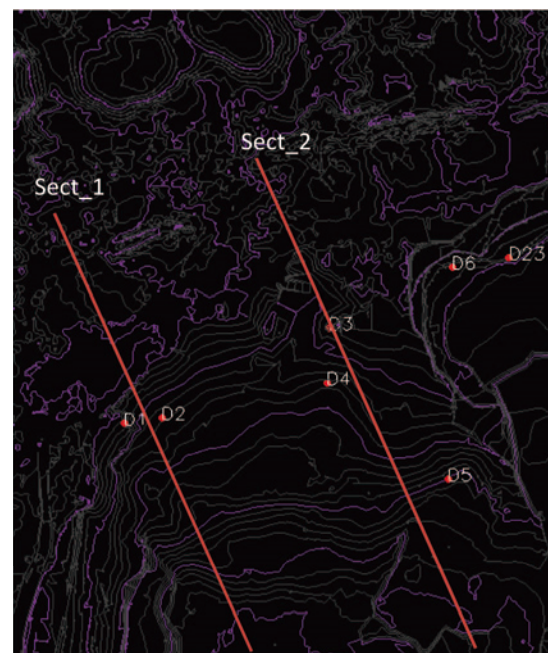
Fig. 17 Location of monitoring point in OPD pit 1-2 DH after resloping is carried out.

Fig. 17 shows the position of monitoring point around sections 1 and 2. Monitoring data collection is carried out between early November and late December. Based on analysis using monitoring data, it can be understand that movement of points D3, D4 and D5 are eastward rather than northward. It might be due to the existence of pond. The result of movement is shown in Fig. 18. From Fig. 18, it can be confirmed that a relatively small deformation is occurred as predicted by numerical calculation using Finite Element Method.
