Structural Strength Degradation of Oil and Gas Refinery Equipment. Case Study: Heat Exchanger Tubes of Hydrocarbon Vapor

Amin Suhadi^{1,*}, Adimas Aprilio¹ and Eka Febriyanti¹

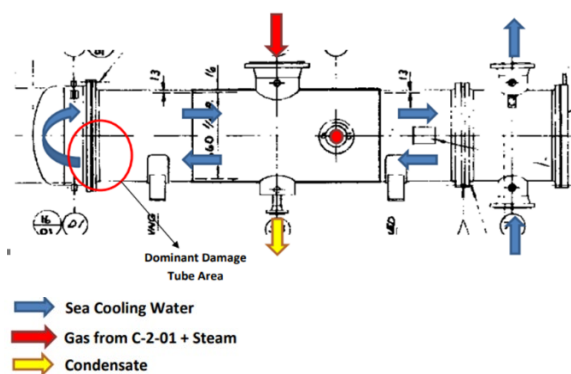
The specimens used for examination in this research were extracted from two heat exchanger tubes that had experienced leakage. These specimens were sourced from an oil refinery in Indonesia and were assigned specimen codes E-2-10 and E-2-11. These tubes were located in the lower section of the heat exchanger, as illustrated in Figures 1 and 2.

Fig. 1: Schematic figure of gas, condensate and water flow in heat exchanger.
