Characterization of high-velocity impact damage in CFRP laminates: Part II - prediction by smoothed particle hydrodynamics

Characterization of high-velocity impact damage in CFRP laminates: Part II – prediction by smoothed particle hydrodynamics

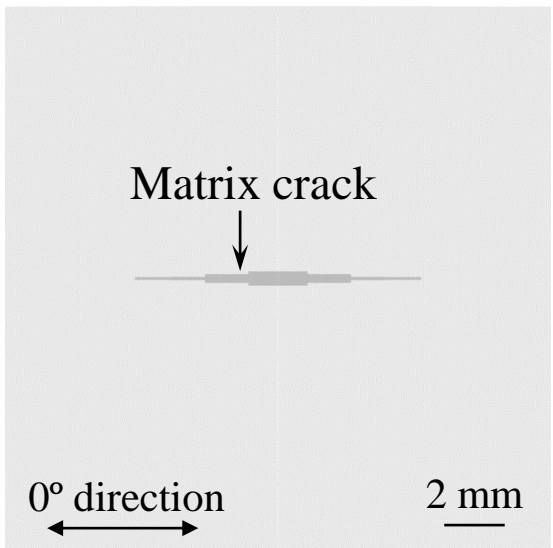
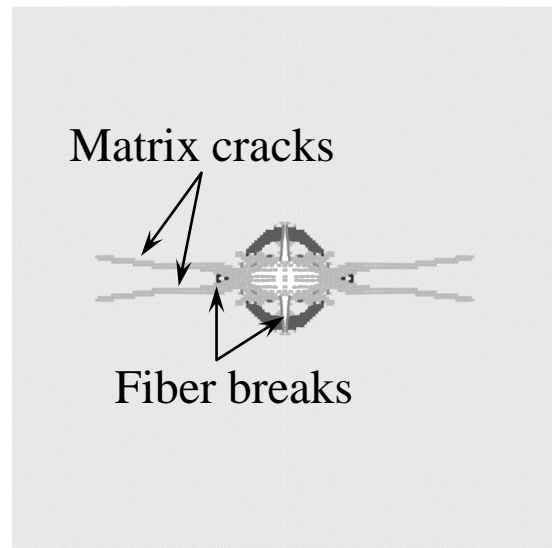
Fig. 5 Damage states on the front and back surfaces. Full dimension of the target is depicted considering the symmetry.

885 m/s

Front

Back

Figure 5 depicts the damage patterns on the front surface and the back surface, in which the whole target dimensions are depicted for easy understanding. Matrix cracking denotes the cracks due to tensile transverse stresses and shear stresses, and matrix crushing indicates the matrix failure by compression and shear. A crater with fiber breaks was formed on the front surface, and matrix crushing and matrix cracking extended in the fiber direction. The straight matrix crushing and cracking appeared as the multiple splits observed in Fig. 1, although the crack lengths differed. Only a single crack was predicted on the back surface at 344 m/s, and this corresponds to the barely visible damage in Fig. 1. Multiple matrix cracks and fiber breaks were generated on the back surface at higher velocities. Small fiber breaks occurred beneath the impact point at 618 m/s, and the fiber breaks increased with increasing velocity. These damage patterns on the front and back surfaces agreed well with the experiment. Unrealistic oblique cracks appeared on the back surface at 885 m/s, possibly due to insufficient damage criterion.

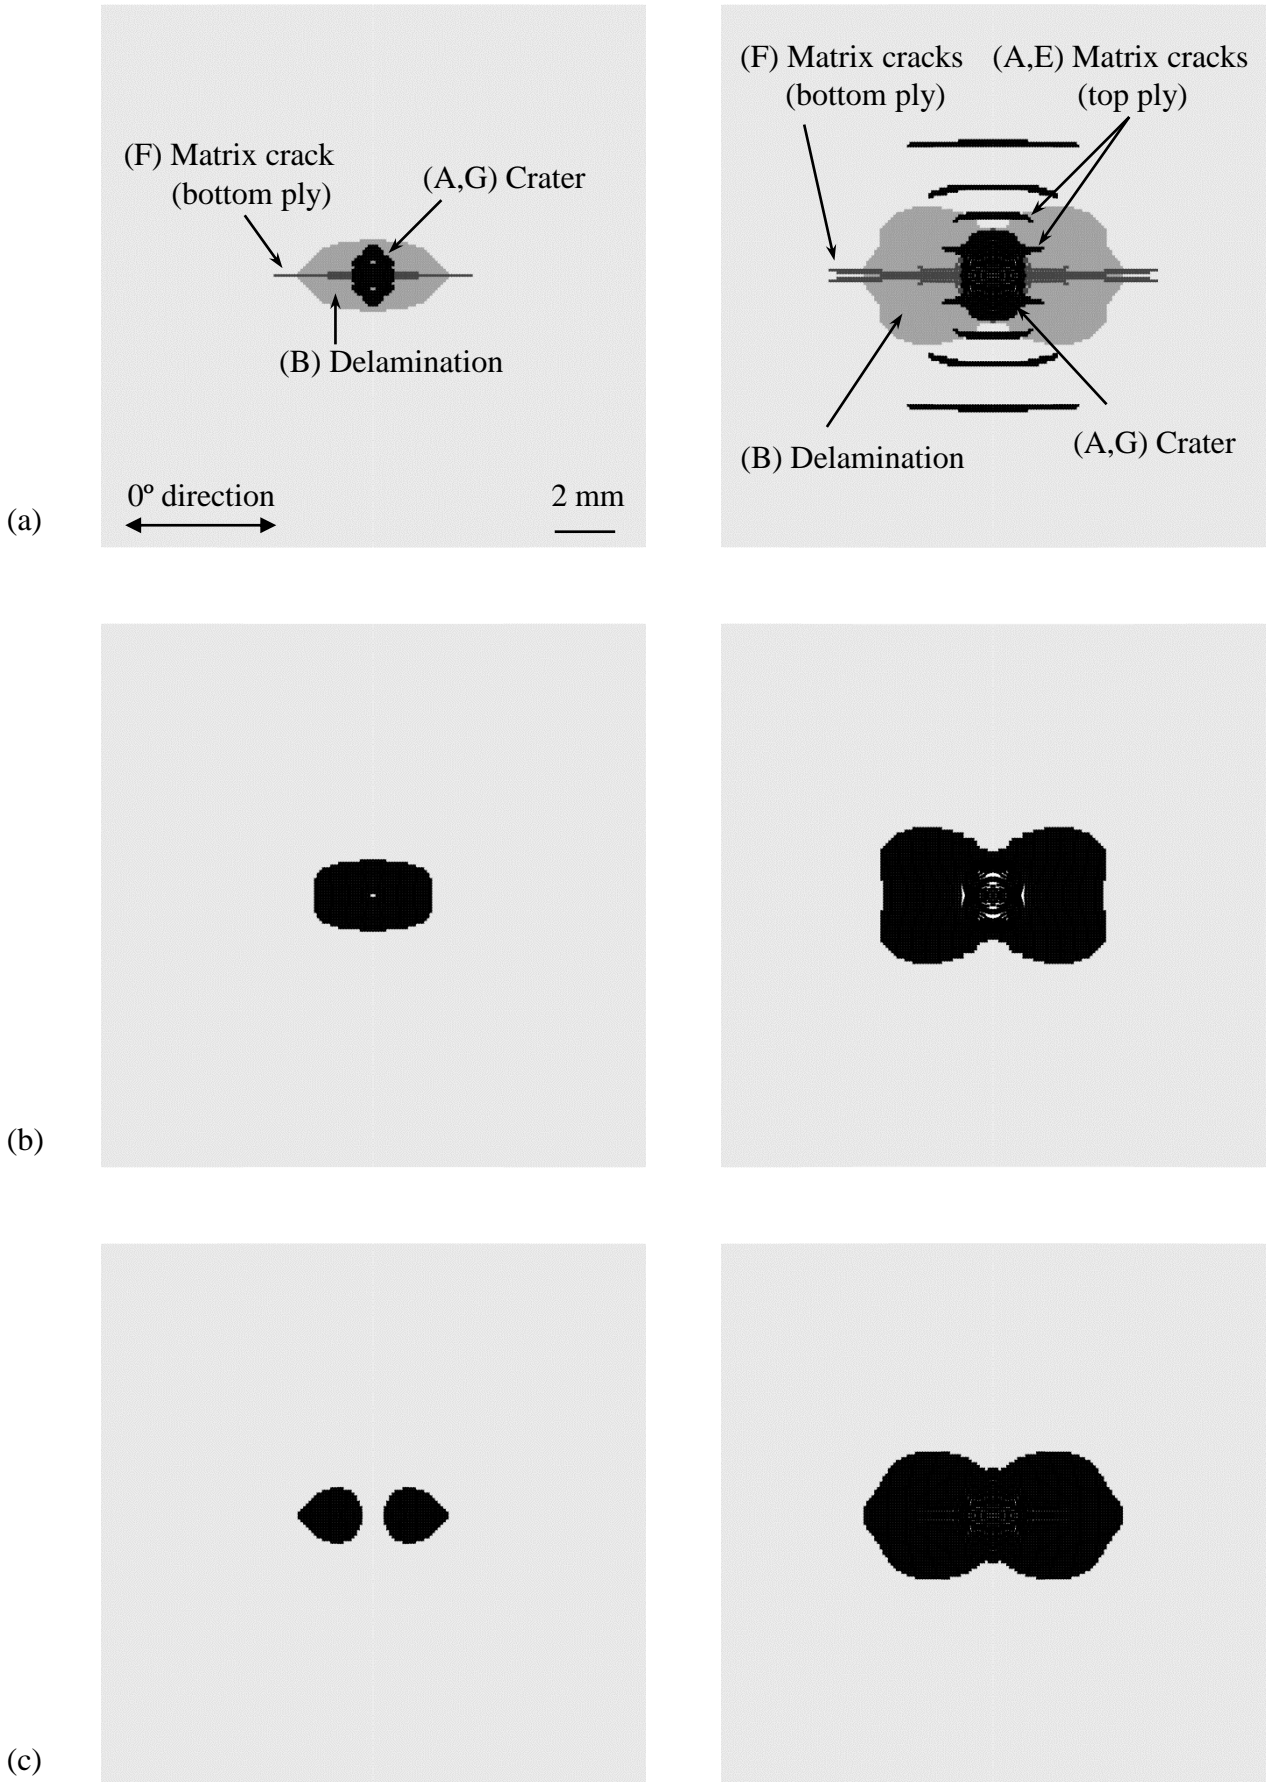
Fig. 8 Projection of the damaged particles. (a) Projected damage area. (b) Delamination at the upper interface. (c) Delamination at the lower interface.

The projection of damaged particles in the z -direction is depicted in Fig. 8a for comparison with the soft X-ray photographs. Delaminations (B) were generated near the crater (A,G) along the matrix crack (F) in the bottom 0° ply, and this pattern agreed well with the observation (Fig. 3). Figures 9b and 9c depict the delamination at the upper and lower ply interfaces. The upper delamination extended more in the 90° direction than did the lower delamination, and this trend was also observed in the experiment. This delamination became peanut-shaped with increasing velocity, which was observed in the experiment, including in the low-velocity impact.
