The Effect of Temperature on Bearing Strength of CFRP Bolted Joint with Washer Constraining

出版情報：九州大学応用力学研究所所報. 142, pp.21-27, 2012-03. Research Institute for Applied Mechanics, Kyushu University

Abstract

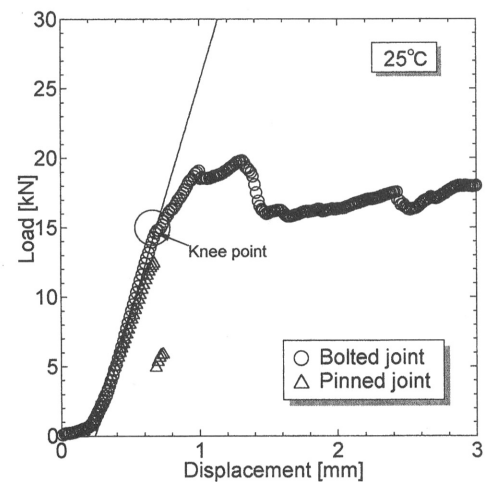
At 25 °C, shown in Figure 4, the L-D response shows nonlinear behavior around 15 kN with a sound and a knee point is appeared. After that, the load increases linearly up to 18-20kN and decreases about 4-5kN from the maximum point gradually. At 150 °C L-D curve on the small load level shows the similar manner to the result of 25 °C and the knee point appears obviously around 12 kN. After that the load increases gradually and slightly decreases at 15 kN without a sound as contrasted with the 25 °C case. The load level at 150 °C is lower than 25 °C in general. Figure 6 shows the L-D response at -100 °C. The load increases linearly until knee point appears. After that the load leads to the maximum value of 25kN and decreases with a large sound. The load level at -100 °C is higher than those at 25 and 150 °C. The knee point appears at 20 kN and a second linear deformation slope is observed to the higher load level. The same is true for a pinned joint.

Figure 4 Load-displacement curves at 25 °C

The load-displacement curves are shown in Figures 4-6. The pinned joint data is referred from [10].

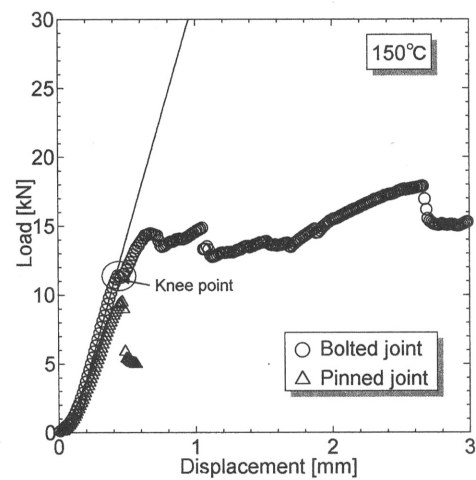
Figure 5 Load-displacement curves at 150 °C

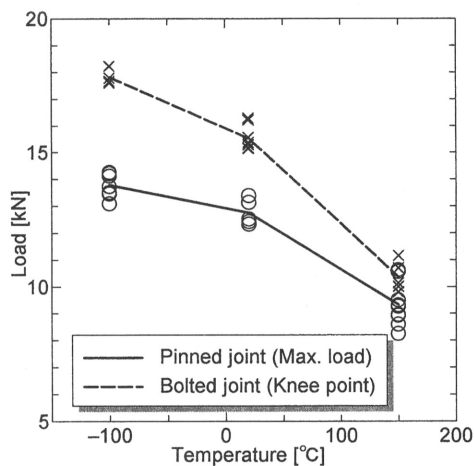
The strength at various environmental temperatures is shown in Figure 7 and listed in Table 1. Bearing strength was defined as the load divided by the product of pin-diameter and thickness. The data of the strength for a pinned joint were obtained by the maximum values on the L-D curve. For bolted joint, the load at the knee point was used. It indicates that the strength decreases with the temperature increasing. The difference of strength between a pinned joint and bolted joint also decreases with the temperature increasing. This result shows that the temperature influences the effect of through the thickness constraint on the strength.

Figure 7 Strength at various temperatures
