Investigation of Delayed Crack Propagation Associated with Hydrogen Effect in a Thin Sheet of Single-Crystalline BCC Iron-Based Alloy

**Investigation of Delayed Crack Propagation
Associated with Hydrogen Effect in a Thin Sheet of
Single-Crystalline BCC Iron-Based Alloy**

Graduate School of Engineering, Kyushu University, Japan
for the degree of Doctor of Philosophy in Hydrogen Energy System

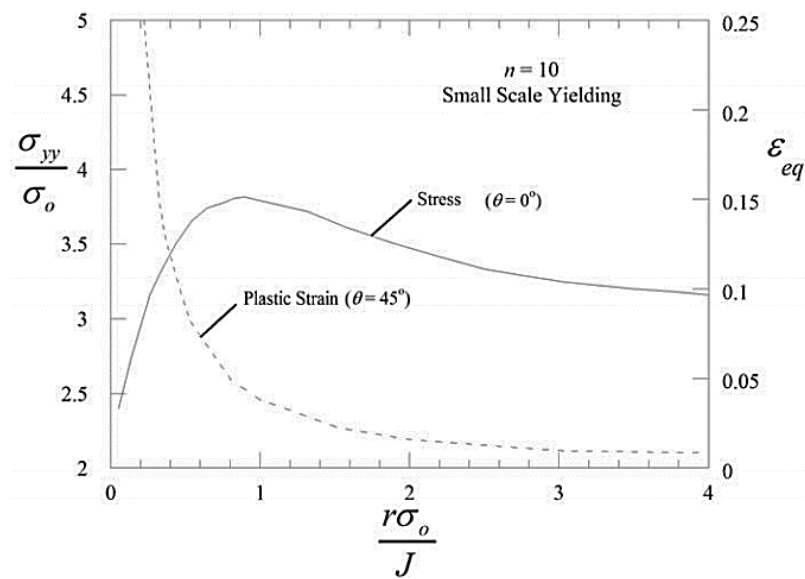
Fig. 1. 4. Stress and strain ahead of a blunted crack tip, determined by finite element analysis [37].

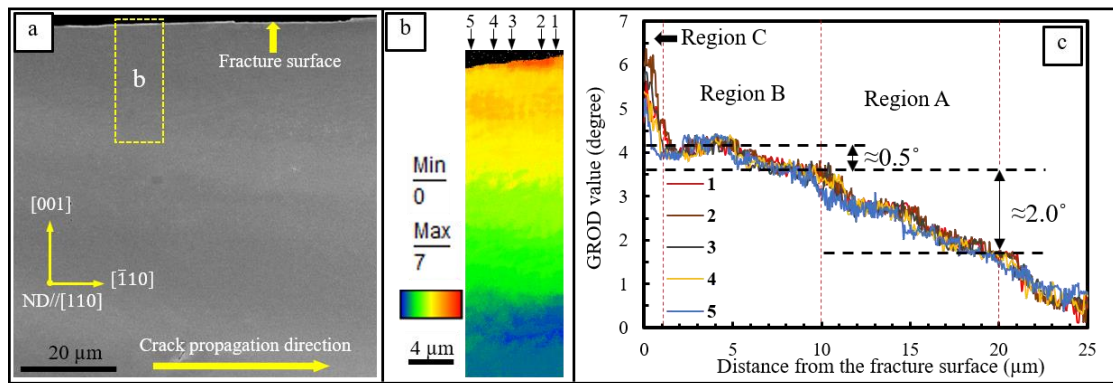
Fig. 2.5. (a) SE image of a polished cross-section along the center of the specimen (the same position as the line labeled d-e in Fig. 2.3(a)); (b) GROD map of the region highlighted by yellow rectangle in (a); (c) Misorientation profile depicted from EBSD measurements along the loading direction [001] (indicated by the five arrows in (b)). GROD has been reported to have a correlation with plastic strain [79-81]. The width of Region B in (c) is identical with the width of Region B in Fig. 2.3(d).

Fig. 2.5 shows a set of EBSD analyses in the region highlighted in Fig. 2.4(d). Interestingly, the grain reference orientation deviation (GROD), which correlates to plastic strain [79-81], indicates that the magnitude of the plastic strain gradient in Region B is much lower than that in Region A, except for extremely near the fracture

surface (Region C). Note that Region C corresponds to the white band (the band is about 2 μm in width) on the top of Fig. 2.4(b) and (d), which is the region immediately beneath the fracture surface. The validity of the orientation information near the fracture surface requires further assessment because the edge of the surface has various types of edge effects during EBSD and ECCI analyses. Coupled with the discussion for Fig. 2.4, Region B has higher plastic strain but lower magnitude of plastic strain gradient compared with those of Region A. In fact, the size of Region B in Fig. 2.5(c) corresponds to that of Region B in Fig. 2.4; therefore, this peculiar strain gradient might be correlated to a reason for the constant plastic zone size of Region B in Fig. 2.4.

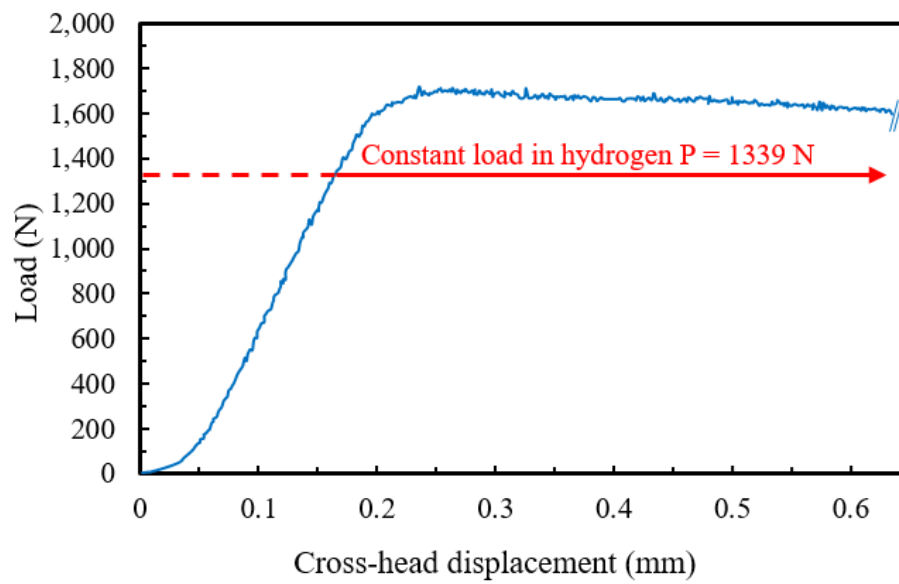
Fig. 3.3 A plot of the cross-head displacement versus the load in air environment; however, the constant load $P = 1339$ N in hydrogen environment (red color) is shown here for comparison.

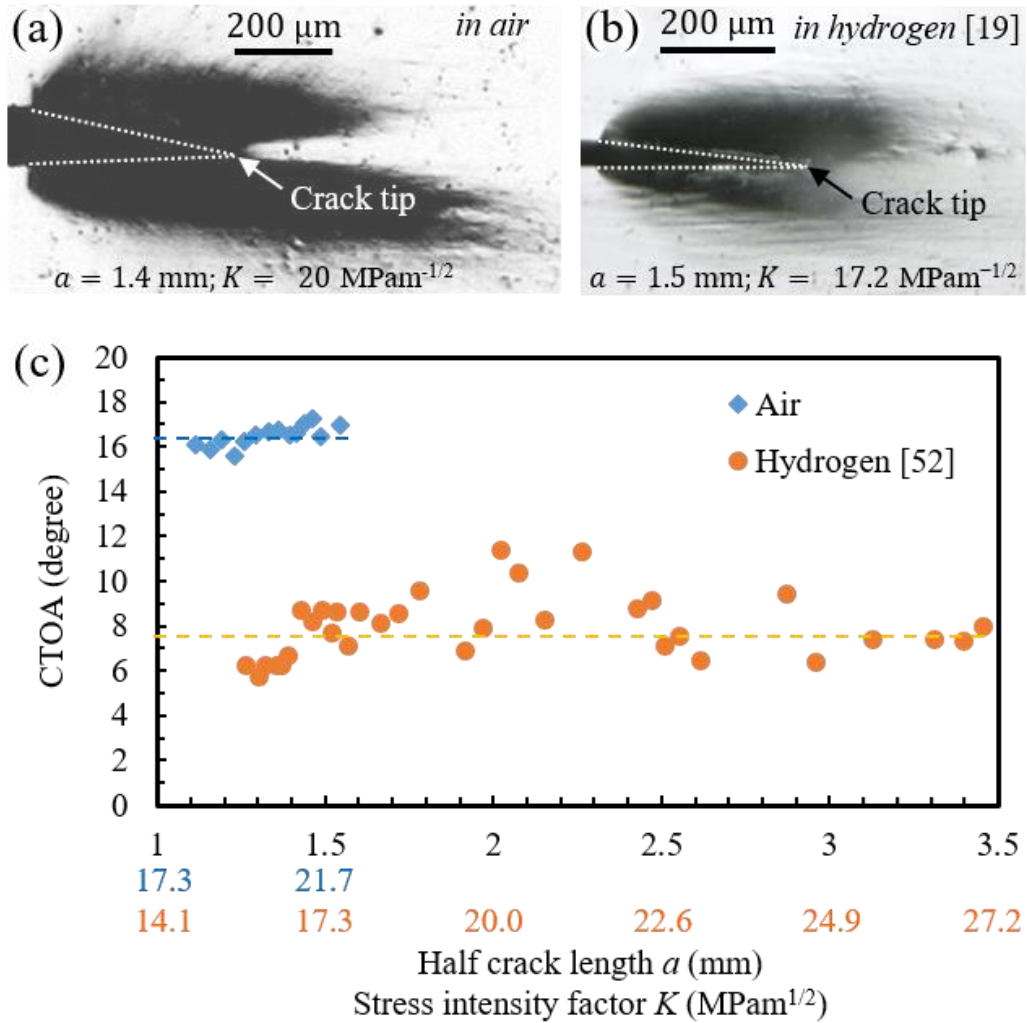
Fig. 3.5 (a) and (b) respectively show optical images of the crack propagation process in air and hydrogen environments. In these images, the dark regions around the crack wake, where the reflection of light illumination was scarce due to specimen necking (i.e. out-of-plane shear deformation), can be seen. Significant necking is observed in air. (c) shows a plot of CTOA versus half crack length a .

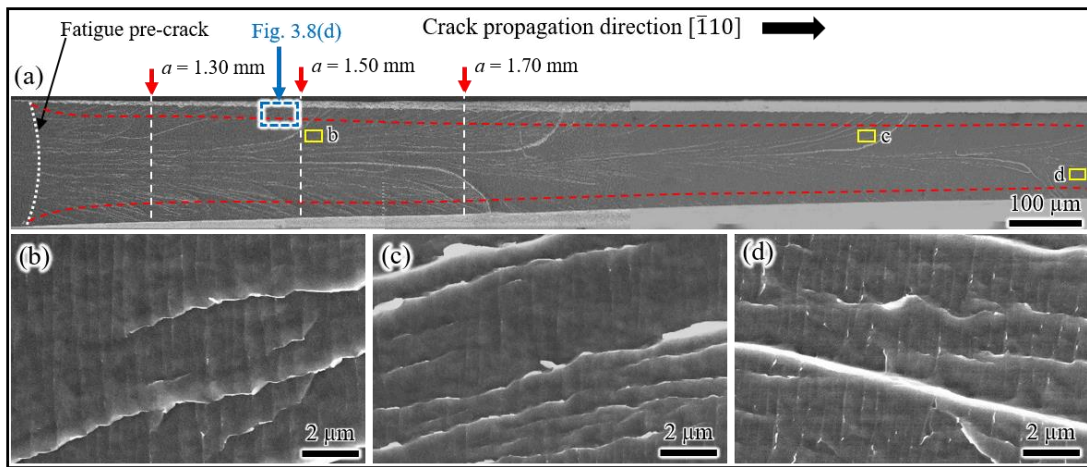
Fig. 3.8 SEM images of the fracture surfaces in a hydrogen environment; (b), (c), and (d) magnification observation of rectangle areas of (a) showing apparent striations. EBSD analysis will be performed in the middle of the specimen thickness at different crack lengths which are indicated by the red arrows.

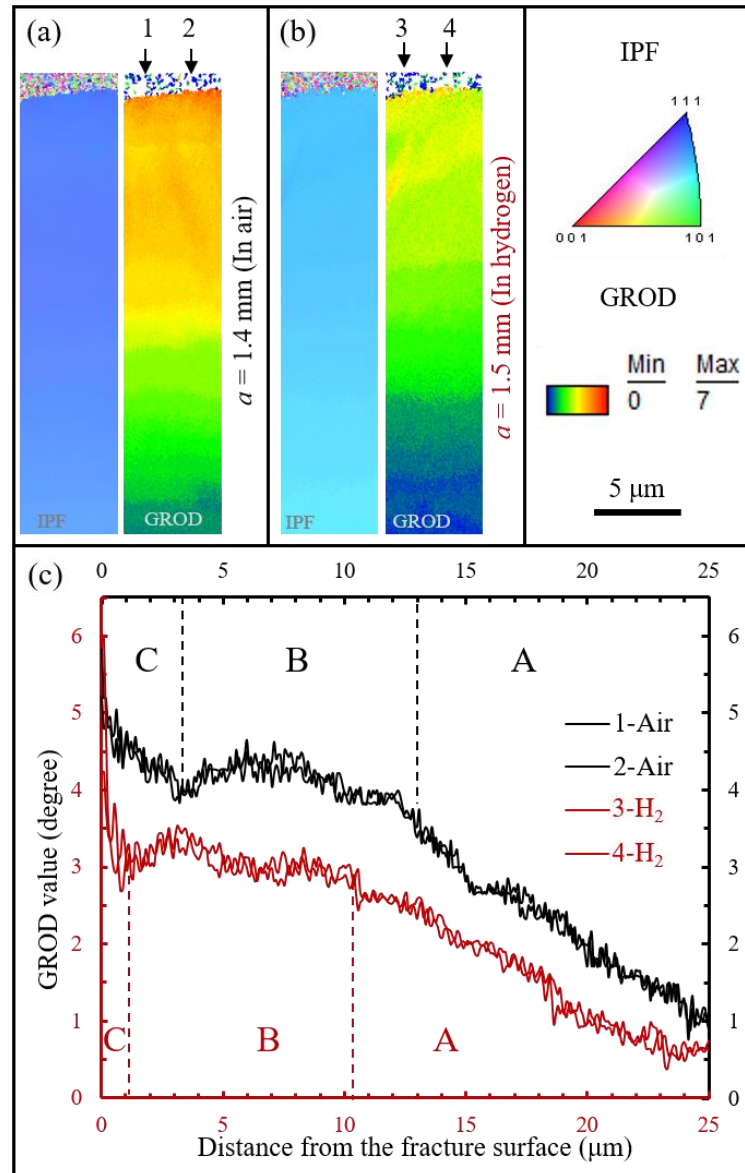
Fig. 3.13 (a) and (b) show IPF and GROD maps investigated at a relative same crack length in air and hydrogen, respectively (in air: $a = 1.4$ mm, $K = 20.8$ MPam^{1/2}; in hydrogen: $a = 1.5$ mm $K = 17.2$ MPam^{1/2}); (c) Misorientation profile depicted from EBSD measurements along the loading direction [001], which is indicated by arrows in (a) and (b).

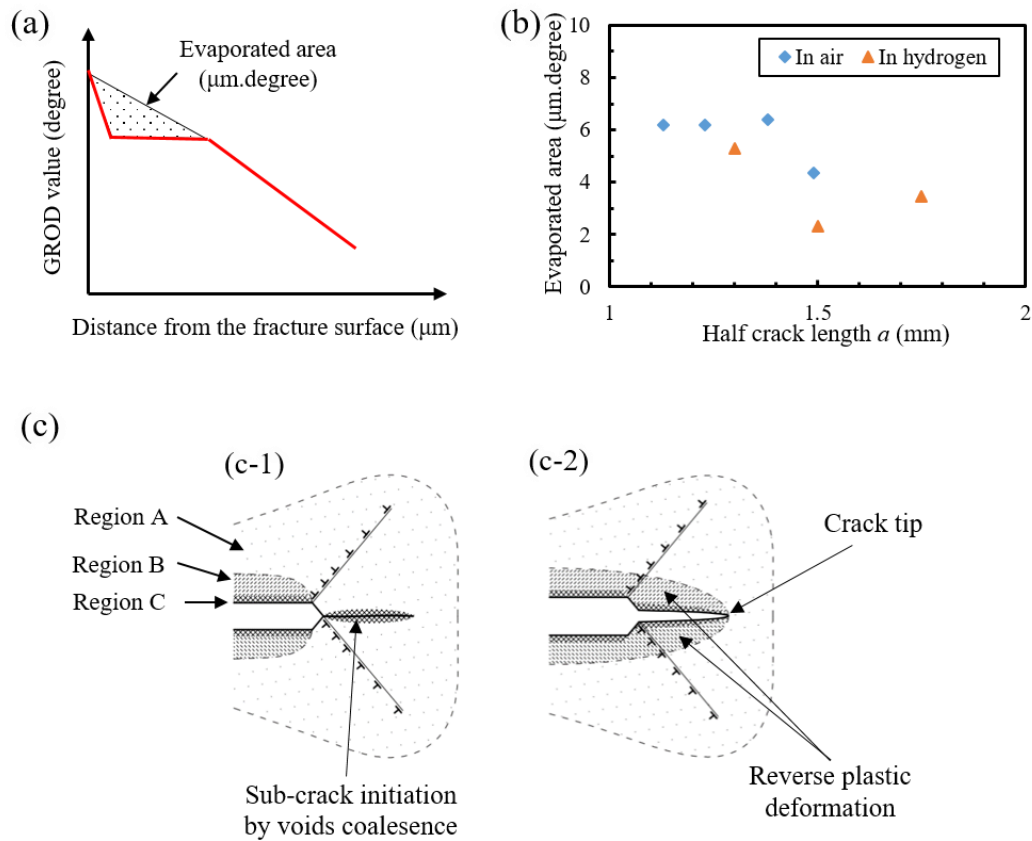
Fig. 3.15 (a) A schematic illustrating the tendency of plastic strain gradients underneath the fracture surface and showing a triangle-dotted region represented the "evaporated" area due to the reverse plastic deformation; (b) the measurements of "evaporated" areas at different crack lengths in air and hydrogen environments; (c) a schematic illustrating effect of the reverse plastic deformation on the CTOA and crack tip geometry; (c-1) sub-crack initiation; (c-2) coalescence of sub-crack and main crack, and the crack tip is slightly blunted by the reverse plastic deformation.

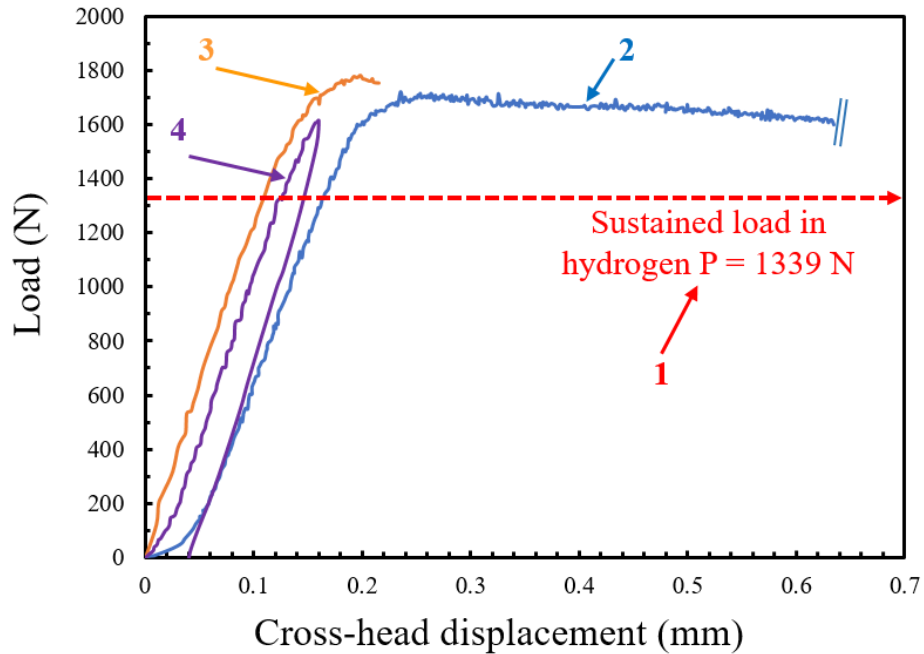
Fig. 4.1 Plots of crosshead displacement and the load of the specimens tested in air environment. Each color (text, lines, arrows) represents each specimen and its information (see Table 1). For a specimen 3, it is hard to identify crack initiation and crack length during crack propagation due to the effect of the painting layer on the specimen surface (DIC method is used for this specimen). Also, the unloading process of specimen 3 did not record, which is a miss.

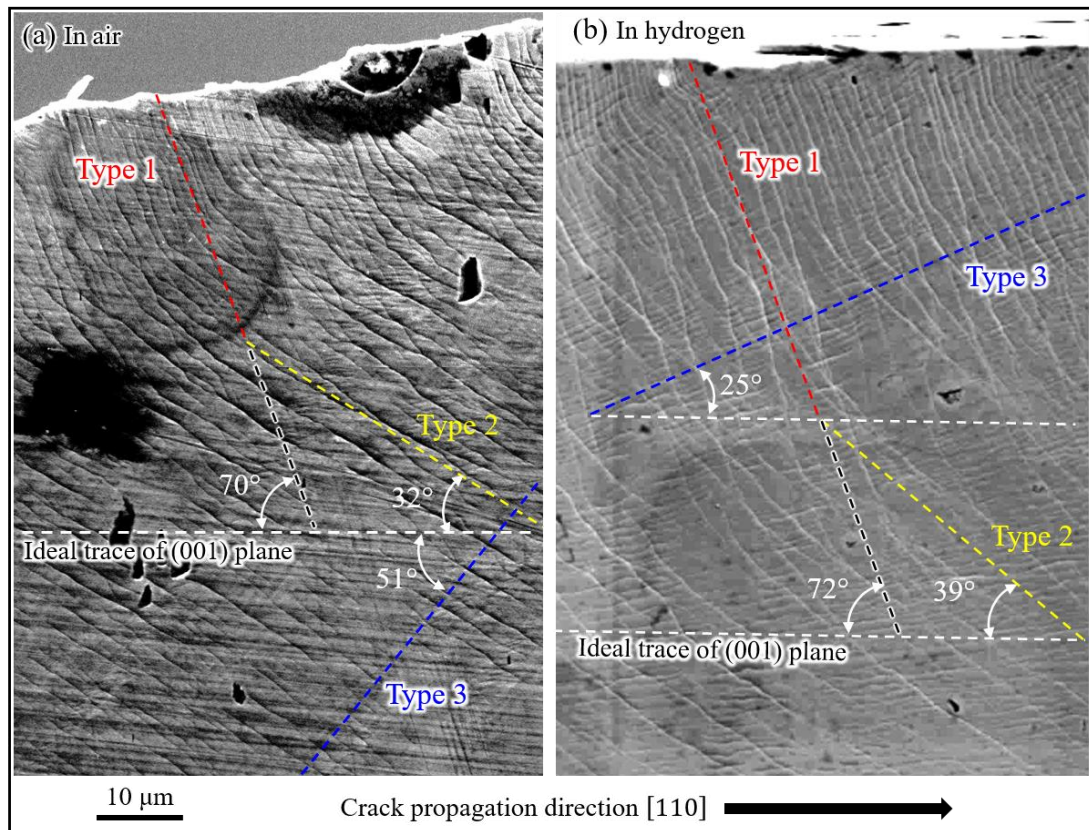
Fig. 4.8 Complementary SEM images of the specimen surfaces showing the clear slip lines (a) in air and (b) in hydrogen. These images are taken in the regions outlined in Fig. 4.7. Each color of lines represents one type of slip traces, which are the same as those of Fig. 4.7.

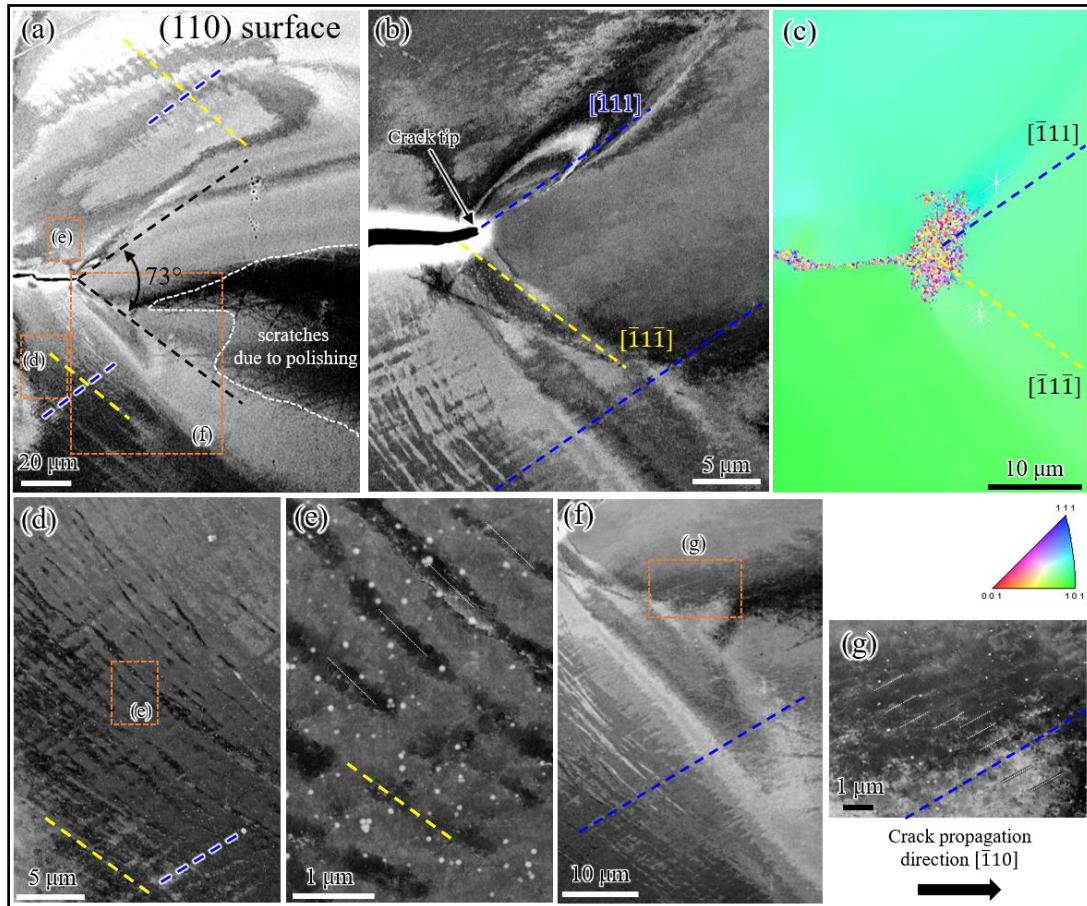
Fig. 4.10 A set of ECC images and EBSD analysis of the cross-sectioned surface after removing about 60 μm of material from the side surface of specimen 3. In these images, except (c), are ECC images showing dislocation structure inside of the specimen. In the areas above (but far away) and below the crack plane shown in (a), the appearance of “crossing lines” of dislocation structures can be seen. The “crossing lines” are showed apparently in (d). It seems that the intersection between slip bands, which are in $[\bar{1}11]$ and $[\bar{1}\bar{1}\bar{1}]$ directions.

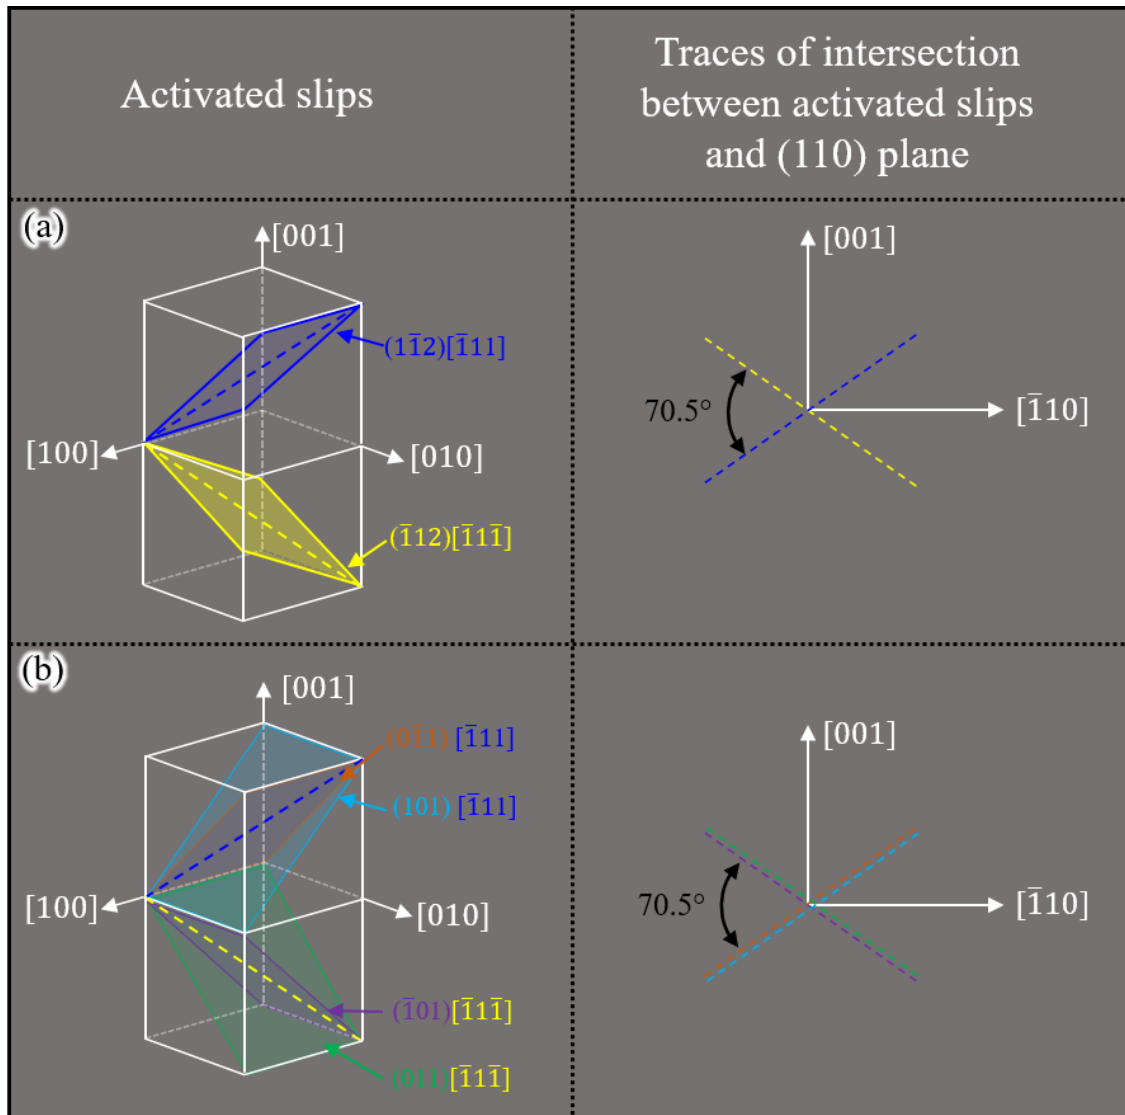
Fig. 4.15 A schematic illustration of the (a) $(112)[111]$ and (b) $(110)[111]$ slip systems which correspond to the slip traces associated with a $(001)[\bar{1}10]$ (crack plane and crack propagation direction) crack propagation under plane strain conditions. Note that the same color indicates identical slip planes and directions.

As the SEM images of fracture surfaces shown from Figs. 4.2 to 4.5, the crack macroscopically propagated in $[\bar{1}10]$ direction. This was presented in most of the studies that used the same material and crack orientation [50, 51, 69, 72, 114, 115]. Furthermore, even some studies [50, 51, 69, 72, 115] designed that crack propagates in $[010]$ direction on (001) plane. The crack propagated macroscopically in $[010]$ direction, but the local crack front and striation lines were perpendicular to two orthogonal $[110]$ and $[\bar{1}10]$ directions, as shown in Fig. 4.16 [117]. Those studies were also analyzed slip systems that activated and contributed to crack propagation under plane strain conditions by experiments [49, 69, 100] and simulations [101], which used the same material and orientation and had tested in air and hydrogen. They reported that emission dislocations from the crack tip is on the $\{112\}\langle 111 \rangle$ and/or $\{110\}\langle 111 \rangle$ slip systems [49, 100, 101]. The proposed $\{112\}\langle 111 \rangle$ and $\{110\}\langle 111 \rangle$ slip systems are shown in Fig. 4.15. These slip systems are symmetrical about the crack plane. Note that the striation is formed by extensive slip at the crack tip. It is interesting that the traces of intersection between the slip planes of $(1\bar{1}2)[\bar{1}11]$ and $(\bar{1}12)[\bar{1}\bar{1}\bar{1}]$ (shown in Fig. 4.15(a)) and the crack plane (001) lie in the $[110]$ direction. Meanwhile, the traces of intersection between the slip planes of $(0\bar{1}1)[\bar{1}11]$, $(101)[\bar{1}11]$, $(\bar{1}01)[\bar{1}\bar{1}\bar{1}]$, and $(011)[\bar{1}\bar{1}\bar{1}]$ slip systems (shown in Fig. 4.15(b)) and the crack plane (001) lie in the
