A monitoring technique for disbond area in CFRP bonded joints using embedded fiber Bragg grating sensors: development and experimental validation

Abstract

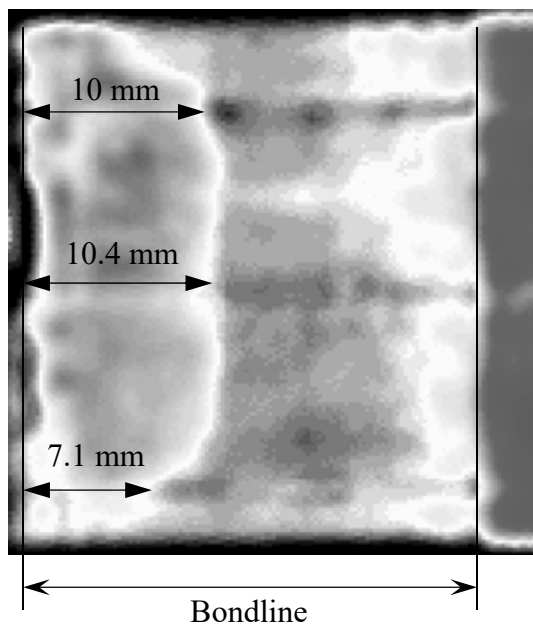
Figure 11 Typical results of nondestructive inspections after 5000 cycles, along with a photograph of the manually-broken specimen.

(a) Ultrasonic C-scan image

(b) Soft X-ray photograph

(c) Microphotograph

An additional experiment was conducted to clarify the cause of the discrepancy observed in Fig. 10. The fatigue test was interrupted at 5000 cycles, and the joint specimen was inspected by conventional
