# EFFECT OF SURFACE TREATMENT ON BONDING BEHAVIOR OF WET LAYUP CFRP—STEEL JOINT AND ITS HYDROTHERMAL DETERIORATION MECHANISM

A Thesis Submitted  
In Partial Fulfillment of the Requirements  
For the Degree of  
**Doctor of Engineering**

to the  
DEPARTMENT OF CIVIL ENGINEERING  
GRADUATE SCHOOL OF ENGINEERING  
**KYUSHU UNIVERSITY**  
Fukuoka, Japan  
**September, 2024**

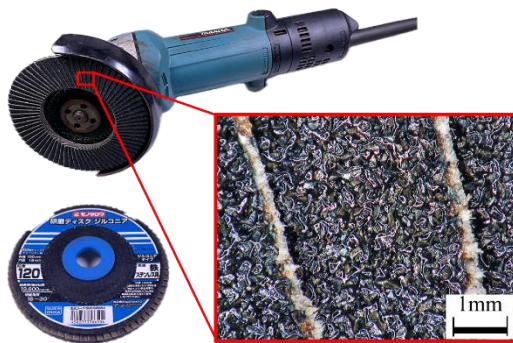
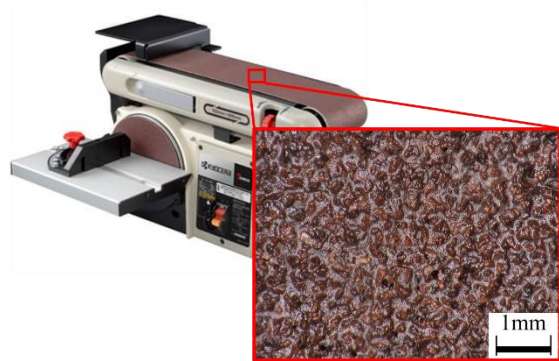
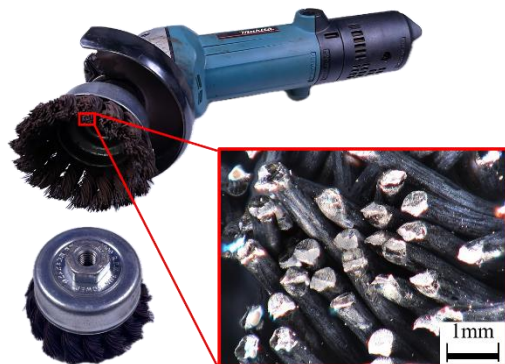
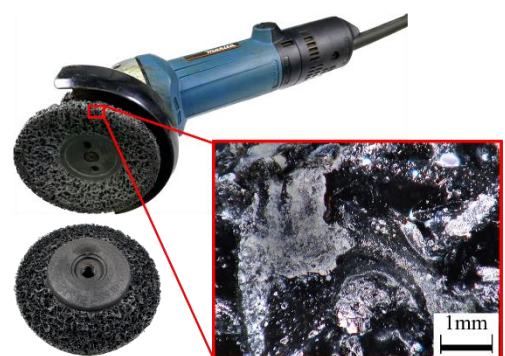
(a) Disc sander

(b) Belt sander

(c) Wire Brush

(d) Bevel non-woven abrasive

(e) Abrasive blast treatment

Fig. 2-2 Photographs of five kinds of surface treatment tools

After surface treatments, all steel plates were subjected to compressed air cleaning. The images of surface treatment tools are shown in **Fig. 2-2**, the power tool trajectory is shown in **Fig. 2-3** and treated surface photographs are shown in **Fig. 2-4**.

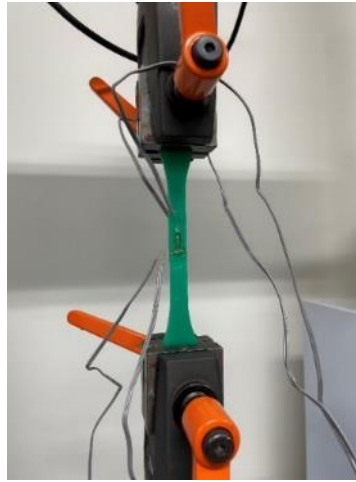
**Fig. 5-11** Tensile test setup

To investigate the effects of moisture and temperature on the mechanical properties of the epoxy resin and its recoverability. All specimens were subjected to a tensile test after hydrothermal aging and dehumidification recovery using a tensile testing machine (Tokyo Koki Tester MSC-10/500-2) at a testing speed of 0.5 mm/min. Strain gauges were attached to the centers of the dog bone specimens to measure their strains under different conditions during the test, as shown in **Fig. 5-11**. Epoxy resin dog bone specimens under all working conditions were tested 5 times in parallel to obtain reliable tensile strength.
