Influences of hydrogen on deformation and fracture behaviors of high Zn 7XXX aluminum alloys

Md. Shahnewaz Bhuiyan^{*a}, Yuki Tada^b, Hiroyuki Toda^c, Su Hang^d, Kentaro Uesugi^e, Akihisa Takeuchi^f, Nobuto Sakaguchi^g, Yoshio Watanabe^h

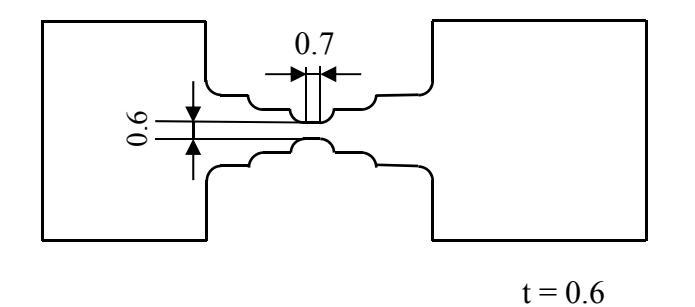
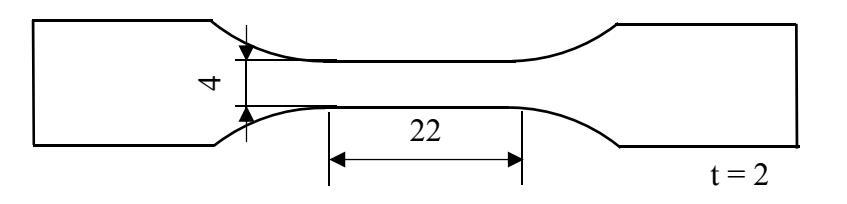
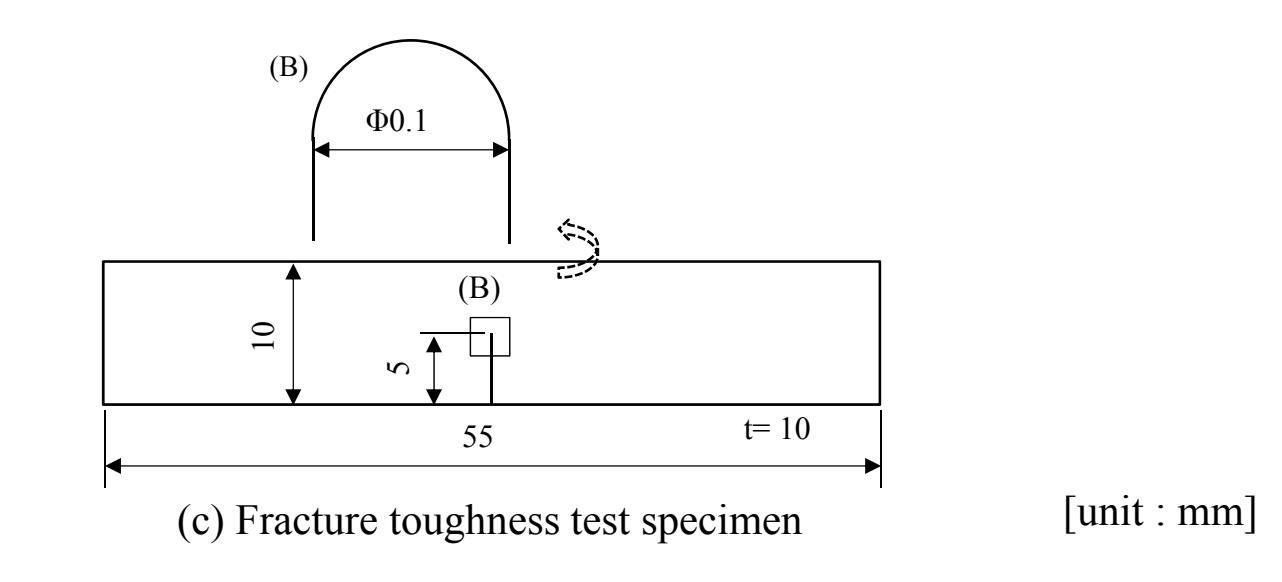
Fig. 1. Geometries of mechanical test specimens

(a) In-situ tensile test specimen

(b) Smooth specimen for room temperature tensile test

Specimens (typically 0.6 (width, W), 0.6 (thickness, T) and 22 (length, L) mm) were machined from the rolled plate in the rolling direction by using an electrodischarge machine (EDM) wire eroder for in-situ microtomography tensile testing and ex-situ tensile testing and is shown in Fig. 1a. Room temperature tensile test specimens (22 (gauge length), 4 (gauge width), and 2 (thickness) mm) were also machined from the rolled plates (Fig. 1b). All the specimens were machined with tensile load applied in the rolling direction. Three-point bend specimens (typically 55 (length, L), 10 (width, W), and 10 (thickness, T) mm) were also machined from the supplied rolled plates for fracture toughness test and is shown in Fig. 1c.

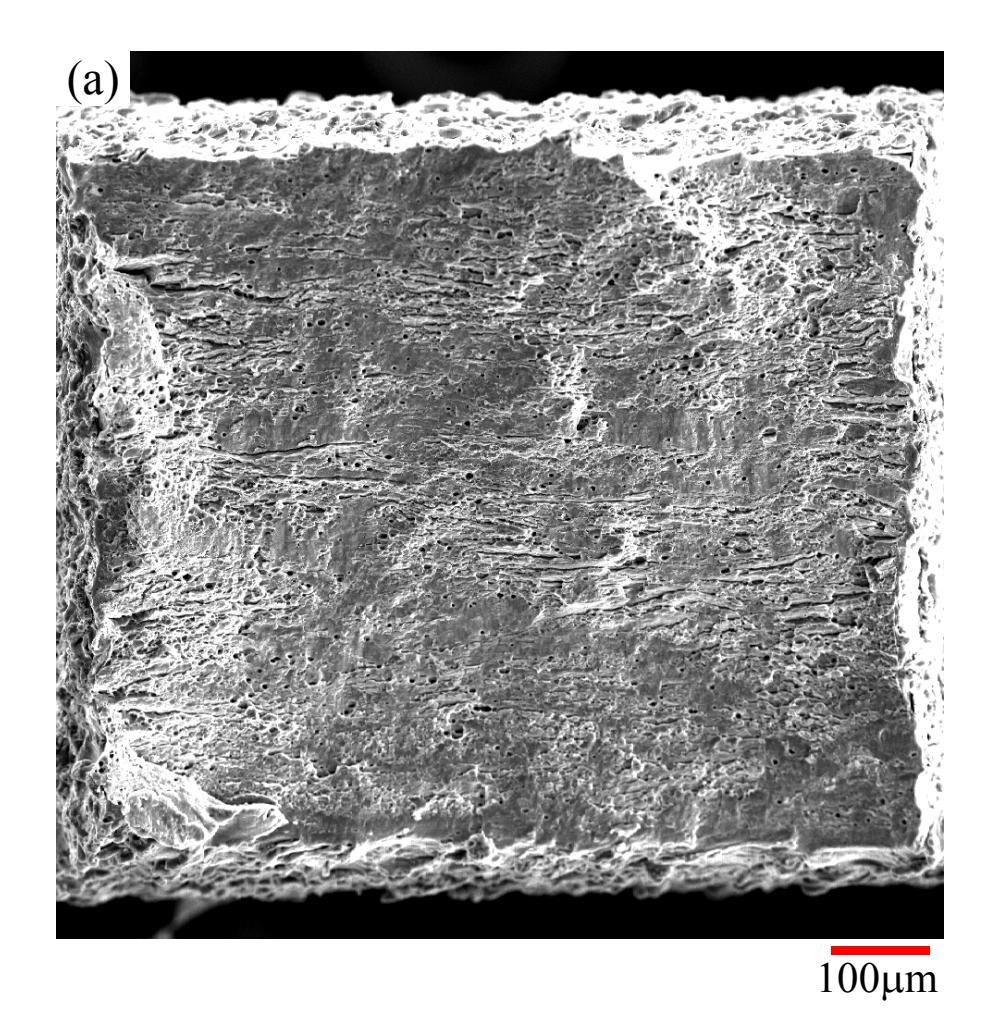
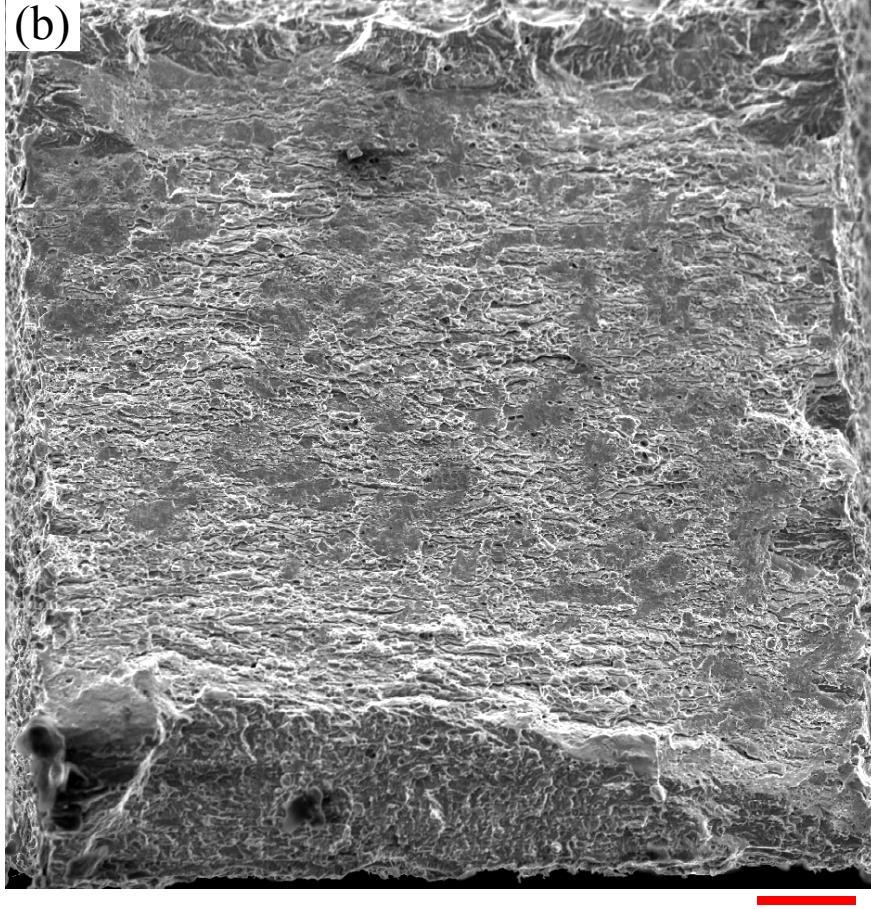
Fig. 11. SEM fractographs showing: (a) overview of the fracture surface of a base 7150 aluminum alloys, (b) overview of the fracture surface of material MH from modified 7150 aluminum alloys

Base 7150 aluminum alloys

Modified 7150 aluminum alloys

Fig. 11 showed the fracture surface observation of base 7150 aluminum alloys. For comparison, the fracture surface of the material MH is also shown. It is interesting to see that the base 7150 aluminum alloys (6 mass % Zn) exhibited ductile fracture. As the amount of Zn is increased from 6 mass % to 10 mass %, the fracture mode also changes and exhibited brittle region (quasi-cleavage feature) only very near to surface area and ductile mode with dimple pattern in the central region. However, both the base 7150 aluminum alloys and the modified 7150 aluminum alloys also showed intergranular failure in the form of elongated features. This investigation suggests that the hydrogen susceptibility has drastically increased with increasing the Zn amount.
