# Theoretical and Experimental Study on Tsunami Induced Instability of Caisson Type Composite Breakwater

出版情報:九州大学工学紀要.72(2), pp.55-68, 2012-06-29.九州大学大学院工学研究院 バージョン: 権利関係: Memoirs of the Faculty of Engineering, Kyushu University, Vol.72, No.2 June 2012

by Simeng DONG<sup>\*</sup>, Kouki ZEN<sup>\*\*</sup>, Kiyonobu KASAMA<sup>\*\*\*</sup>, Bo WANG<sup>\*</sup> and Akihiro TAKESUE<sup>†</sup>

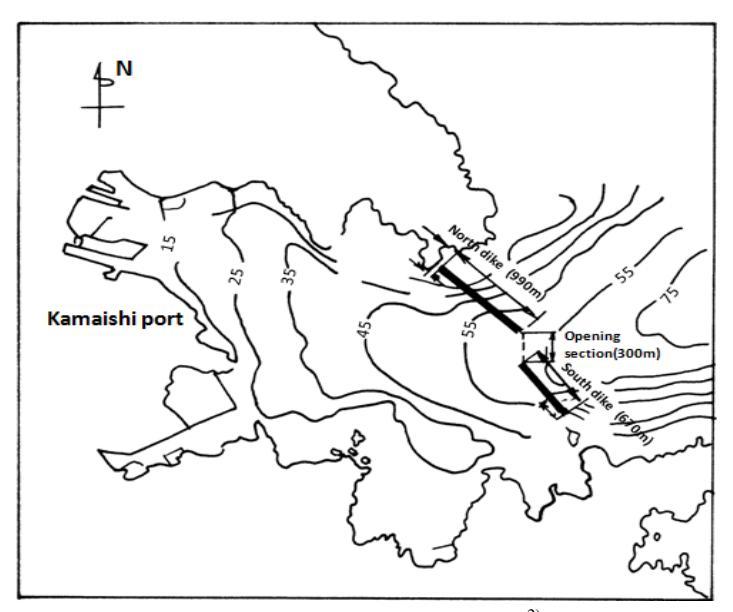
Fig. 1 Kamaishi breakwater layout in Kamaishi port<sup>2)</sup>, Iwate prefecture (after Uezono,1987)

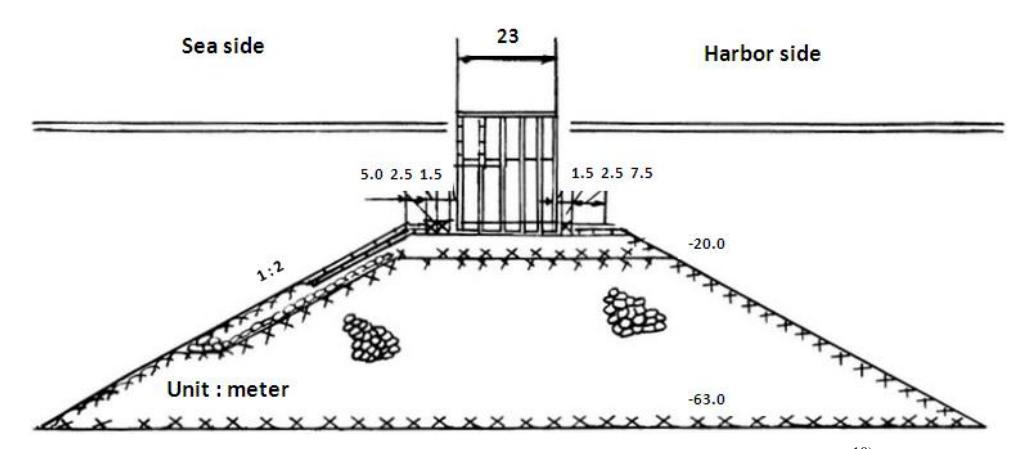
The section 4 of Kamaishi breakwater south dike, the deepest part in the whole breakwaters, was chosen as the research section. The illustration of it is shown in **Fig. 2**.

Fig. 2 Cross section of Kamaishi breakwater's southern dike, section 4.10

A model for laboratory experiment was established by simulating the Kamaishi breakwater's southern dike, section 4 at a scale of 1/100. The rubble mound material is crushed stones of which  $D_{min}$  is 2mm,  $D_{max}$  is 35mm and  $D_{50}$  is 10mm. The dimensions of caisson are 195mm in height, 185mm in length and 190mm in width. The caisson was filled with sand. The density of sand is 2.03 g/cm<sup>3</sup>. In order to reproduce the effects of hydraulic head difference on caisson type breakwaters during tsunami waves, three pumps were introduced to create hydraulic head difference. The experiment layout was shown in **Fig. 8**. The cross section view of the caisson type composite breakwater located in water tank is shown in **Fig. 8** as (a) cross section. A pump system was established to control the hydraulic head difference from the sea side towards the harbor side of the physical model. Legend in **Fig. 8** shows the installations of measuring equipment. The plan view of the physical model is presented in Fig. 8 as (b) plan view. All the equipments were set on the caisson which was located in the middle of tank. The two side caisson boxes among three caisson boxes were placed to avoid the friction effect along tank walls. All the dimensions are shown in **Fig. 8**.

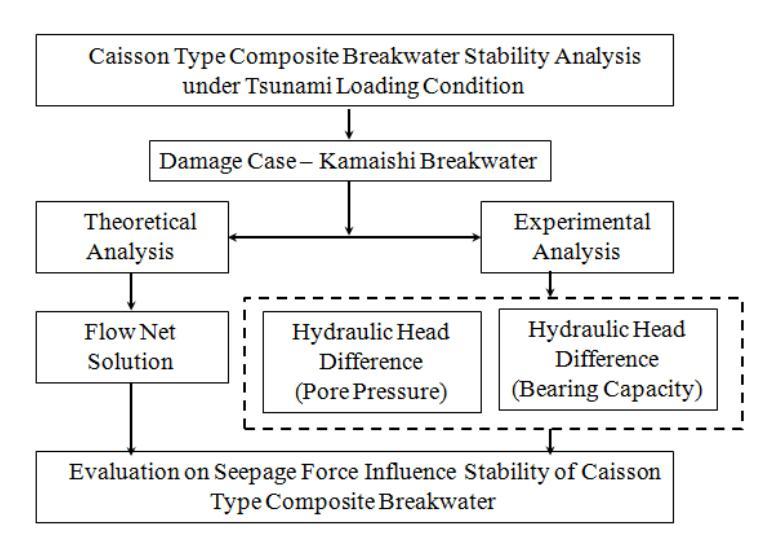
From this study, a simplified failure criterion has been proposed to analyze the stability of the mound element under seepage condition. Two kinds of laboratory experiments have been planned to investigate the failure mechanism. **Figure 3** shows the research procedures.

Fig. 3 Flow chart of stability analysis of caisson type composite breakwater.

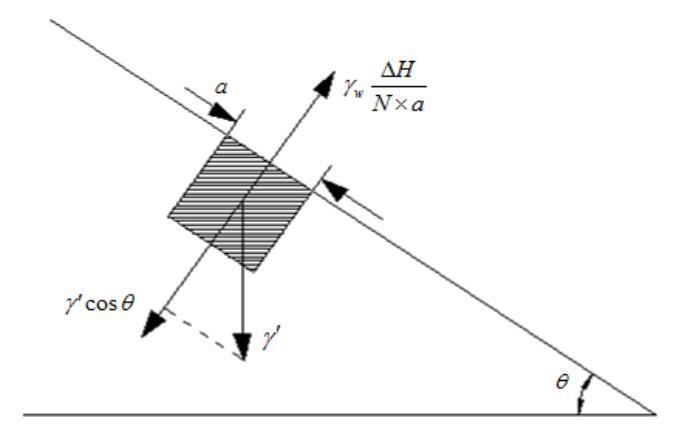
where  $\gamma'$  is the rubble mound's effective unit weight,  $\theta$  is the slope angle,  $\gamma_w$  is the unit weight of water,  $\Delta H$  is the hydraulic head difference between the seaside and the harbor side, N is the number of equipotential line, and a is the length of the unit square inside the flow net as shown in **Fig. 4**.

Fig. 4 Force decompose sketch of unite square on surface of rubble mound.

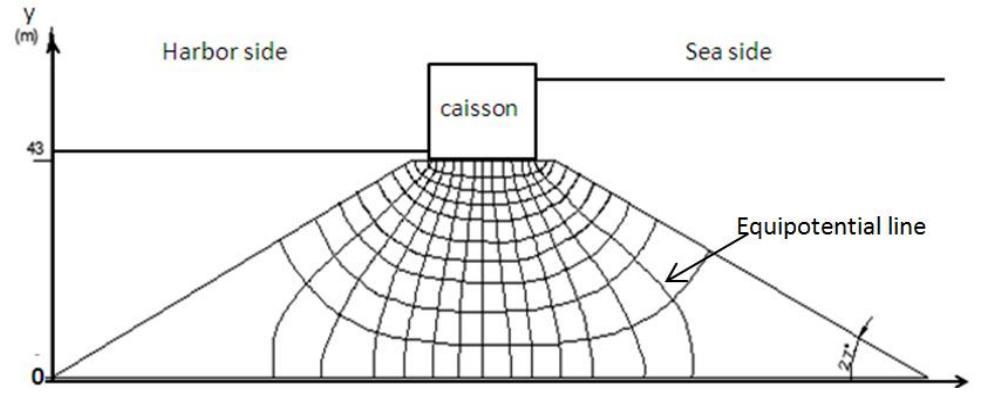
Fig. 5 Flow net illustration of Kamaishi breakwater.

**Figure 5** applies the Kamaishi breakwater case data from the tsunami event and uses the theoretical method of calculation in order to find the failure area. The dimension data of Kamaishi breakwater were described as following: the caisson was 26 meters in width and 20 meters in height, slope angle of rubble mound was 27 degrees with the slope ratio equals to 1:2. The height of rubble mound was 43 meters. Hydraulic head difference from sea side towards harbor side was

13.64 meters. The calculated data are given as  $\gamma_w = 1 \text{ N/m}^3$ ;  $\gamma' = 0.8 \text{ N/m}^3$ ;  $\theta = 27^\circ$ ; N = 14;

$\Delta H=13$ m and the value of "a" is obtained from Fig. 5.

Furthermore, detailed results indicate that the areas of instability occur within 1.2m off the caisson toe on the harbor side along the rubble mound crest. According to Harry's <sup>12)</sup> study on the seepage force induced instability problem, this reasonably small area might be the triggering factor

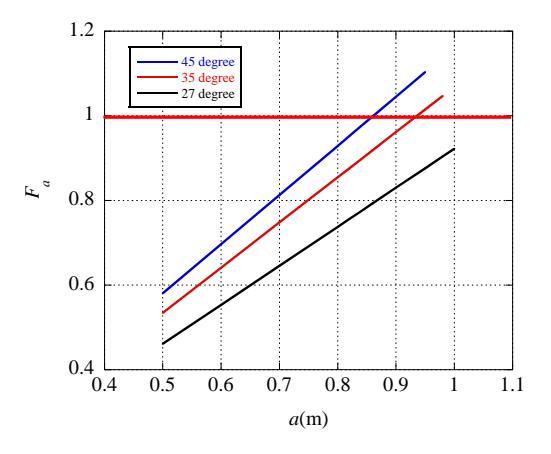
In order to get a deeper understanding of the influence of seepage flow on the stability of the rubble mound, parametric studies were carried out to investigate the relationship between slope angle and the value of "a" as well as the relationship between hydraulic head difference and the value of "a". The results were shown in **Fig. 6** and **Fig. 7**. In these two figures, the vertical axis represents the value of calculated  $F_a$ . The solid red lines shown in **Fig. 6** and **Fig. 7** imply that when  $F_a$  is equal to 1, the values of "a" above solid red line were the unstable areas. Therefore, the critical value of  $F_a$  can be obtained from the graphs. Major trends of the development of these values are concluded as: the value of  $F_a$  decreases when slope angle increases under the condition of constant hydraulic head difference. On the other hand, the stability of rubble decreases when hydraulic head difference increases for the same breakwater.

Fig. 6 Relationship between a and  $F_a$  with different slope angle (same hydraulic head difference).

Fig. 7 Relationship between a and  $F_a$  with different hydraulic head differences (same slope angle).

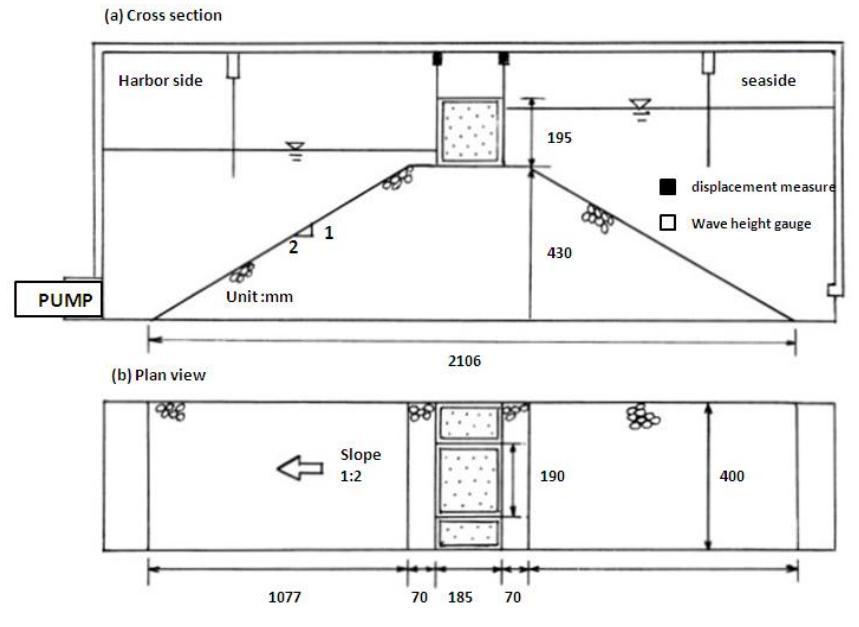
Fig. 8 Layout of experiment model in water tank (script).

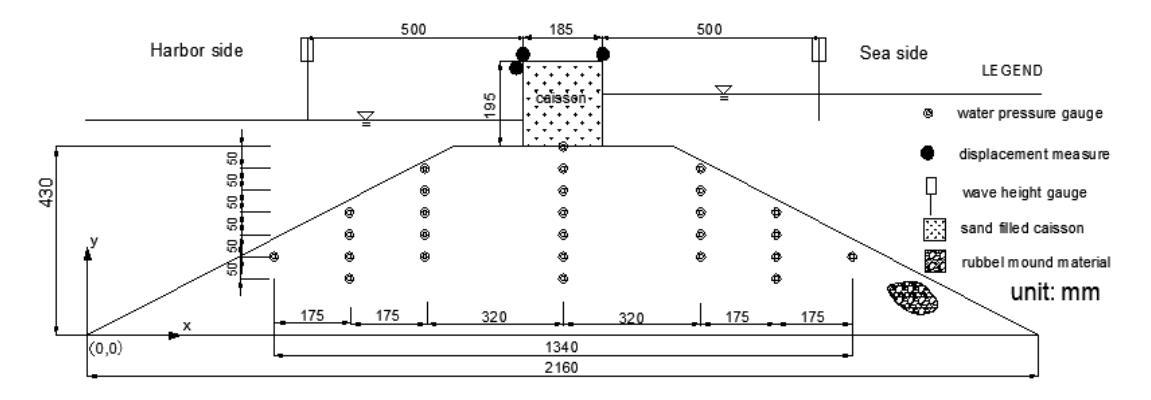
The objective of the experiment is to observe the failure phenomena when hydraulic head difference is created. Water pressure gauges were embedded in the rubble mound to investigate the variation of pore pressure during the experiment, and wave height sensors were set on both sides of the caisson as shown in **Fig. 9**. The x-y coordinate was used as shown in **Fig.9** and initial point was also given in the graph for later coordinate reference. The experimental data were collected electronically and processed by computer.

Fig. 9 Experiment equipments settings.

Data from the above experiments were processed and utilized for calculation. In **Fig.10**, only the upper part of rubble mound in **Fig.9** where the pore pressure gauges were installed area is demonstrated. The starting of x-axis is set 300mm from the left toe of rubble mound and y-axis is set 130mm from the left toe of rubble mound. From the pore pressure data obtained in the experiment, the hydraulic gradient distribution was illustrated as in **Fig. 10** by Tecplot software<sup>14</sup>. It represents that the hydraulic head difference generates great pore pressure from the seaside towards the harbor side, which might cause the instability of rubble mound.

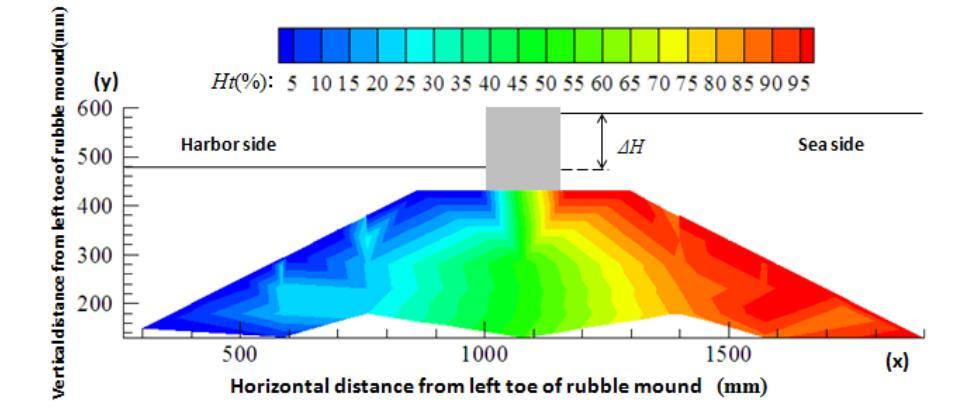
Fig. 10 Pore pressure distribution generated by the hydraulic head difference.

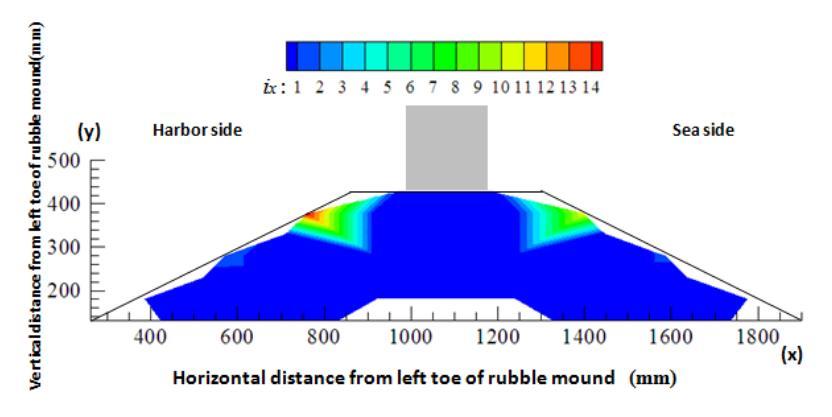
**Figure 11** and **Fig. 12** show the calculation results from Eq. 4. From the plots, it can be concluded that the hydraulic gradient concentration is greater in the horizontal direction than the vertical direction with the same hydraulic head difference of 118mm.

Fig. 11 Hydraulic gradient distribution in the horizontal direction.

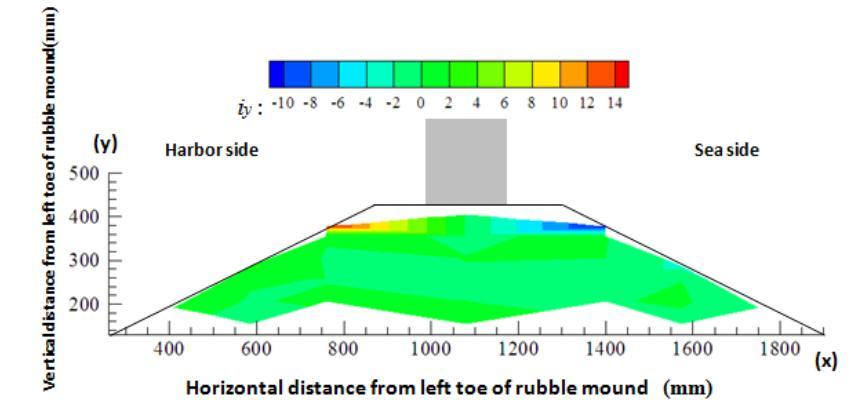
Fig. 12 Hydraulic gradient distribution in the vertical direction.

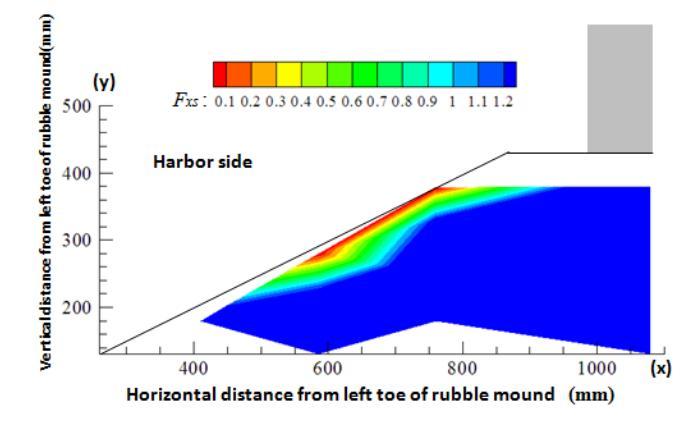
**Fig. 13**  $F_{xx}$  calculated by failure criteria.

The calculation result is shown in **Fig.13.** It can be seen that when hydraulic head difference is 118mm, the rubble mound slope surface area with depth of 62.3mm has failure potential. This corresponds 6.2 m at full scale. However, in the laboratory modeling tests, the "pop out" failure due to seepage forces is hardly found. Although the hydraulic gradient shows a concentration on the surface of the rubble mound and  $F_{xs}$  have been dramatically reduced, it is less likely that the excessive pore-pressure (seepage force) can cause the catastrophic failure at hydraulic head difference of 118mm. This leads to the hypothesis that the combination of seepage force with downstream surface erosion caused by overtopping might be the major cause of caisson type breakwater failure. Detailed investigation and experimentation focused on this failure mechanism should be carried out. Besides the suggestions given above, the lack of failure observed under these wave conditions might be due to the selection of rubble mound material in this experiment. Finer rocks with smaller diameters should be tested in later experiments.

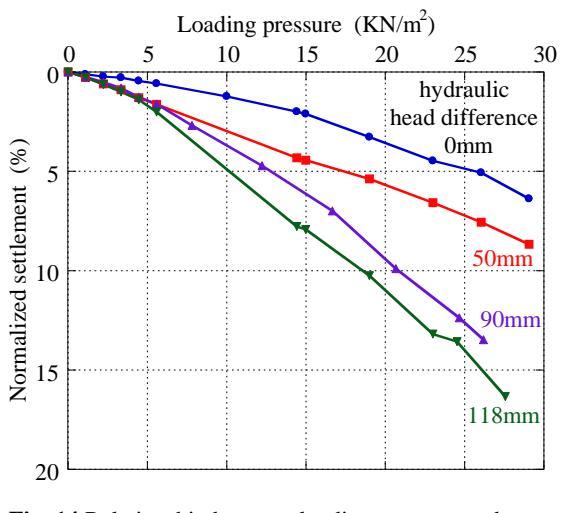
When weight was loaded on the caisson, displacements of the caisson were observed, and these displacement data were collected at certain hydraulic head difference. The settlement values have been compared in **Fig. 14**.

Fig. 14 Relationship between loading pressure and normalized settlement of caisson.

The settlement of caisson due to weight loading shows a trend: when loading increases, the settlement becomes larger. As expected, the larger hydraulic head difference influenced the bearing capacity of the rubble mound. The curves show a clear tendency that the settlement increases about 50% when hydraulic head difference increases from 0mm to 118mm. It is indicated that the displacement of caisson becomes larger when the hydraulic head difference becomes larger. It might trigger entire failure of rubble mound at a certain value of hydraulic gradient. In other words, it is found that the seepage force contributes to reduce the bearing capacity of rubble mound.

The analysis of the results in **Fig. 14** and **Fig. 15** show that pore pressure generated by seepage flow brings the decreases of effective stress which may cause instability of the caisson. Therefore, it is necessary to calculate the entire stability of rubble mound to analyze the influence of seepage flow on the caisson type breakwaters.

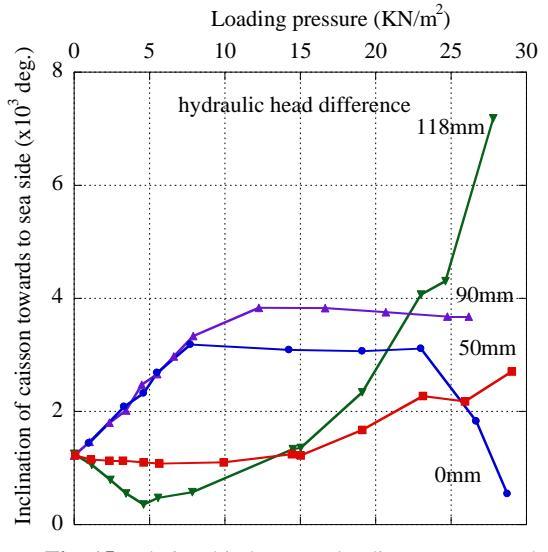
**Figure 15** shows the relationship between the caisson incline angle and weight loading. When the hydraulic head difference stays constant, the loading value reaches  $15 \text{ KN/m}^2$ . The settlement of the caisson develops significantly when the loading increases to  $25 \text{ KN/m}^2$ , and the biggest hydraulic head difference (118mm) creates the largest settlement. In other words, the increase of hydraulic head difference has a negative influence on the stability of caisson and with such a big displacement.

The inclinations were also calculated from this experiment and from the results in **Fig. 15**. The deformation of the rubble mound becomes significant when hydraulic head difference increases, in this case to 118mm, and the caisson is prone to be less stable when hydraulic head difference is large.

Fig. 15 Relationship between loading pressure and inclination of caisson towards to sea side.

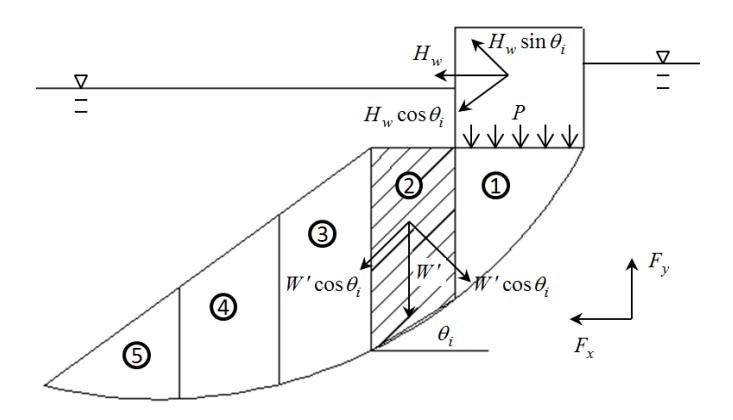
Fig. 16 Model of circular failure analysis.

as illustrated in **Fig. 16.** It shows the calculation of characteristics of the slip surface on the rubble mound with mathematical equations given as follows:

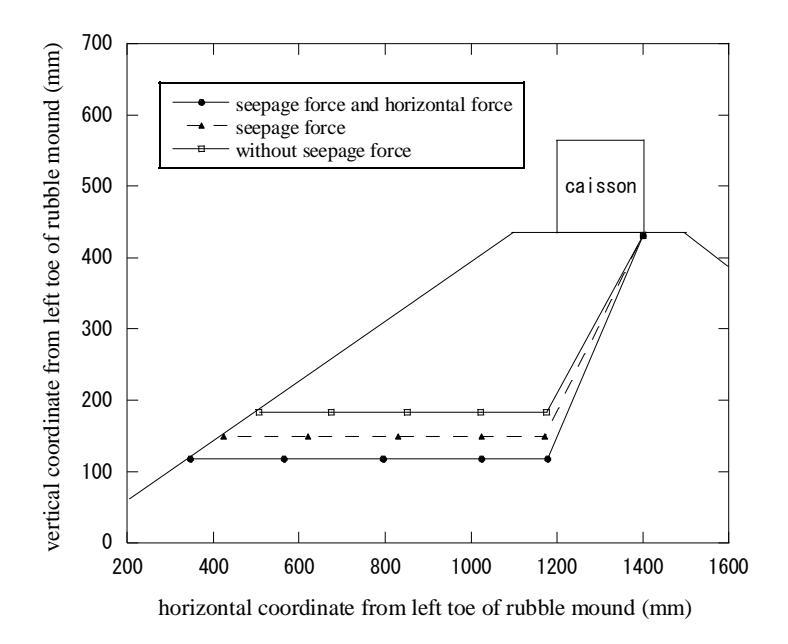
In order to get a clear understanding of the seepage force influence on caisson stability, further calculations were done and the results are shown in **Fig.17**. The locations of slip surface indicate the influence of seepage flow in rubble mound. By comparing with three conditions, the results show that the slip surface which induced by static horizontal force and seepage force is the shallowest line among three lines, the shear outlet of slip surface moved from the bottom of rubble mound towards the top of rubble mound significantly compared with conditions with seepage flow and without seepage flow in rubble mound.

Fig.17 Comparison of slip surface calculation of rubble mound under tsunami loading and without seepage condition.
