# Characterization of high-velocity impact damage in CFRP laminates: Part I- experiment

Shigeki Yashiro<sup>a,\*</sup>, Keiji Ogi<sup>b</sup>, Tsukasa Nakamura<sup>c</sup>, and Akinori Yoshimura<sup>d</sup>

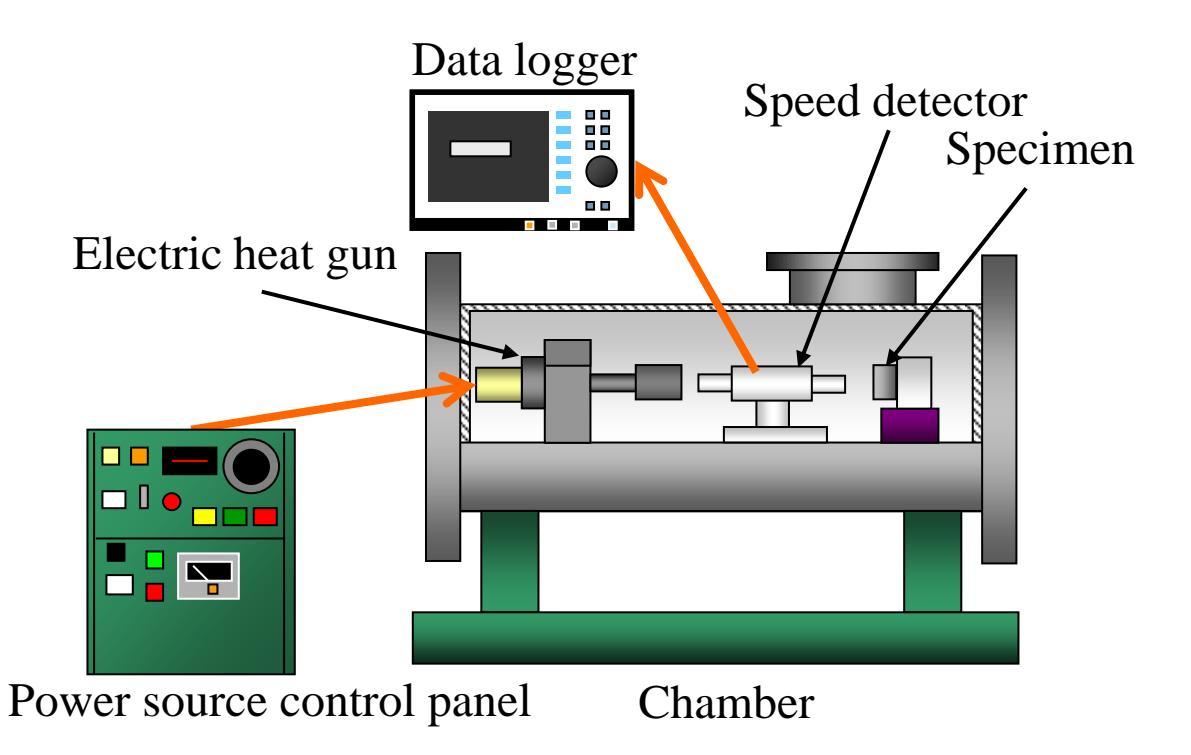
Figure 1 schematically depicts a high-velocity impact testing machine (Maruwa Electronic Incorporated). This machine consists of a control unit for the power source, a chamber in which a projectile was shot at a target, and a speed detector with a data logger. The projectile, set in a sabot, was accelerated with high-temperature, high-pressure metal plasma obtained by melting and evaporating an aluminum foil subjected to high-voltage pulse current. The sabot was stopped at the mouth of the gun, and the sphere moved ahead by inertia. The velocity of the projectile was variable from 40 to 1500 m/s. The velocity was controlled by the voltage applied to the aluminum foil and was precisely measured by obtaining the time required for the projectile to pass the prescribed distance (250 mm) in the speed detector. Only the four

- Fig. 1 Schematic diagram of the high-velocity impact testing machine with an electric-heat gun.
- Fig. 2 Damage states on the front and back surfaces of the UD  $[0_{16}]$  laminates.

edges of the specimen were fixed to a square-frame jig, and therefore bending due to impact was permitted. The projectile was a steel ball 1.5 mm in diameter (14.2 mg in mass), and the impact velocity was 300 to 1200 m/s. The tests were conducted in an atmospheric environment.

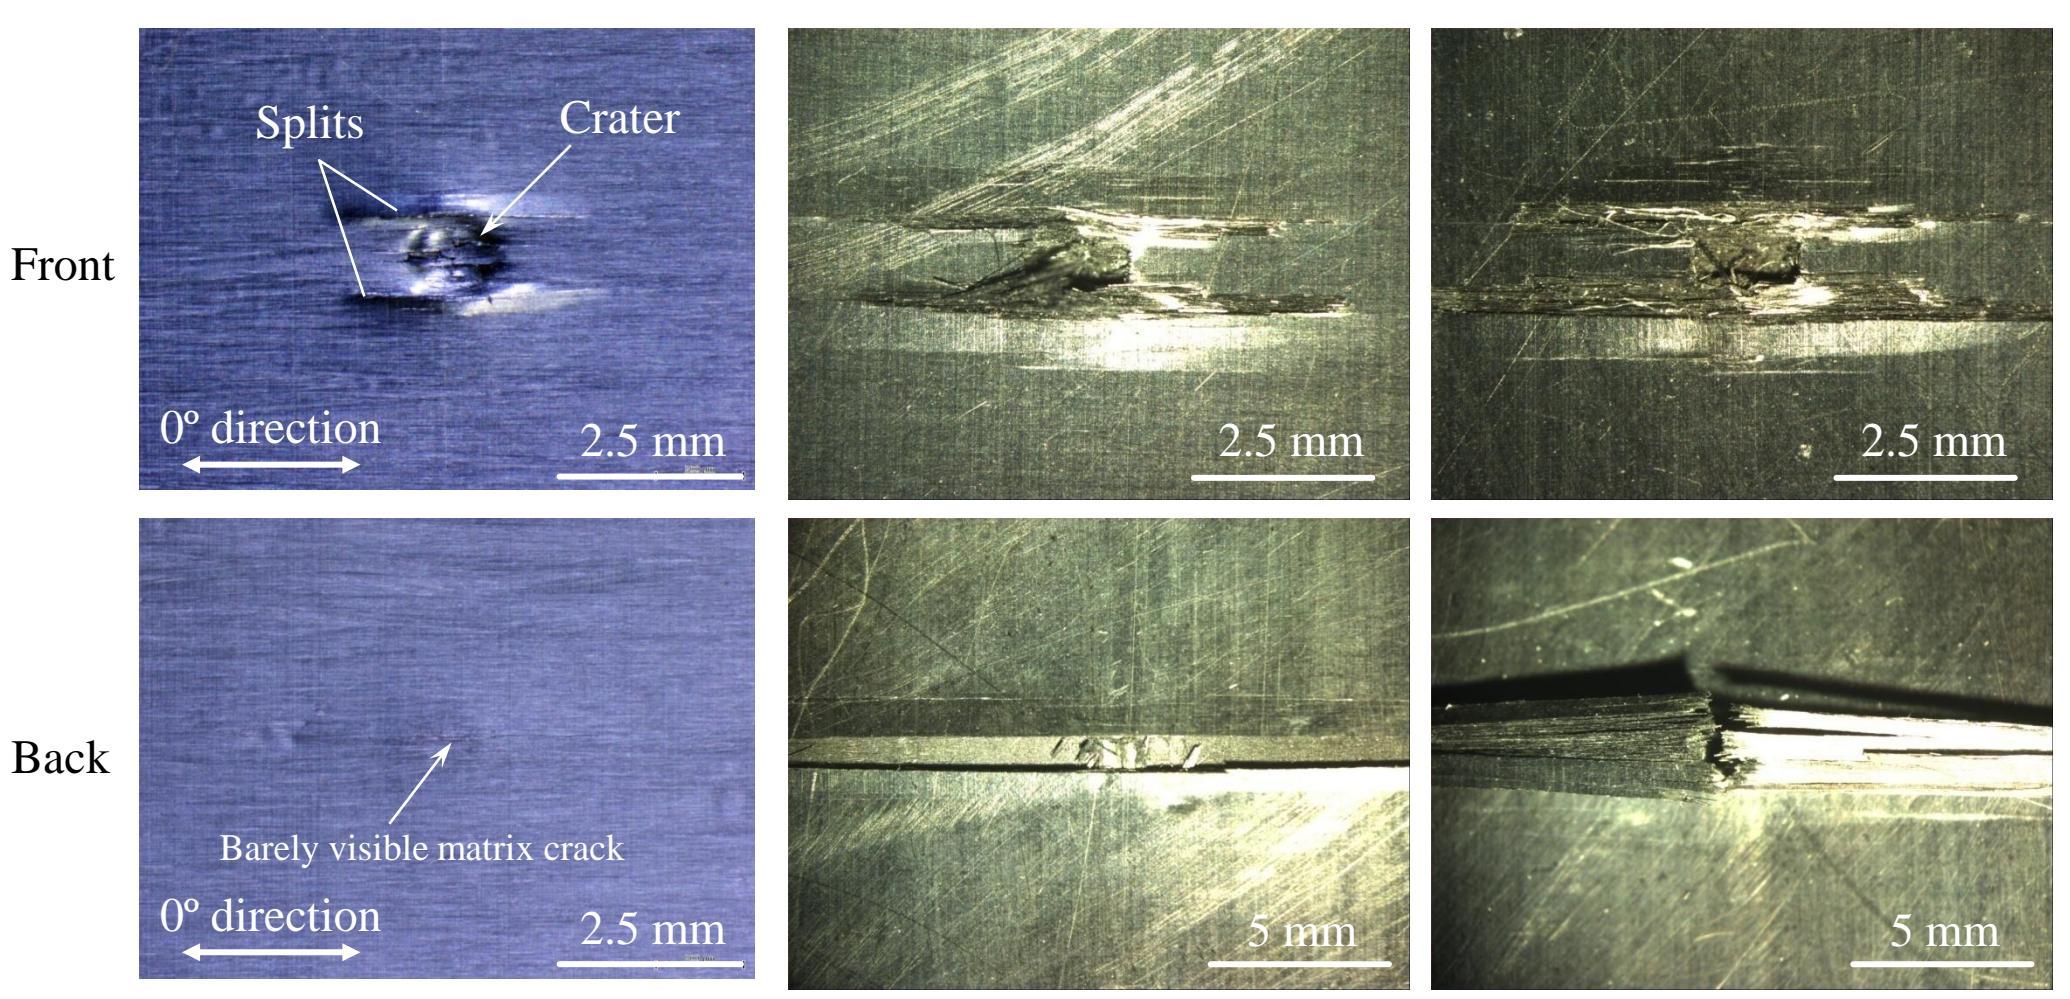
- Fig. 3 Damage states on the front and back surfaces of the CP1 [04/904]s laminates. A barely visible matrix crack was observed on the back surface at 217 m/s.

Figures 2-5 depict the damage patterns on the front surface and the back surface at specified impact velocities. None of the specimens were penetrated by the projectile, despite severe damage on the back surfaces. The front surfaces of all of the specimens had a crater with splits extending from the crater edges. This damage pattern appeared regardless of the stacking sequence and the impact velocity. The back surfaces had fiber breaks due to the indentation of the projectile and the accompanying splits; this pattern was observed in all four stacking sequences. Splits on the back surface in the UD laminate were generated at a lower velocity (437 m/s) than in the other laminates because of its low bending stiffness in the transverse direction. The fiber breaks on the back surface exhibited the zigzag pull-out patterns that can be seen on tensile fracture surfaces, so it was determined that the bending-induced tensile stress along the fiber direction caused fiber breaks on the back surface.

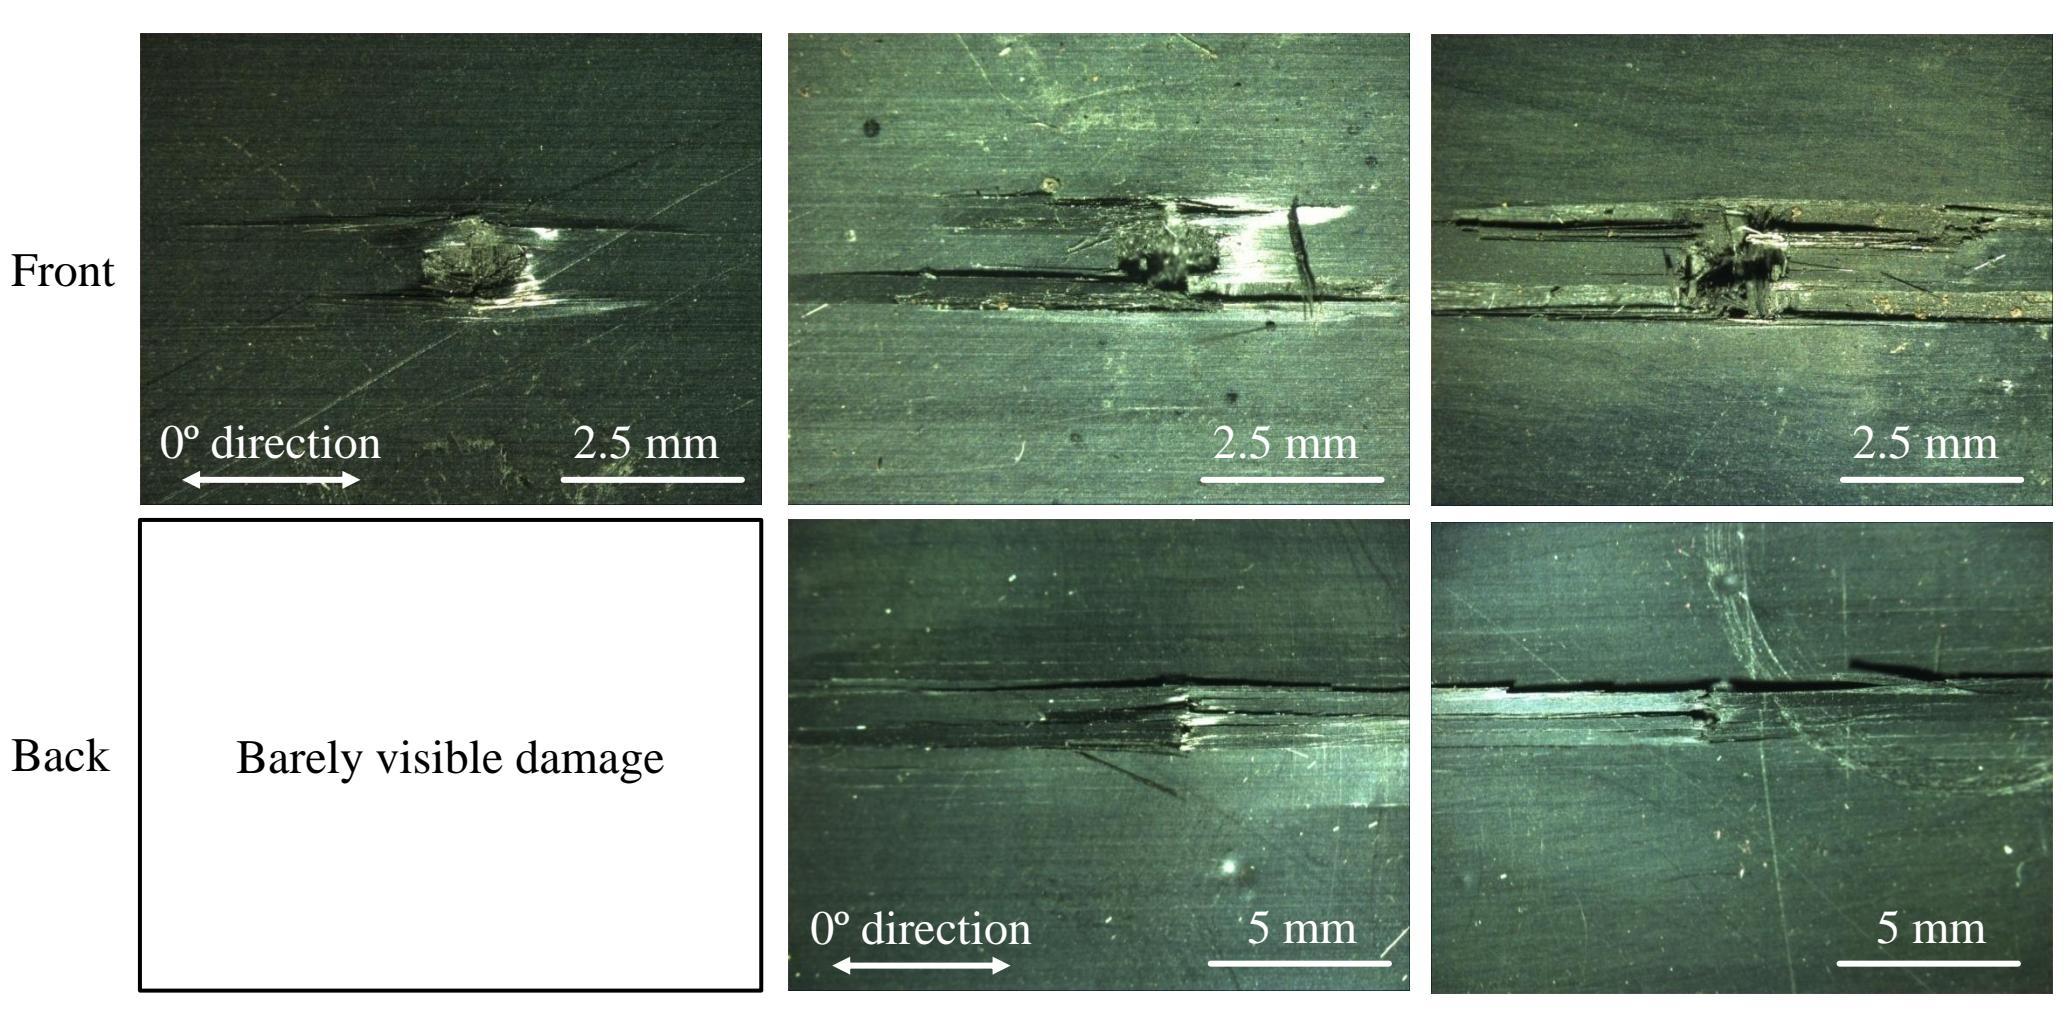
- Fig. 4 Damage states on the front and back surfaces of the CP2 [0/90]<sub>4S</sub> laminates. Barely visible damage appeared on the back surface at 378 m/s.

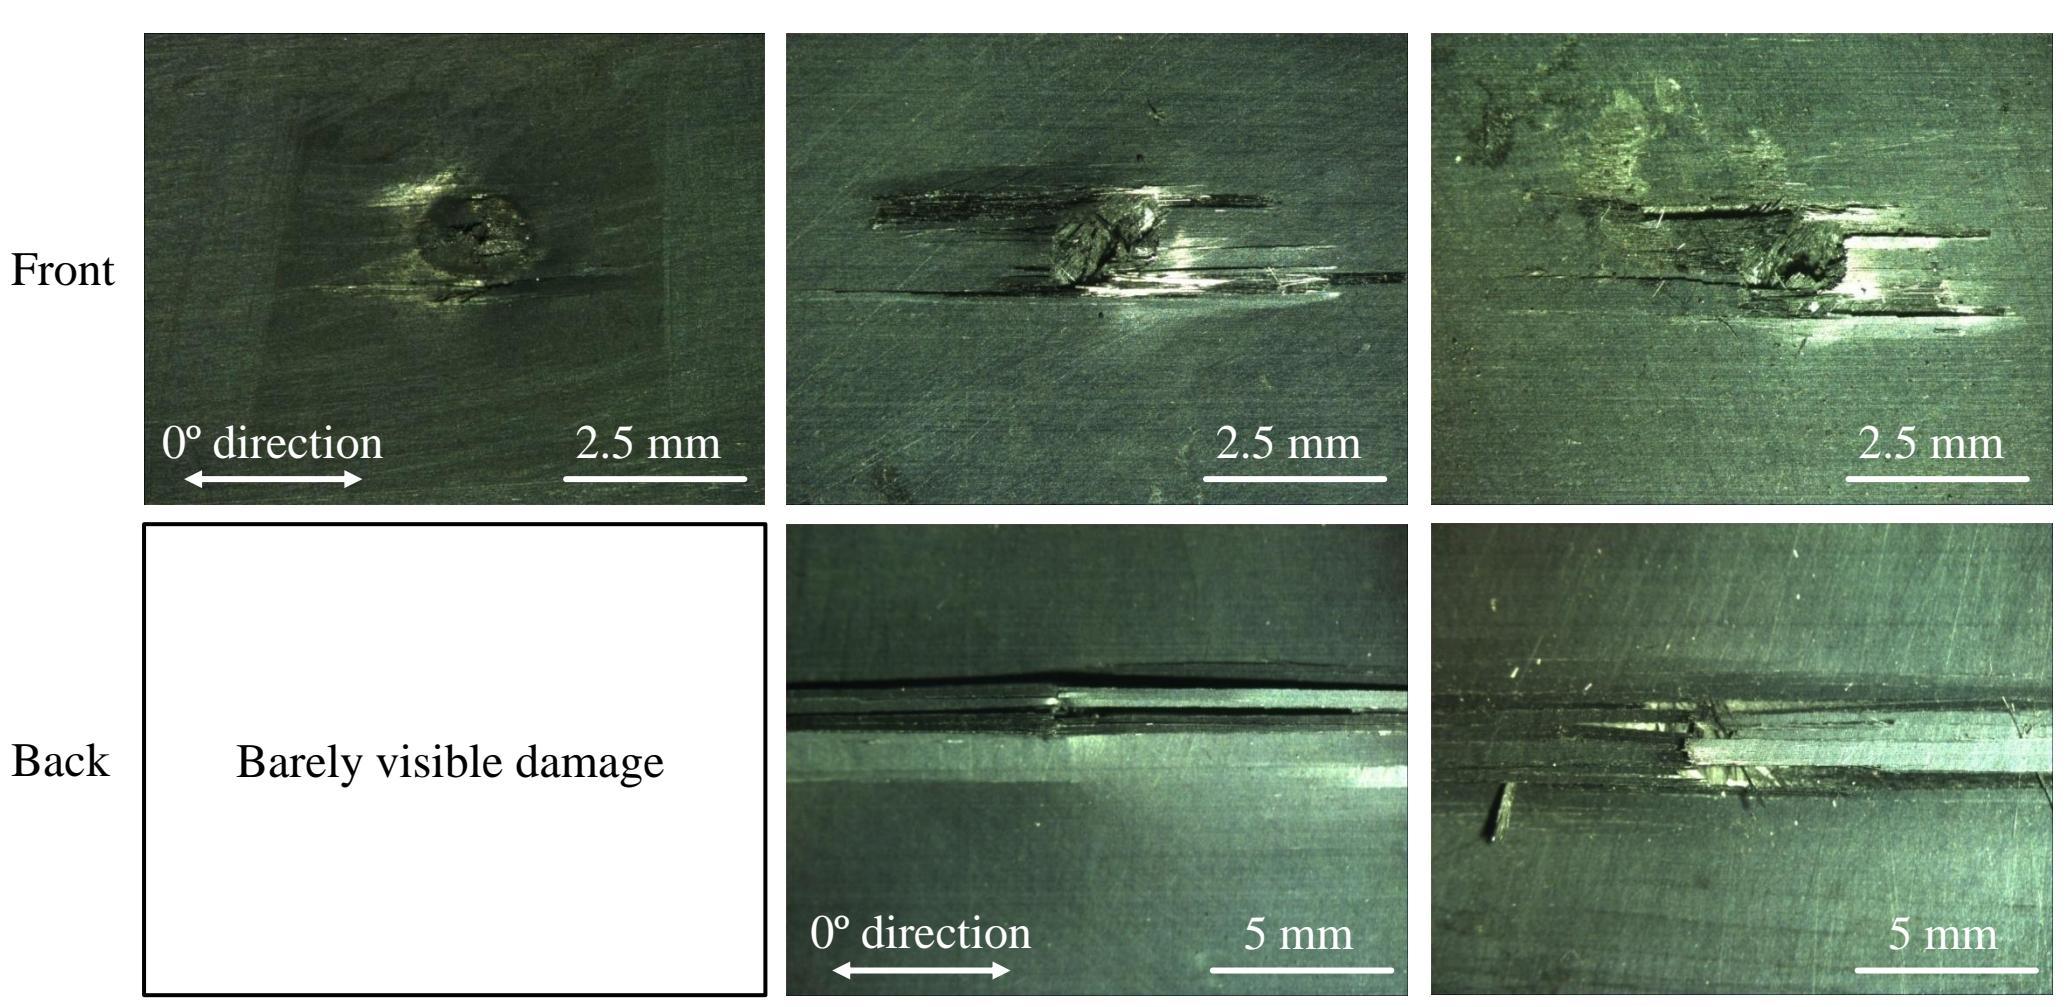
- Fig. 5 Damage states on the front and back surfaces of the QI [0/45/90/-45]<sub>S2</sub> laminates. Barely visible damage appeared on the back surface at 480 m/s.

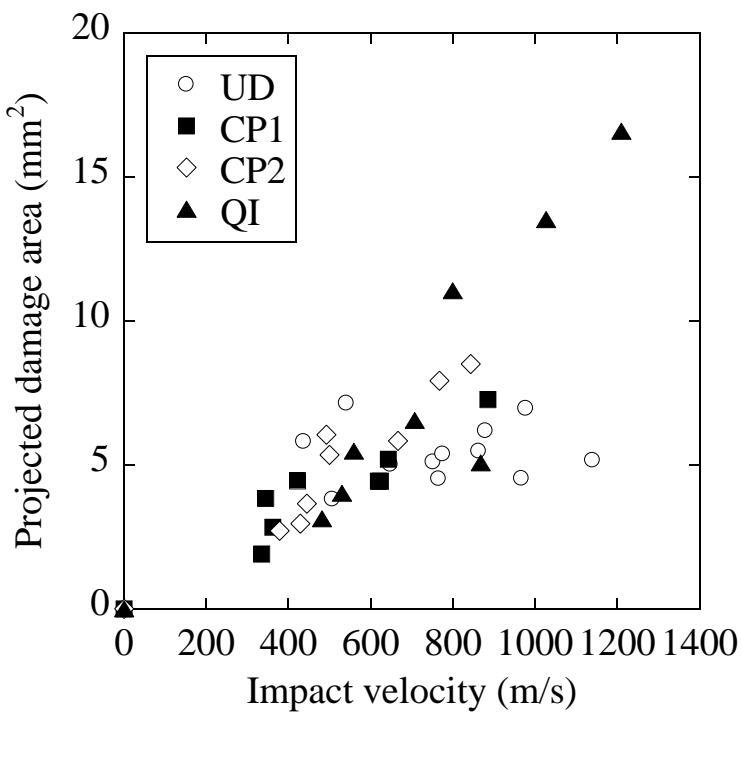
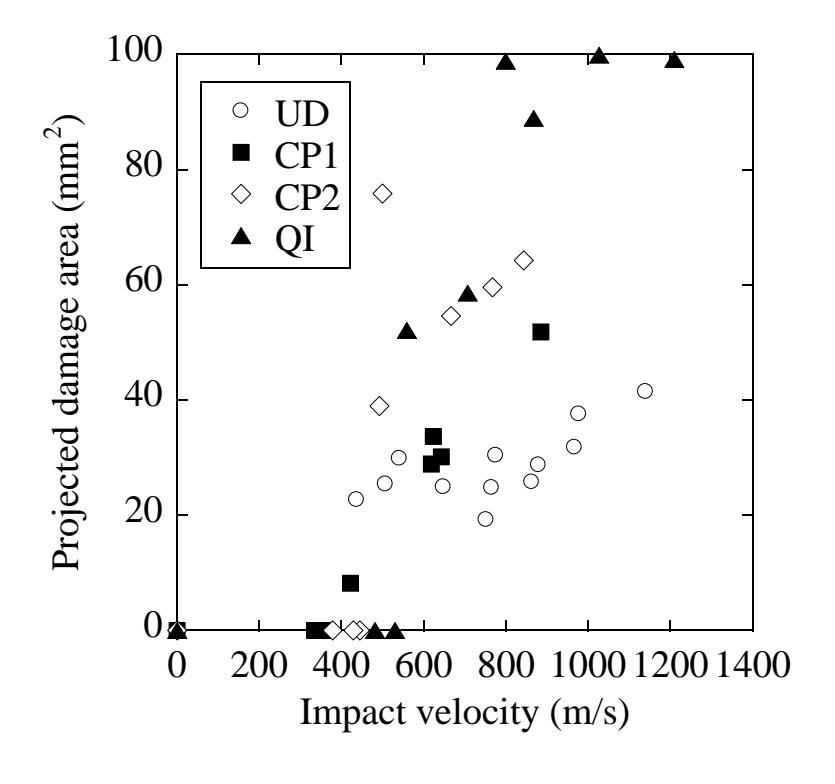
back surface, the damaged region was approximated by several rectangular shapes instead of the projection because of the large out-of-plane deformation. Figure 6 plots the projected damage area against the impact velocity. The damage area on the front surface increased with increasing velocity. This trend was most prominent in the QI laminate, followed by the CP1 and CP2 laminates. However, in the UD laminate, the projected damage area was almost constant (5 mm<sup>2</sup>) when plotted against the impact velocity. The damage area on the back surface increased with increasing impact velocity in all the laminates. This increasing trend was significant in the QI and CP2 laminates, and the damage area of the CP1 laminate was always smaller than that of the CP2 laminate. Although the increasing trend also appeared on the back surface of the UD laminate, the growth rate was less than that of the other laminates. The damage area on the front and back surfaces will become constant at higher impact velocities generating a perforation hole [9,25].

- Fig. 6 Relationship between the projected damage area on the front and back surfaces and the impact velocity.
- Fig. 7 Full cross-sections of the impacted UD and CP1 specimens.

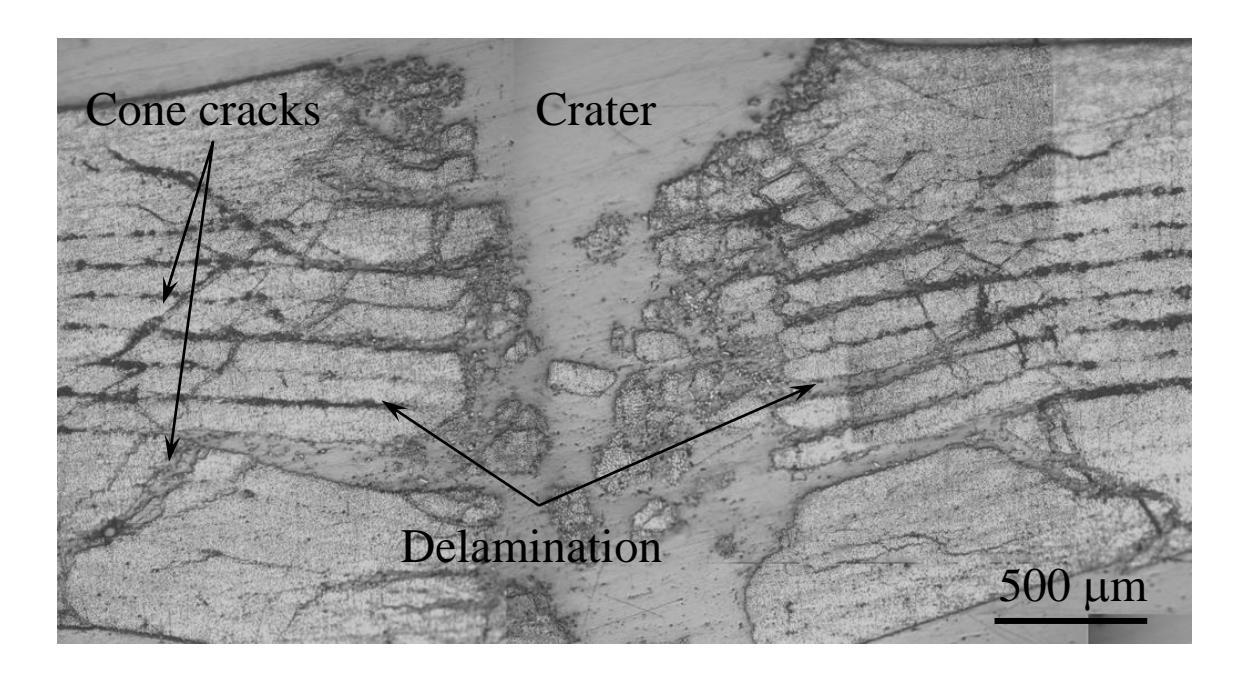
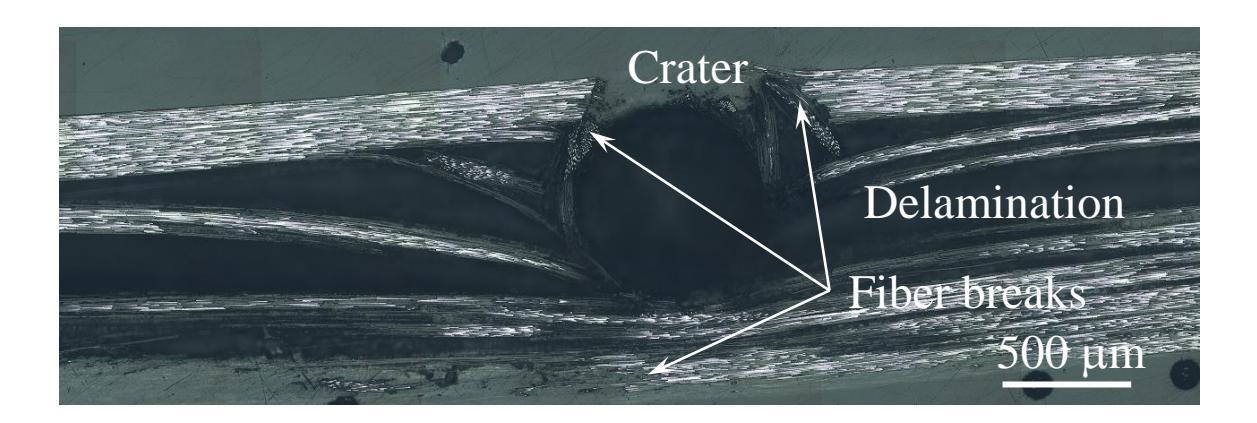
Figure 8 depicts the damage state beneath the impact point in the UD laminate. A crater, delaminations, and oblique matrix cracks appeared in the N-section (Fig. 8a). The region just beneath the crater broke catastrophically. Oblique matrix cracks (i.e., cone cracks) were generated outside the catastrophic failure zone and were connected with delamination. In the bottom ply, a matrix crack connected to the ply failure zone had a large opening distance due to severe bending deformation. The crater and delaminations were also observed in the P-section (Fig. 8b). The fibers seemed to be cut by out-of-plane shear deformation at the crater

edge. The P-section delamination had a larger opening displacement than the N-section, and therefore the delamination extended extensively toward the fiber direction.

- Fig. 8 Damage states beneath the impact point of the UD [0<sub>16</sub>] laminate. Impact velocities were 760 m/s for the normal cross-section and 530 m/s for the parallel cross-section.

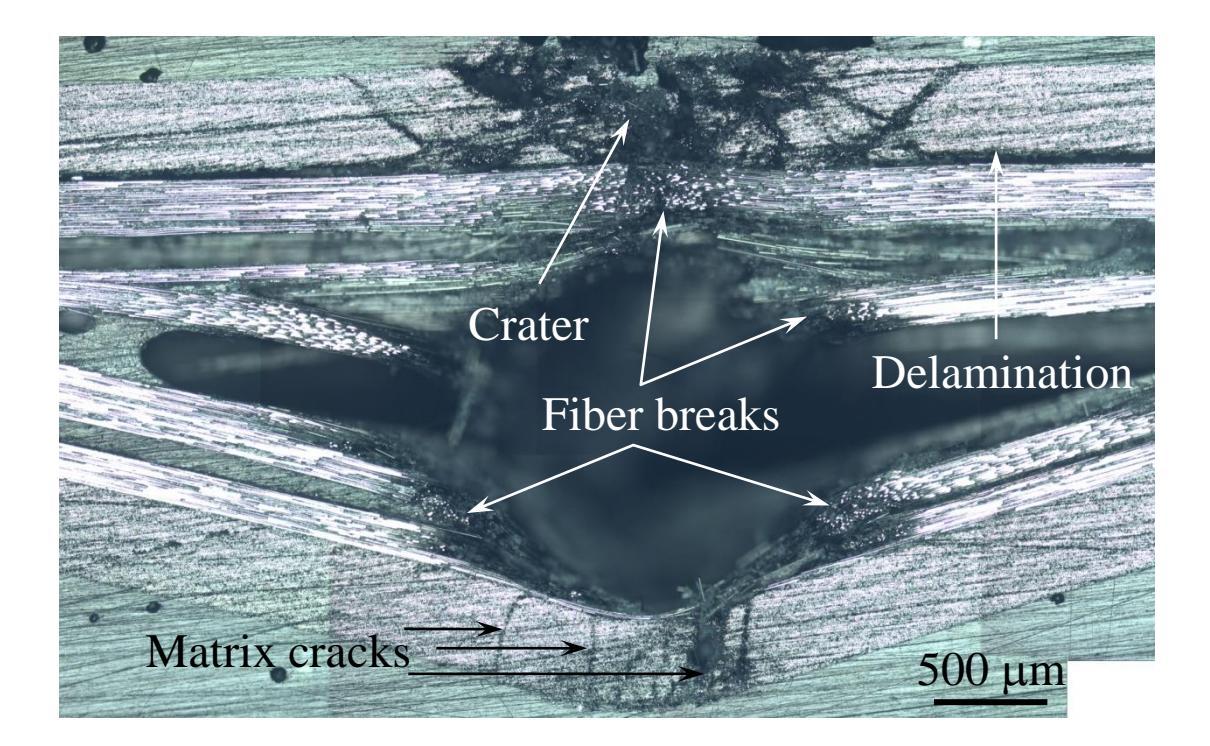
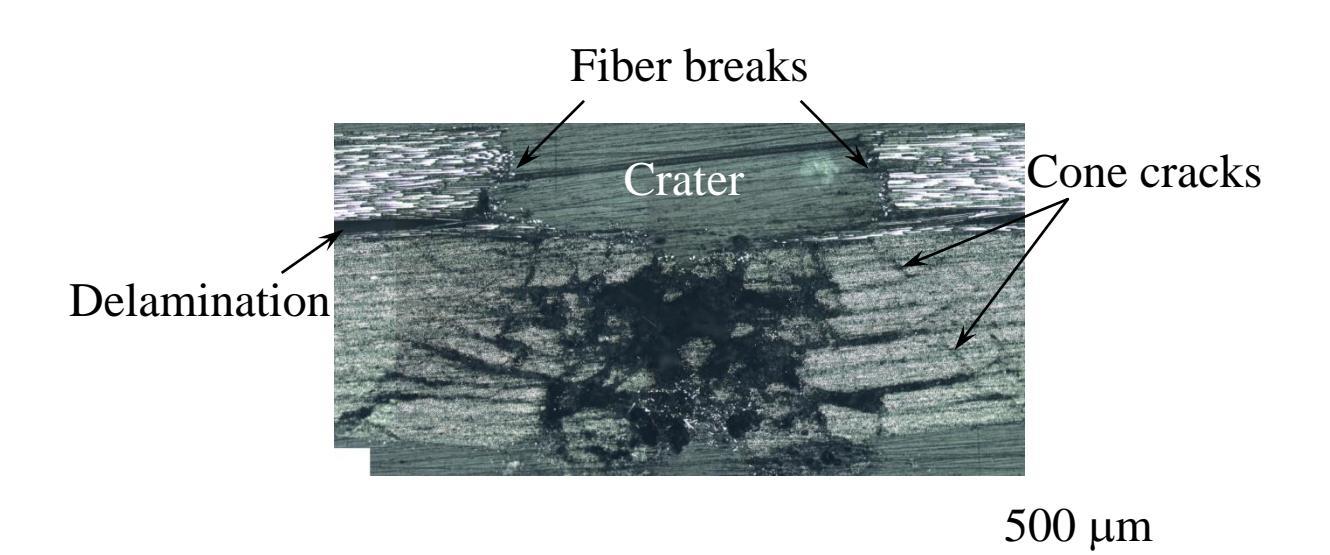
Figure 9 depicts the damage state beneath the impact point in the CP1 laminate. A crush region (i.e., a crater) in the top 0° plies, fiber breaks and delamination in the 90° plies, and matrix cracks in the bottom 0° plies were observed in the N-section (Fig. 9a). The fiber breaks and delaminations in the 90° plies induced easy deformation of the bottom 0° plies, and matrix cracks were then generated in the bottom plies. A crater with fiber breaks, a catastrophic ply-failure zone, cone cracks, and delaminations were observed in the P-section (Fig. 9b), where the four bottom 0° plies were delaminated and dropped off. Considering fiber breaks in 90° plies beneath the impact point in the N-section, the catastrophic ply-failure zone was found to include extensive fiber breaks, matrix cracking, matrix crushing, and delaminations. Cone cracks and delaminations outside the catastrophic ply failure zone in the 90° plies were similar to those observed in the N-section of the UD laminate (Fig. 8b).

- Fig. 9 Damage states beneath the impact point of the CP1 [04/904]s laminate. Impact velocities were 508 m/s for the normal cross-section and 600 m/s for the parallel cross-section. The 0° plies on the back surface peeled off due to extensive delamination.

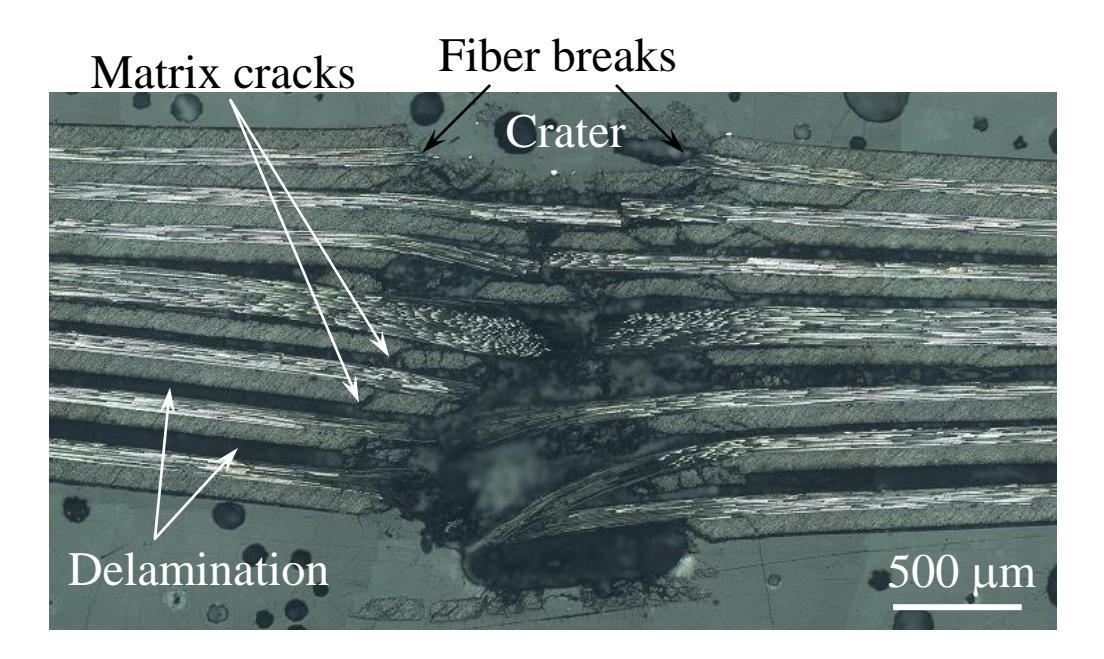
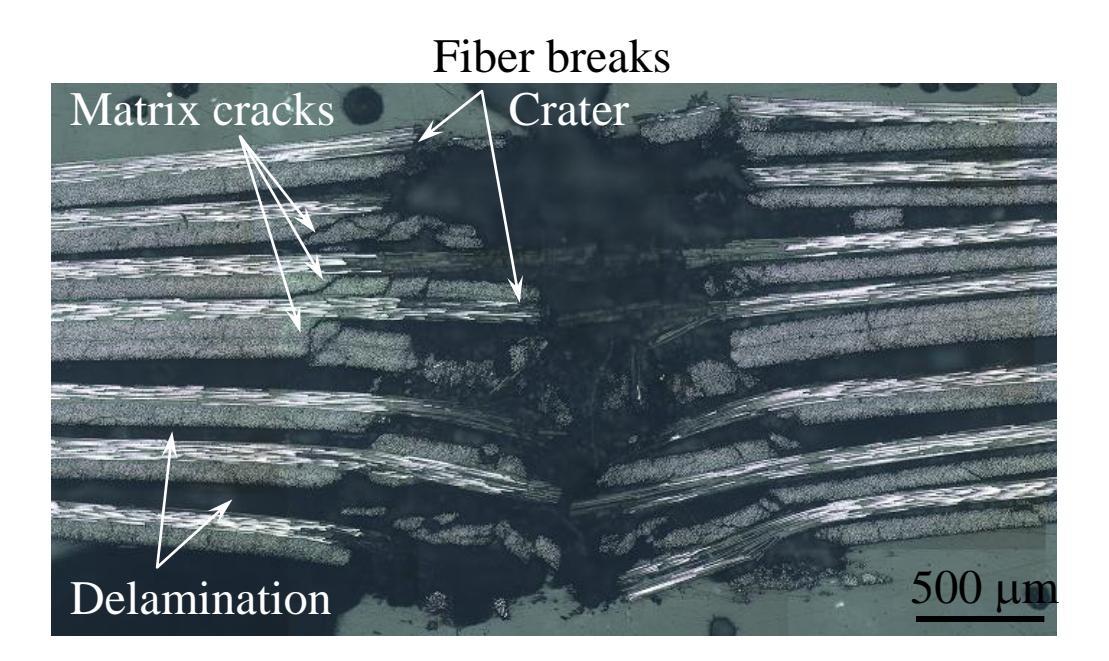
The damage patterns beneath the impact point in the CP2 laminate are depicted in Fig. 10. A crater, fiber breaks, matrix cracks (cone cracks), and delaminations were observed in both the N- and the P-sections. Some matrix cracks were generated in a single ply, with their tips connected to delamination that occurred only at the  $0^{\circ}/90^{\circ}$  ( $90^{\circ}/0^{\circ}$ ) interfaces in the N- (P-) section. More specifically, the upper (lower) ply of delamination was always the transverse (longitudinal) ply. This pattern suggested that the delamination extended from a catastrophic ply failure such as matrix cracking in the transverse ply. Although oblique matrix cracks were generated in every transverse ply, these cracks did not make straight cone cracks beyond the longitudinal plies due to the severe delamination.

- Fig. 10 Damage states beneath the impact point of the CP2 [0/90]<sub>4</sub>s laminate. Impact velocities were 500 m/s for the normal cross-section and 700 m/s for the parallel cross-section.

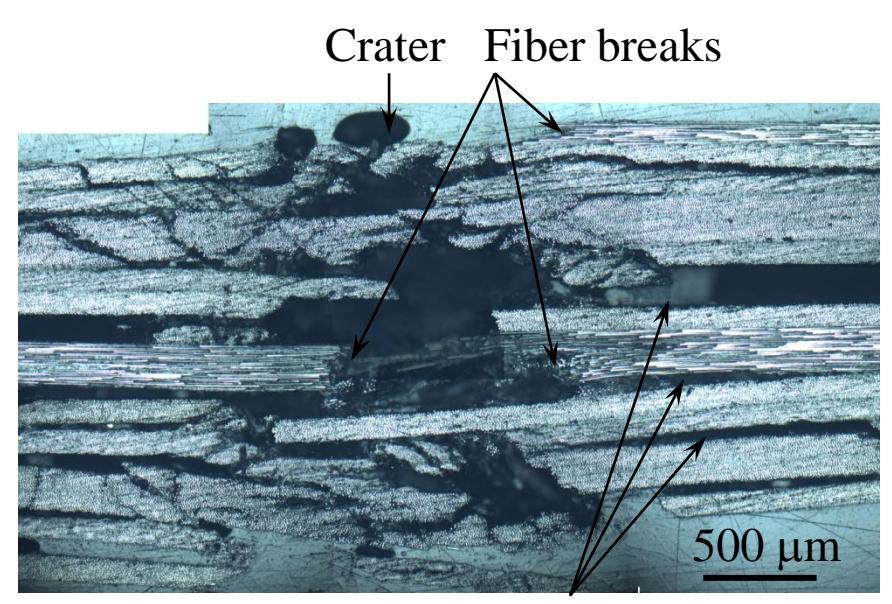
Figure 11 depicts the P-section including the impact point for the QI laminate, although both the top and bottom plies had dropped parts. Fiber breaks, delaminations, and matrix cracks in off-axis plies were observed, and there was no well-defined cone crack because of extensive delamination. Most of the ply interfaces were delaminated, and the stress concentration just beneath the impact point was reduced. This dissipated the impact energy and prevented damage progress in each ply, and thus a small catastrophic ply failure zone was formed.

- Fig. 11 Damage states in the parallel cross-section including the impact point of the QI [0/45/90/-45]s2 laminate. The impact velocity was 707 m/s.

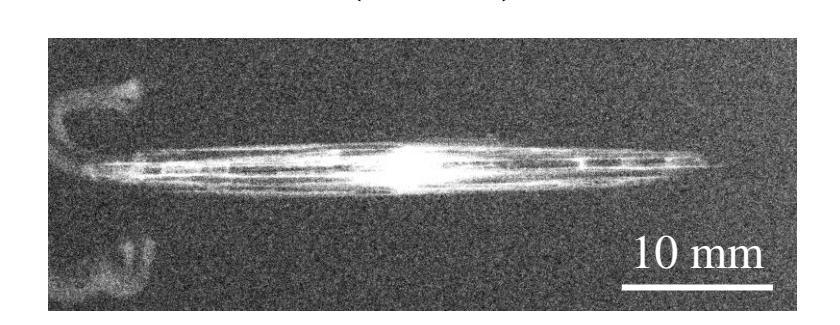
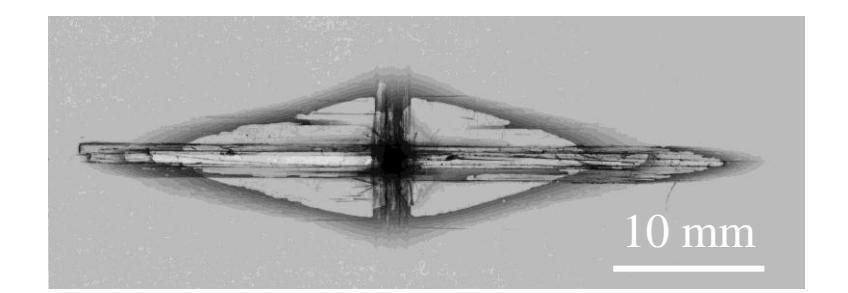
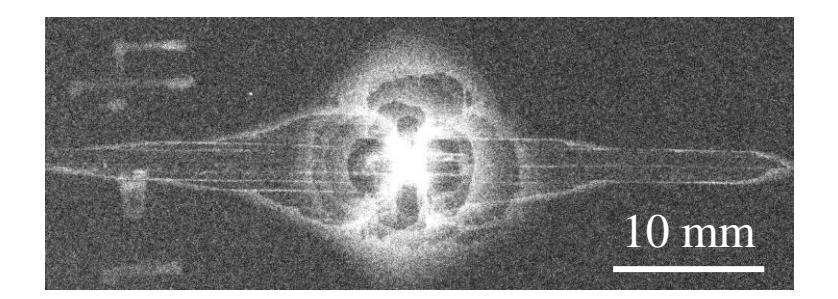
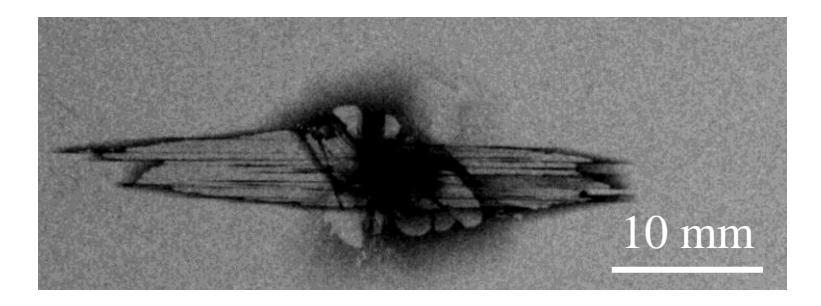
Typical soft X-ray photographs of the four laminates are presented in Fig. 12. The UD laminate exhibited delamination elongated in the fiber direction, while the delamination was small in the transverse direction. Delaminations observed near the impact point in the CP1 laminate could be separated into two delaminations since there were two ply interfaces. One was a delamination at the upper 0°/90° ply interface that was connected to the matrix cracks in the top 0° plies and extended in the transverse direction. The other was a pair of fan-shaped delaminations along the matrix crack in the bottom 0° plies that were symmetric about the impact point. Multiple fan-shaped delaminations near the impact point and elongated delamination accompanied by a matrix crack in the bottom ply were observed in the CP2 and QI laminates.

The fan-shaped delaminations were symmetric about the impact point in all of the stacking sequences except for the UD laminate. This delamination pattern was the same as that observed in the laminates subjected to low-velocity impact [26-28]. The delamination at the lowest interface extended along the matrix cracks (splits in Figs. 2-5) in the bottom 0° ply. These results indicate that delamination caused by high-velocity impact consisted of fan-shaped delaminations covering the region between the matrix cracks in two neighboring plies and elongated delamination along the matrix cracks in the bottom ply, and that this

Fig. 12 Soft X-ray photographs of the impacted specimens. Fan-shaped delaminations and elongated delamination along the matrix cracks in the bottom ply were generated.

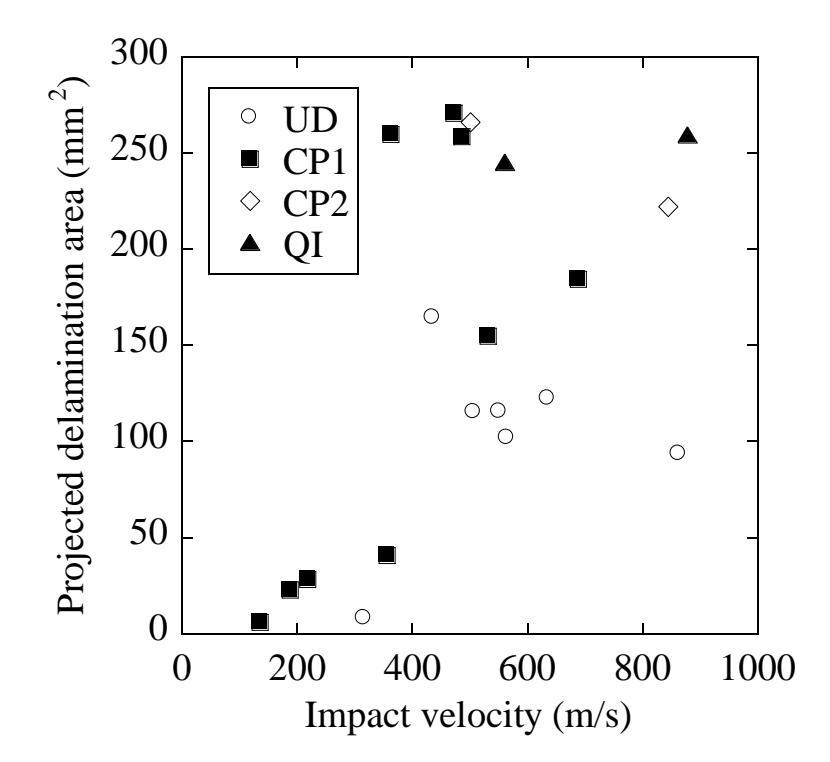
Figure 13 plots the projected area of the internal damage, mostly delaminations, against the impact velocity. The delamination area gradually increased with increasing velocity (< 350 m/s) and steeply increased at a velocity within 350-500 m/s. Small but visible damage (i.e., fiber breaks) appeared on the back surface at that velocity range, and this observation suggested that the impact energy could be dissipated mostly by delamination extension, not by fiber breaks. The projected delamination area was approximately constant with impact velocity over 500 m/s (several kJ of impact energy). This trend was observed in all of the stacking sequences, but the constant values differed among them. This result agreed with the observations of specimens perforated by high-velocity impact [8,11] and was in contrast to the low-velocity cases [27,29]. For low-velocity impacts or quasi-static indentations, the energy of indentation was absorbed by delamination extension caused by global deformation. The bending deformation was localized by increased impact velocity, and the energy absorption mechanism then changes from delamination to fiber breaks in the high-strain range [4]. The trend of a constant delamination area indicates that the impact energy was mainly absorbed by fiber breaks in the crater and the catastrophic ply-failure zone. This discussion suggests that the most important parameter governing the ballistic limit is the fiber strength and that decreased interlaminar toughness may increase the delamination area, the dissipated amount of the impact energy, and finally the ballistic limit velocity (energy). However, additional tests and observations are necessary to confirm this.

Fig. 13 Projected delamintion area of the UD and CP1 laminates against the impact velocity.
