Unzen Volcano : the 1900-1992 eruption

11. Debris Flows in Mt. Fugen

Muneo HIRANO, Haruyuki HASHIMOTO and Toshiyuki MORIYAMA¹

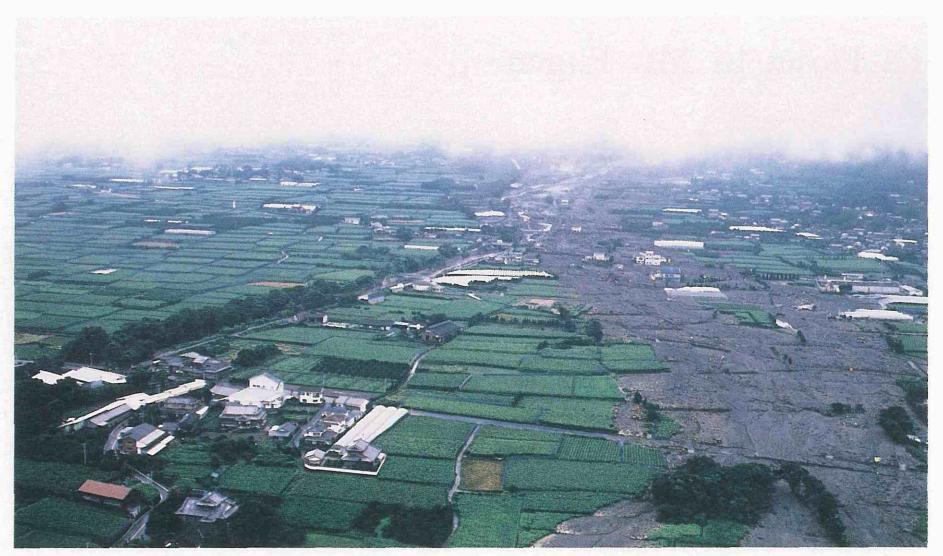
Fig. 11-1. Debris flow flooded into the protected low land on June 30. About 130 houses were broken. (by Hirano, July 2, 1991).

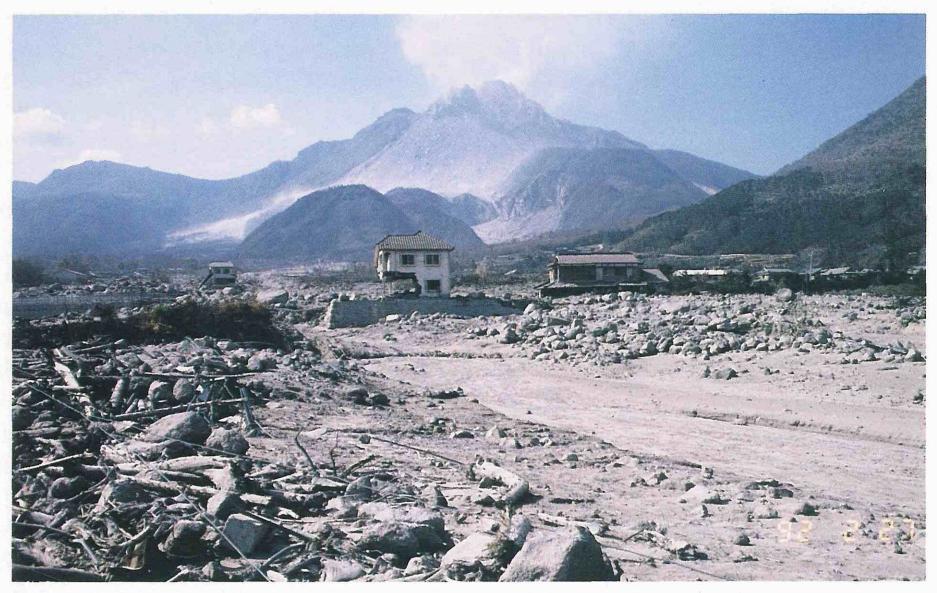
Fig. 11-2. Broken houses by the debris flow on 30 June. Houses have been still left broken in the limited-entry zone. (by Hirano, 22 February 1991).

On the same day, 30 June, a debris flow occurred in the Yue River, too, and caused damage in Ariake town (Fig. 11-2). The debris flow swelled with a lot of dead trees, blocked the bridges and flooded. Despite the larger scale of debris flow, damage was comparatively small, because the rain was heavy but brief and because there were a small number of houses in that area; one person was slightly injured and nine houses

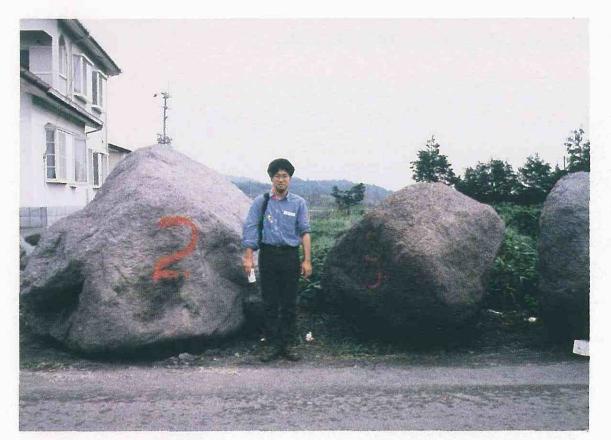
Fig. 11-3. Large blocks of rock brought by the debris flow of May 15 at the lower reach of the Mizunashi River. (by Hirano, 24 May 1991).

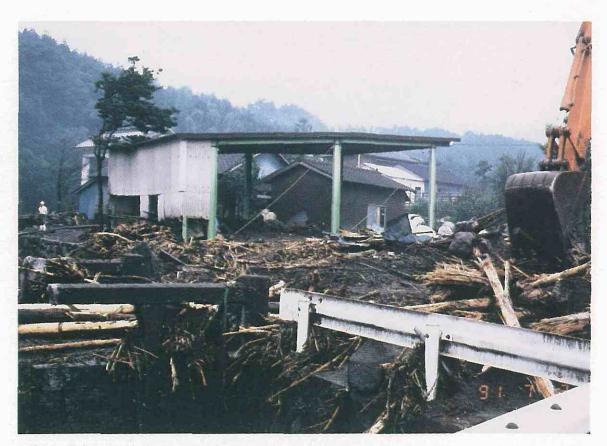
Fig. 11-4. A house broken by the debris flow of June 30 at the Yue River. (by Hirano, 2 July 1991).

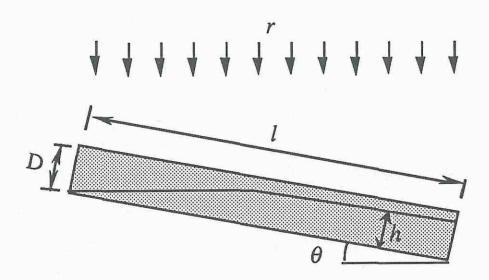
Fig. 11-6. Schematic sketch of a slope.

According to the experimental results (Hirano et al., 1977), debris flow occurs when surface flow appears on a slope due to the heavy rainfall. The criteria of the surface flow is given as follows. On a slope shown in Fig. 11-6, the momentum and continuity equations of subsurface flow are expressed as

$$\frac{\partial (\lambda h)}{\partial t} + \frac{\partial (\nu h)}{\partial x} = r\cos\theta \qquad (1)$$

and
$$\nu = k\sin\theta \qquad (2)$$

where λ is the porosity, *h* is the depth of the flow, *t* is time, θ is the angle of slope, ν is the velocity of the flow, *x* is the coordinate taken in the downstream direction, *r* is the rainfall intensity, and *k* is the hydraulic conductivity.

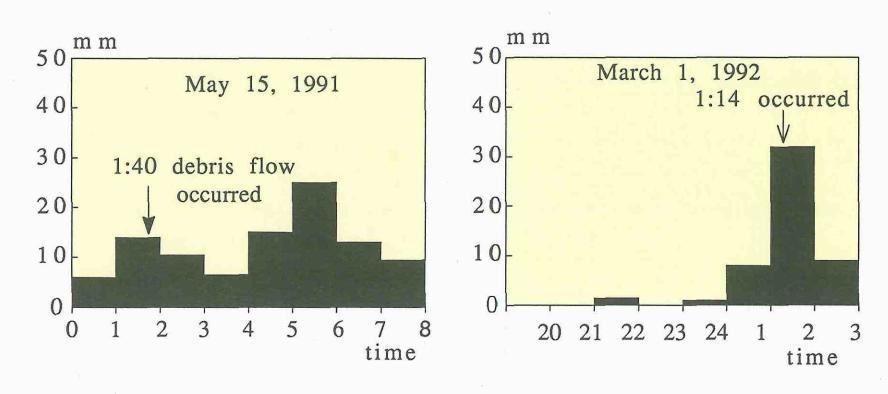
Fig. 11-7. Hyetograph at Unzen Meteorological Observatory. (The debris flow occurred in the Mizunashi River)

Figure 11-7 shows hyetographs recorded at the Unzen Meteorological Observatory when debris flows occurred on 15 May 1991, and on 1 March 1992, respectively. In both cases, debris flows occurred between the first and second hours after it began to rain. This shows that debris flows can occur even without the precursory rainfall.

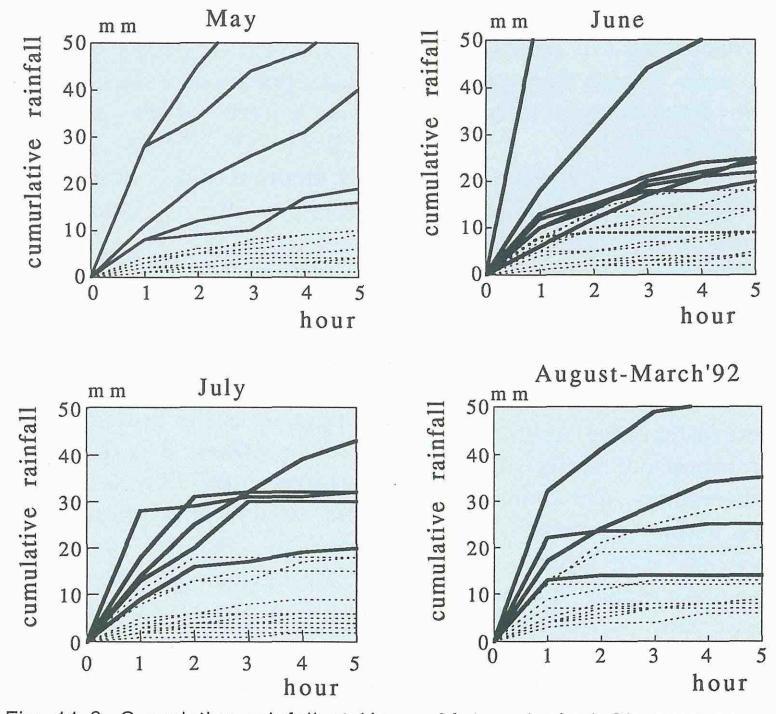
Fig. 11-8. Cumulative rainfall at Unzen Meteorological Observatory. (Solid lines: debris flow occurred; dotted lines: not occurred)

The maximum cumulative amount of rainfall for the cumulative durations were calculated for both cases with and without debris flows, using the rainfall data collected by the Unzen Meteorological Observatory. In cases when debris flows occurred, the amount of rainfall by the time of the occurrence was computed, and in cases without debris flows, whole data were used.

Figure 11-8 shows the cumulative amounts of rainfall against cumulative durations, for both cases with and without debris flows. The figure represents the following facts; (1) the time of concentration is estimated to be about an hour on average, (2) the occurrence of debris flows is possible when the amount of rainfall exceeds 7 mm / hr, and (3) debris flows will definitely occur for the rainfall over 15 mm / hr. At Sakurajima Volcano, which has been active in this 20 years, debris flows have been generated by rainfall with the amount of 7 to 13 mm over a period of forty minutes. By comparison, we can conclude that the debris flows in the Mizunashi River show the typical property of volcanic debris flow caused by a small amount of rainfall.
