Unzen Volcano : the 1900-1992 eruption

19. Earthquake Observations at Mt. Mayuyama

Hajime TSUTSUMI, Toshihiko ASO, Shoichi KITAGAWA¹, and Kiyoshi UNO²

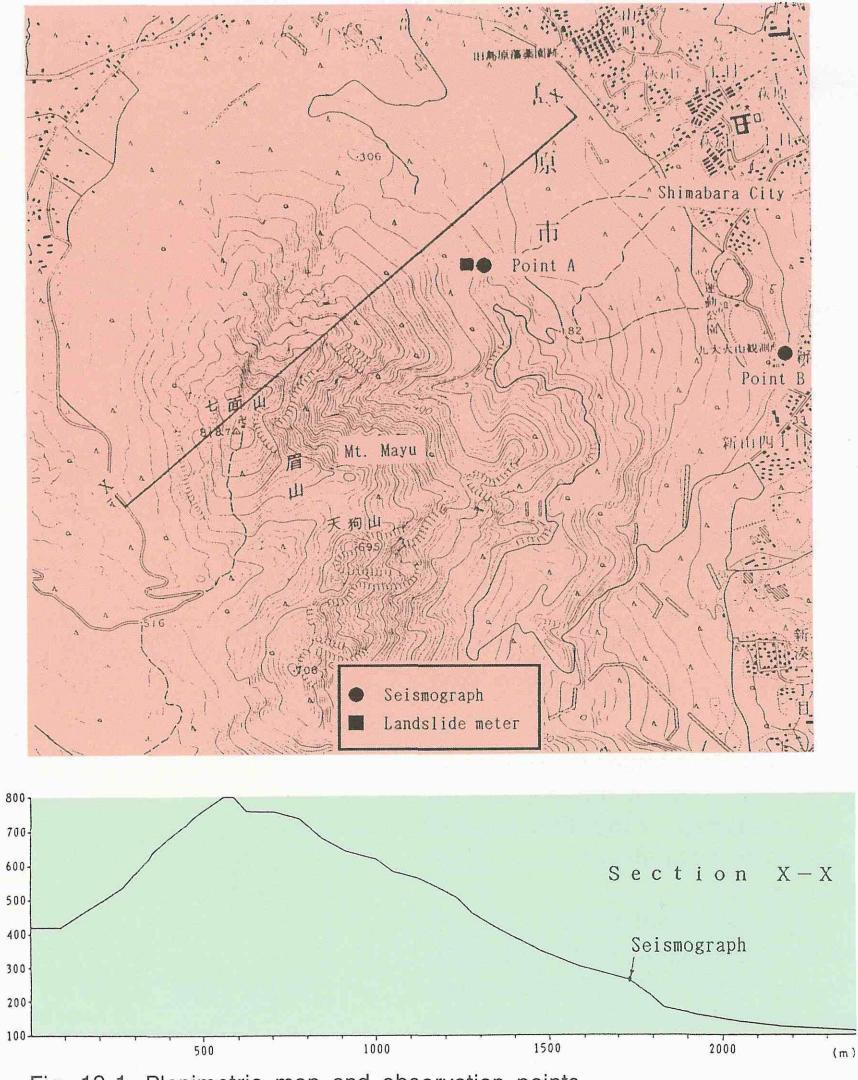
Fig. 19-1. Planimetric map and observation points.

We are making earthquake observations at two locations shown in Fig. 19-1. One (Point B) is the Shimabara Earthquake and Volcano Observatory of Kyushu University, and the other (Point A) is located on the northeast mountainside of Mt. Mayuyama, where a landslide is most likely to occur in future. Ovservations at Point A is for investigations of the earthquake behaviour at Mt. Mayuyama, and those at Point B for analyses of seismic waves through the mountain bedrock. One set of seismographic instruments can measure accelerations in three dimensions at the same time and this system can cover wide ranges of acceleration, frequency and strains. We located a landslide meter near Point A, which consists of three steel wires about 40 meters long and measures strains at the surface of the slope. The measurement interval is two hours and a trigger is set for the sudden changes above $\pm 25 \mu$ due to earthquakes. Data obtained from the seismographs and the landslide meter have been sent to Kyushu University by an extensive digital line and analyzed.

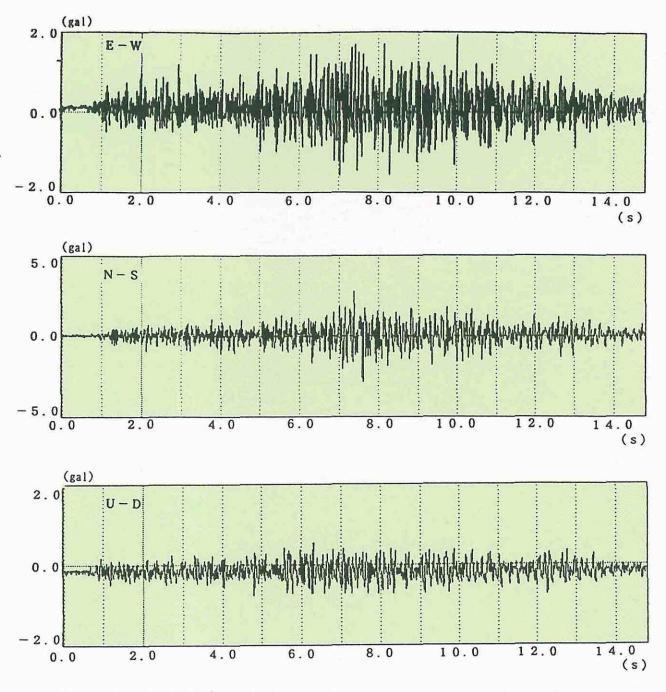
Fig. 19-2. Time history of observed earthquake.

Figure 19-2 shows the time history of the above earthquakes measured at Mt. Mayuyama. The maximum acceleration was 2.5 gal in the N-S direction. Figure 19-3 presents the power spectrum, showing the frequency characteristics of seismic motion at Mt. Mayuyama. Data obtained from the landslide meter does not show significant strains of the slope even during the earthquake.

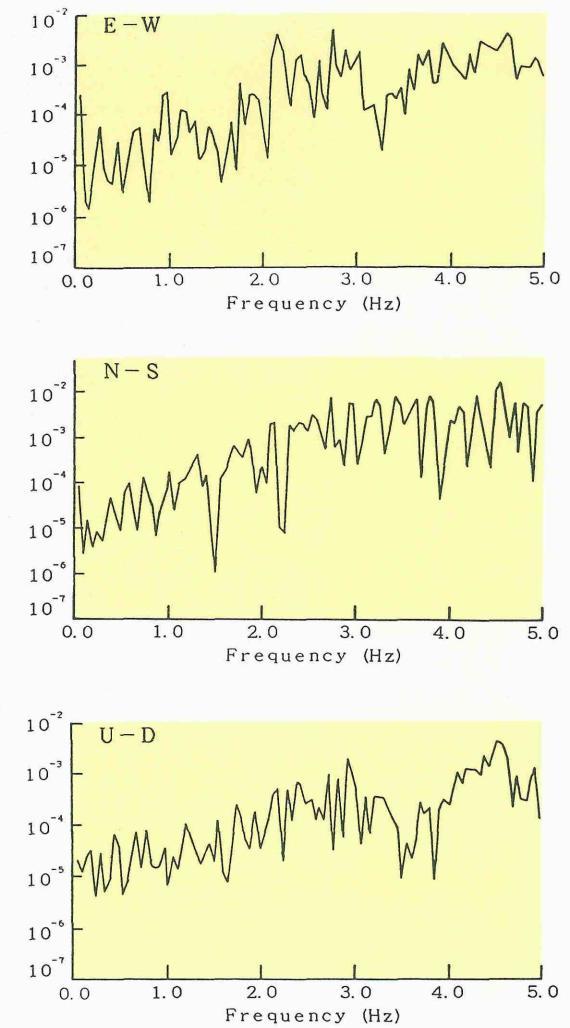
Fig. 19-3. Power spectrum of observed earthquake.

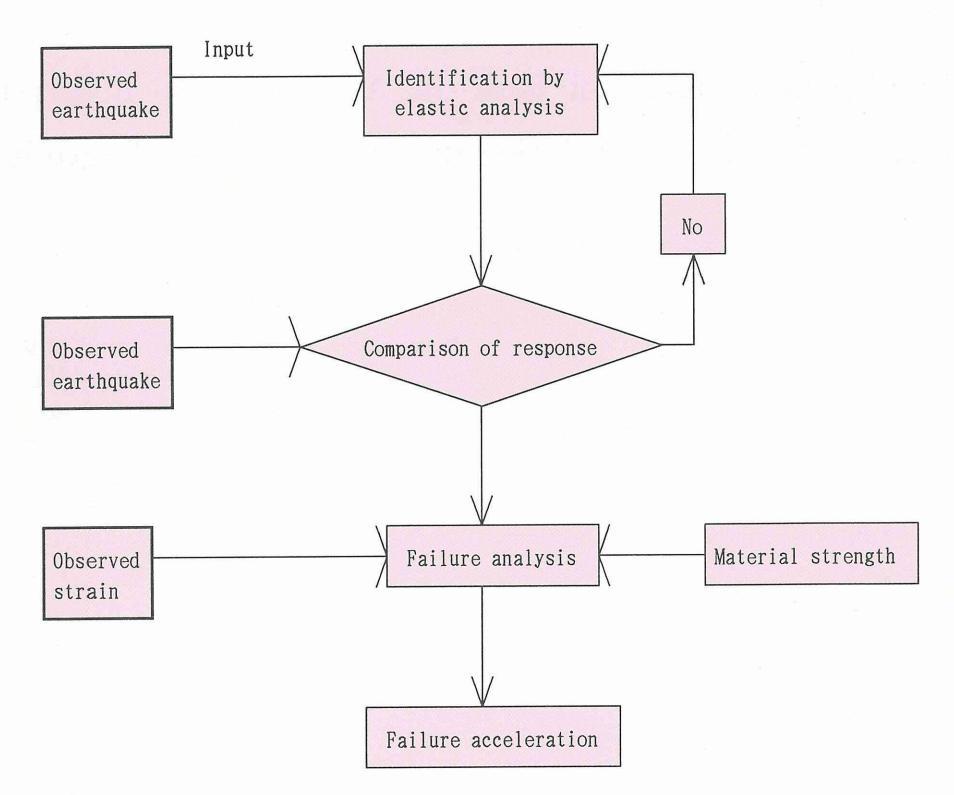
Fig. 19-4. Analysis procedure.

To examine the possibility of the slope failure at Mt. Mayuyama, it is important not only to continue the observations of earthquakes and landslides, but also to study the dynamic characteristics of Mt. Mayuyama. There is little information concerning the geological data and material properties of this slope. However, dynamic failure analysis can be improved and reinforced, if combined with observed seismic data. We will present here one possible process for failure analysis, which is schematically outlined in Fig. 19-4.

We will model the slope of Mt. Mayuyama as an assemblage of many "elements" for computation by means of finite element method. Definition of such elements depends on an elastic material behaviour, a damping factor, and so on. The mechanical responses of these elements to the earthquake can be computed based on data of the seismic waves through the bedrock obtained at Point B. Comparing the acceleration recorded at Point A with the computed accelerations, we can get useful information to improve computational parameters describing mechanical properties of the elements. Repeating this procedure
