Late Type III Endoleak of a Powerlink Stent Graft : Report of a Case

Koichi Morisaki, Takuya Matsumoto, Yutaka Matsubara, Kentaro Inoue, Yukihiko Aoyagi, Daisuke Matsuda, Shinichi Tanaka, Jun Okadome and Yoshihiko Maehara

Department of Surgery and Science, Graduate School of Medical Sciences, Kyushu University, Fukuoka, Japan.

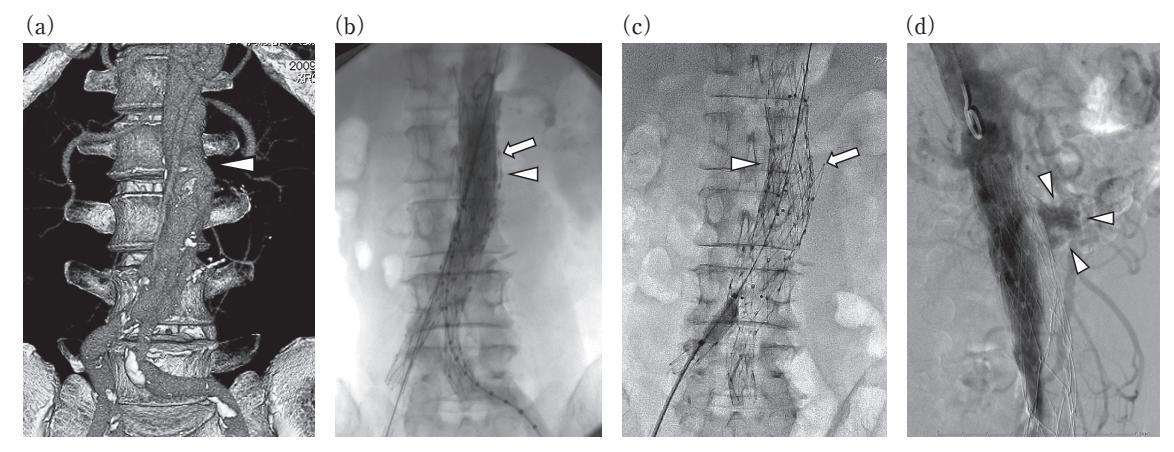
Fig. 1

- (a) Arrow head represented the origin of aneurysm in 3D-CT.
- (b) At the first treatment, completion angiography showed no findings. Arrow head represented origin of aneurysm and arrow represented proximal end of main body of Powerlink.
- (c) X-ray fluoroscopy revealed a gap between the extension and main body. Arrow head represented origin of aneurysm and arrow represented proximal end of main body of Powerlink. Arrow head represented origin of aneurysm and arrow represented proximal end of main body of Powerlink.
- (d) Angiography showed a type III endoleak from the junctional zone (arrow head).

infrarenal abdominal aorta considering the future risk of a type IA endoleak (Fig. 1a, 1b).

Postoperative CT showed no findings of an endoleak. Follow-up was later performed with ultrasound (US) and plain CT due to renal dysfunction. A follow-up examination performed three years later showed a decrease in the size of the aneurysm to 47×59 mm in diameter. US and CT performed at four years of follow-up showed an endoleak and increase in the size of the aneurysm to 55×66 mm. Angio-CT disclosed findings suspicious of a type I or type III endoleak; therefore, angiography was performed. X-ray fluoroscopy revealed a gap between the extension and main body, while angiography showed a type III endoleak from the junctional zone (Fig. 1c, 1d).

Under general anesthesia, an Endurant aortic extension was deployed inside the Powerlink stent graft. Postoperative CT showed that the type III endoleak had disappeared.
