Study on Effect of Reinforcement using Helical Bars on Circular RC Columns under Cyclic Lateral Load

Do-Yeon Kim¹, Ja-Eun Shin², Seong-Kyum Kim³, Il-Young Jang⁴ ^{1,2,3,4} Department of Civil Engineering, Kumoh National Institute of Technology, Korea correspondence should be addressed to Il-Young Jang; jbond@kumoh.ac.kr

Abstract: To improve an earthquake-resistance of highway bridge constructed in South Korea before 1992, in this study, it was conducted quasi-static test according to the displacement-controlled (strain control) method on RC columns reinforced helical bar. In the experiment, fracture behavior of the circular column and its lateral load-displacement was investigated using three types of reinforcing bar, which has 6, 8 and 10 mm of the diameter. As a result, it was confirmed that seismic performance was dependent on reinforcement of helical bar and its size. During the test, the specimen reinforced using helical bar with 8 mm in the diameter was highest in maximum lateral load, of which the value accounted for 130.9 kN. For a diameter of 10 mm, however, it showed an over-reinforcement effect. Therefore, it would be cautious in reinforcing the helical bar, considerin

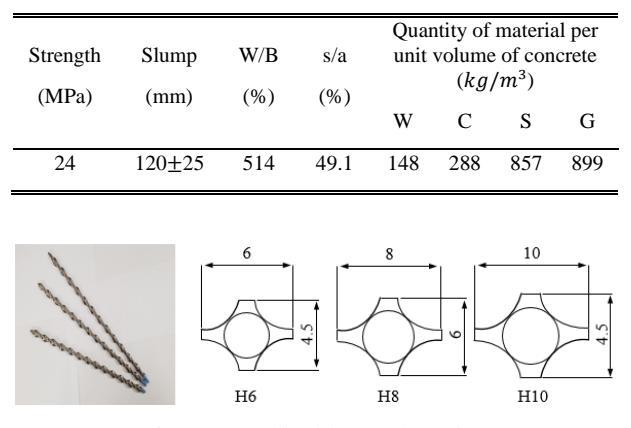
Figure 1. Helical bar and section

The deformed rebar with a yield strength of 400 MPa and concrete with a design strength of 25 MPa were used in this study. The concrete mix design is given in Table 1. Also, in order to improve the performance of the specimen against-earthquake, in terms of the lateral load, it was used reinforcement in a specified section outside the column. As organic materials may result in separation and spalling from the concrete, inorganic material with similar physical properties of the conventional reinforcement was adopted [7]. A helical bar used as the reinforcing material originates from nickel-chrome alloy and has high resistance against corrosion. Moreover, the reinforcement possessing spirally twisted shape exhibits an enhanced ductility and tensile strength, of which the strength accounts for about 1,100 MPa, compared to the rounded form [8]. These properties can produce the increased binding force to external force, and simultaneously not be easily cut off due to high elongation rate [8]. Therefore, it is expected to show excellent performance as a reinforcing material by resistance to earthquake. The helical bar with different types of diameter was used in the present works, and its schematic diagram is shown in Fig. 1.

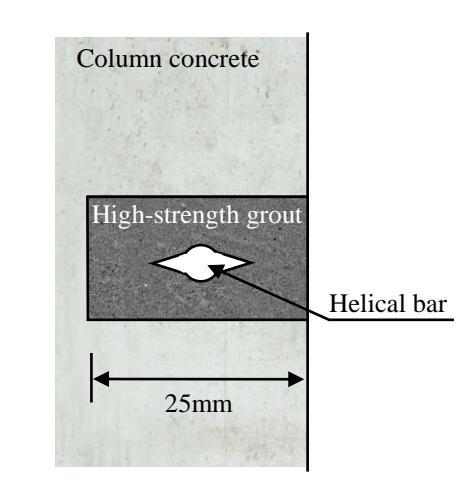
Figure 3. Reinforced section of setting helical bar

After removing the concrete cover of about 20-30 mm from the surface of the RC specimen, the helical bar was installed along the furrow. Then, ends of the reinforcement were fixed in a hole of 50 mm using high strength epoxy as if a vertical anchor to achieve sufficiently restraining force. In turn, the buried space was filled out using rapid hardening grout with a strength of 40 MPa, followed by an adhesive agent was used for enable to behave integrally between old and new cross section. Reinforcing the helical bar in the column is shown in Fig. 3 as schematic diagram.

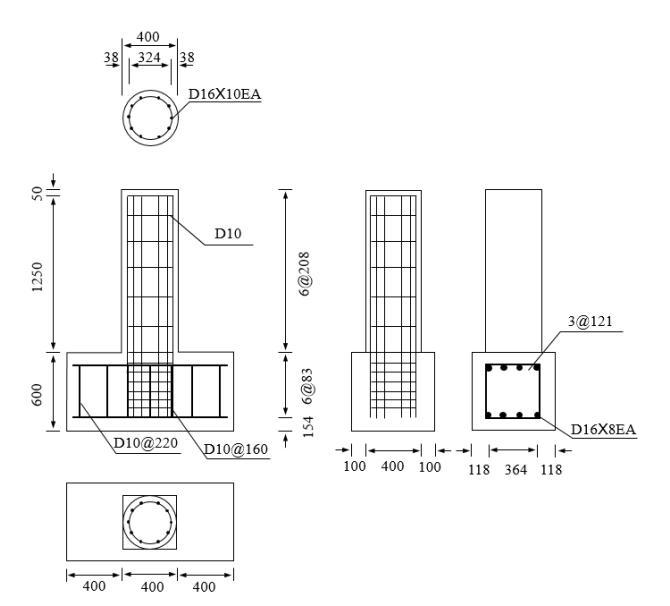
Figure 2. Design section and arrangement of specimens

The specimen with a quarter-scale of the circular pier was designed dividing into a foundation part and a column one. The former was fabricated with formwork $(1,200\times600\times600 \text{ mm} \text{ in length})$ using normal rebars to ensure a restraining force when loaded laterally to the circular column, and the latter was manufactured with a transverse reinforcement ratio of 0.25% and an aspect ratio of 3.0, which equals to a height of 1,250 mm and a diameter of 400 mm. Fig. 2 shows the detail and picture of the RC specimen, respectively.

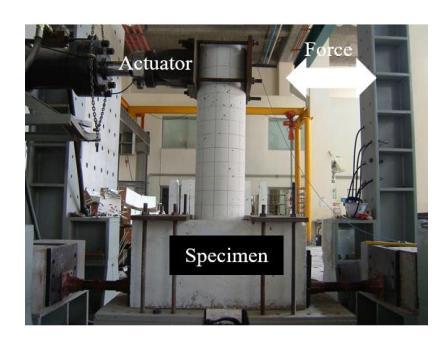
Figure 4. Experimental setup for cyclic loading test

To determine the load ratio in lateral force to the RC specimen, the yield displacement was verified through the control specimen, of which a value of the displacement(δy) was 22 mm. Based on the result, the drift level ($\delta / \delta y$) was 0.25% (5.5 mm), 0.5% (11 mm), 0.75% (16.5 mm), 1.0% (22 mm), 1.5% (33 mm), 2.0% (44 mm), 2.5% (55 mm), 3.0% (66 mm), 4.0% (88 mm) and 5.0% (110 mm). Fig. 4 show an experimental setup for cyclic loading adopted in this study.

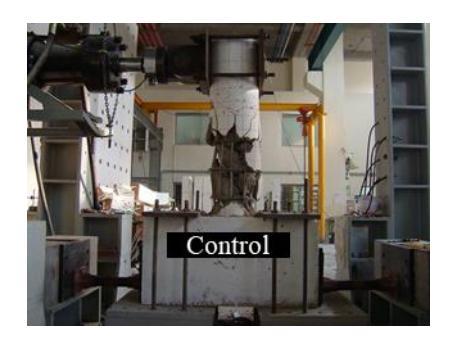
Figure 5. Control specimen experimental result

Control specimen After flexing up to 109.6 kN of the maximum lateral load with a non-reinforced specimen, concrete sheath was removed from the test specimen at a height of 500 mm from the base joint, the section of the plastic hinge after 2.5% of the drift level, and rebars were exposed and severely bent in the same direction as the loading direction. In other words, due to the loss of concrete, some resistance to transverse loads was lost, and only the capitulation of axial rebar and the core concrete resisted. After the drift level 3.0%, the core restraint concrete inside the axial rebars was destroyed due to severe cracks, and its resistance to transverse loads was reduced rapidly. Since the large amount of core concrete loss occurred, the axial rebar has decreased its bonding performance with the concrete, causing a slip behavior, and showed the severe rebars buckling in the plastic hinge region, which is a 200 mm height section from the base joint. Fig. 5 shows specimen destroyed after the experiment.

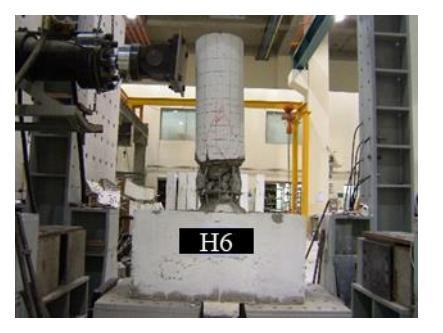
Figure 6. H6 specimen experimental result

H6 specimen The specimen is spiral-reinforced with a 6 mm diameter helical bar that extends the danger cross section from the base joint to a height of 500 mm. The spacing of the reinforcing helix is 100 mm. During the test, the maximum lateral load applied to the specimen was 105.2 kN, and after the drift level 3.0%, the helical bar was first cut by lateral load, and then the reinforcement was severely cut off. Due to the lateral confinement loss as a stiffener, it showed a drastic decrease in performance as in the case of unreinforced specimens. In this test condition, the sectional force of 6 mm diameter helical bar is weaker than that of unreinforced specimen in order to obtain high lateral load resistance. Fig. 6 shows specimen destroyed after the experiment.

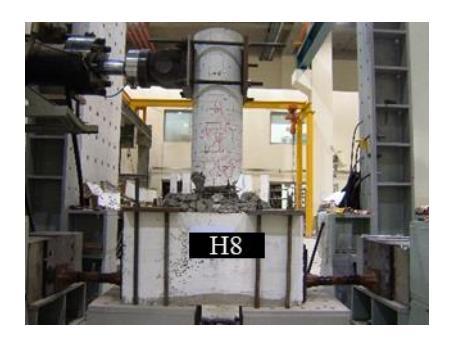
Figure 7. H8 specimen experimental result

H8 specimen It is a specimen reinforced up to 500 mm, the dangerous section, with a spiral gap of the column of 100 mm using a helical bar of 8 mm in diameter. The maximum lateral load of the specimen during the test was 130.9 kN. After the drift level 3.0%, the first reinforcing bar, helical bar, was cut by lateral load, but unlike the 6 mm diameter reinforcement, no additional cuts occurred elsewhere. Because of the reinforcement of the spiral, it

is considered that even if the reinforcement is cut in one section, it does not cause severe damage to the entire reinforcement effect. Therefore, the remaining sheath showed less failure due to cracks, and the energy absorption capability for the lateral load even to the end of the experiment was demonstrated without the loss of lateral resistance. It is shown that the lateral load strength is reduced from 3.0% of the drift level and 60 mm of displacement, but is not sudden and is decreased smoothly. Fig. 7 shows specimen destroyed after the experiment.

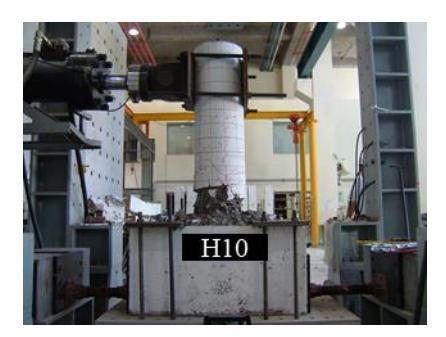
Figure 8. H10 specimen experimental result

H10 specimen It is a specimen reinforced up to 500 mm, the dangerous section, with a spiral gap of the column of 100 mm using a helical bar of 10 mm in diameter. It is a reinforcement to be used when a relatively large reinforcing performance is required, and it has a disadvantage that it is difficult to construct due to a high sectional force and is expensive. The maximum lateral load of the specimen during the test was 123.1 kN. It shows high energy absorption at more than 4.0% of the drift level. However, due to the use of reinforcement having too large section force relative to the performance of existing members, the main reinforcement was cut from the drift level lower than in the case of H8 due to its high lateral binding force. Fig. 8 shows specimen destroyed after the experiment.

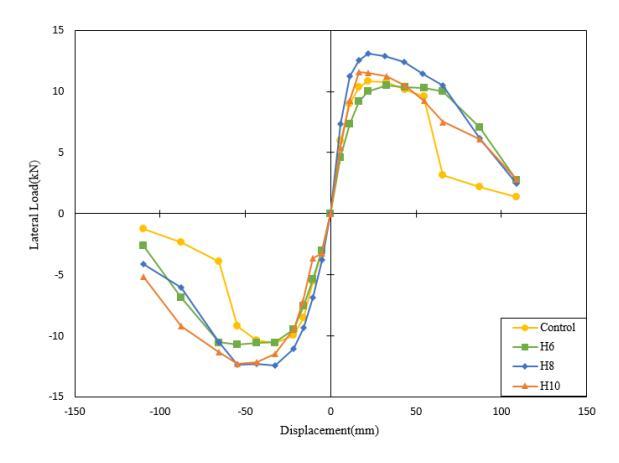
Figure 9. Lateral load – Displacement envelope of all specimens

The envelope was created by deriving the maximum lateral load for each displacement from the load displacement curves obtained through the experiment. The area formed with the x-axis below the graph is considered to be the ductile strength of a structure that can absorb external energy in the event of an earthquake, at a envelope consisting of displacement of the transverse axis and lateral load of the longitudinal axis. It can be seen that the performance is drastically degraded from the drift level of 2.5% (55 mm) as compared with the Control specimen which is not reinforced. All of the reinforced specimens show a difference in magnitude, but generally show an improvement in reinforcing performance after this section. Fig. 9 is the load-displacement envelope of the entire specimen displayed on one coordinate. At the load-displacement envelope obtained when the reinforcement diameter is variable, with all the reinforcement spacing of 100 mm, the performance of the 8 mm diameter reinforcement was best demonstrated. It is shown that the reinforcement spacing of the 8 mm diameter reinforcement spacing of the 8 mm diameter reinforcement spacing in the envelope test to improve both stiffness and ductility.
