Surface Modification of Low Energy Helium Ion Implanted Austenitic Stainless Steel by Tensile Stress

Abstract

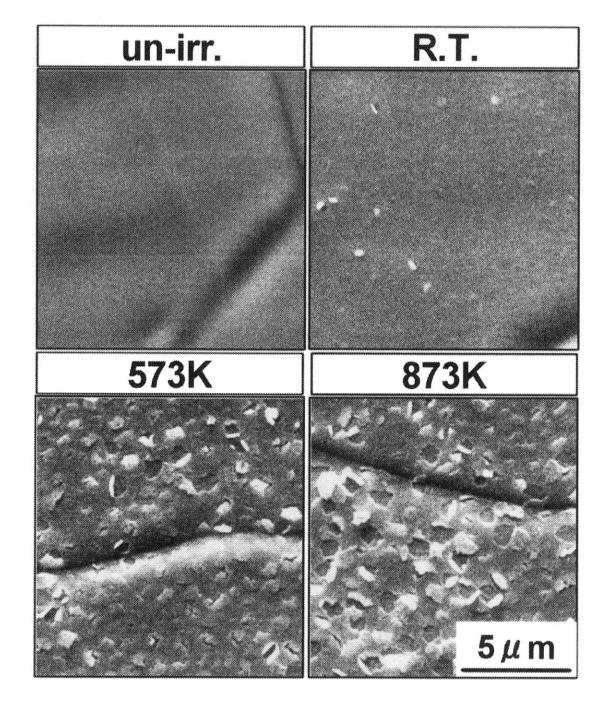
Fig.1 SEM surface images of specimens unirradiated and irradiated at R.T., 573 K and 873 K.

Figure 1 shows SEM images taken from specimen surfaces before and after the irradiation. Grain boundaries were easily detected due to thermal etching during annealing before the helium irradiation. No significant modification except for slight dispersion of small blisters was discerned on the sample surfaces irradiated at R.T. On the other hand, exfoliation of blisters was observed on the surfaces irradiated at 573 K and 873 K.

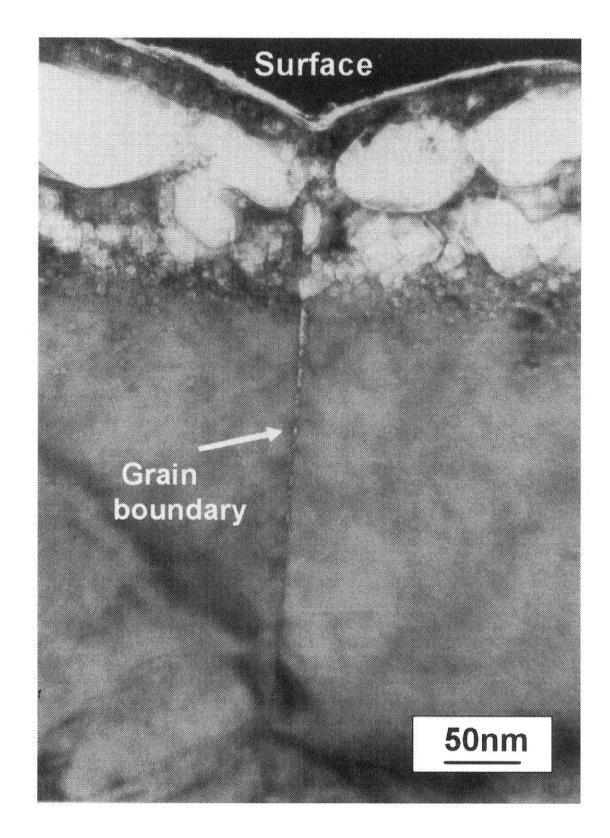
Fig.2 TEM image of cross-sectional view of specimen surface irradiated at 873 K.

Shown in Fig. 2 is a cross sectional TEM image near the specimen surface irradiated at 873 K. Cavities with a diameter of over 100 nm, which should induce blistering, were observed in the sub-surface region of 100 nm. In addition, bubbles with a diameter of a few nm to several tens nm were also formed and distributed up to about 150 nm in depth in grain interiors. They reached up to 400 nm in depth when present at grain boundaries.

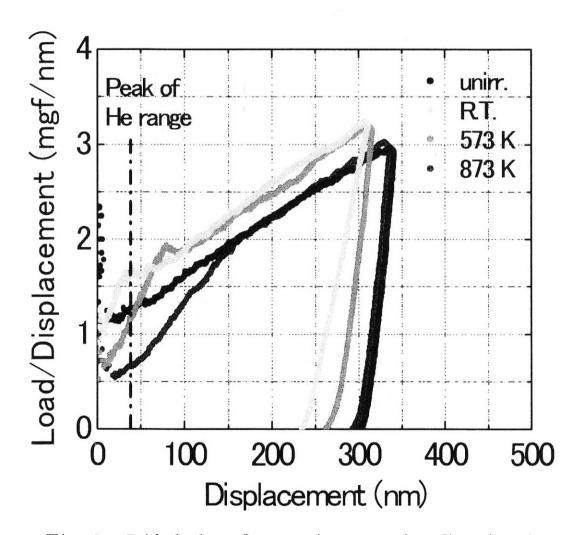
Fig. 3 L/d-d plots for specimens unirradiated and irradiated at R.T., 573 K and 873 K.

Figure 3 shows L/d-d plots for both unirradiated specimens and those irradiated at R.T., 573K and 873 K. The gradient of the plot in the loading stage corresponds to

the hardness according to equation (2). The plot of the unirradiated specimens show good linear correlation between L/d and d through the whole loading process. This means that hardness is constant along the depth direction. On the contrary, the gradient of the irradiated specimens changes along the depth. This change is probably attributed to hardening near the surface due to helium irradiation. The gradient also shows that the hardening near surface decreased with increasing irradiation temperature.

Figure 3 also shows that the range of hardening increased with increasing irradiation temperature. In the case of high temperature irradiation, hardening was observed up to 80 nm and 150 nm in depth at 573 K and 873 K, respectively. In the case of 873 K, the hardening spread to deeper regions where bubbles were observed in Fig. 2. It seems that formation of highly pressurized bubbles would be a cause of surface hardening noted above. Figure 4 shows the evaluated Vickers hardness of the surface based on Eq.2. The hardness decreased with increasing irradiation This trend could be, at least partially, temperature associated with the reduction of bubble pressure, which is expected to take place through vacancy absorption and/or bubble coalescence at high temperature.

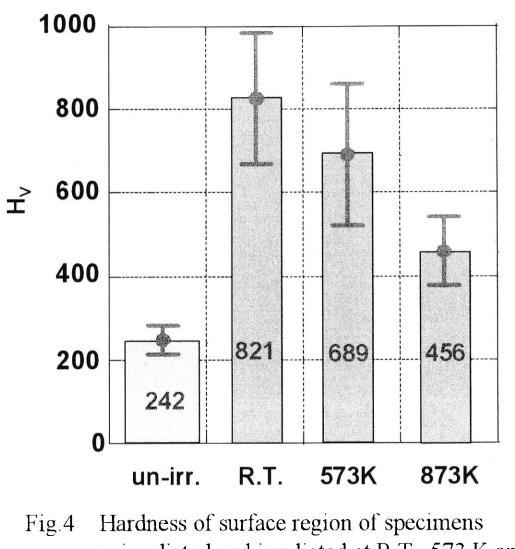
unirradiated and irradiated at R.T., 573 K and 873 K. Hardness was evaluated by Eq.(2).

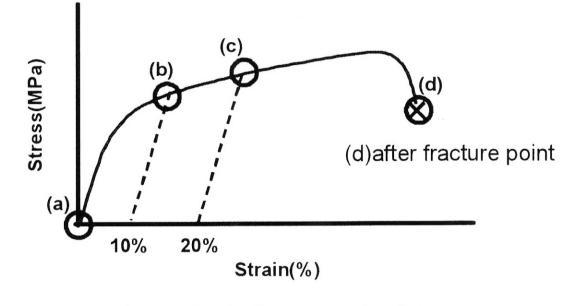
Fig. 5 Typical stress-strain plot.

Shown in fig.5 is atypical stress-strain plot. Surface modification was observed at 10%(b), 40%(c) strain and fracture(d). Figure 6 shows SEM images of the specimen surface, which was not irradiated, before and after the tensile test. Slip lines were observed on the surface, but cracks were not formed. Shown in Figs. 7 are SEM images of the surface of irradiated specimens after the tensile test. In the case of the specimen irradiated at R.T., many blisters appeared on the surface after tensile stress application and they were exfoliated. In addition, cracks were observed in

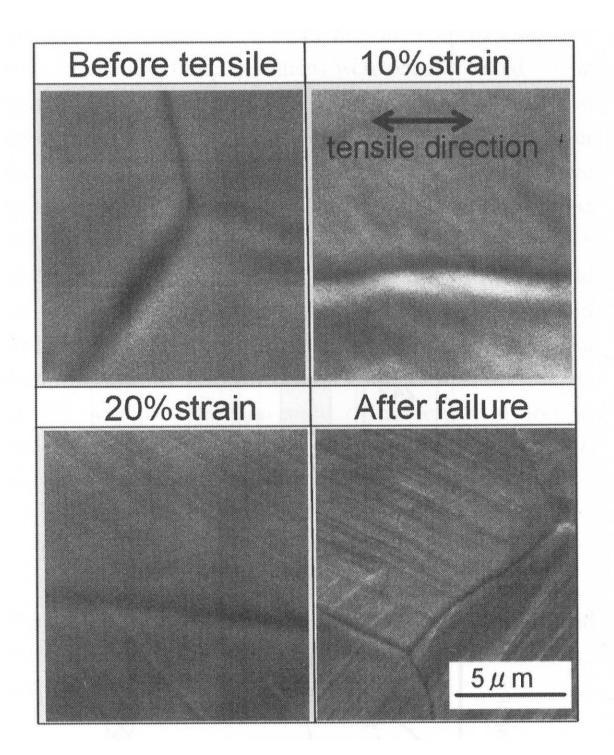
Fig.6 SEM surface images of unirradiated specimen before and after tensile test.

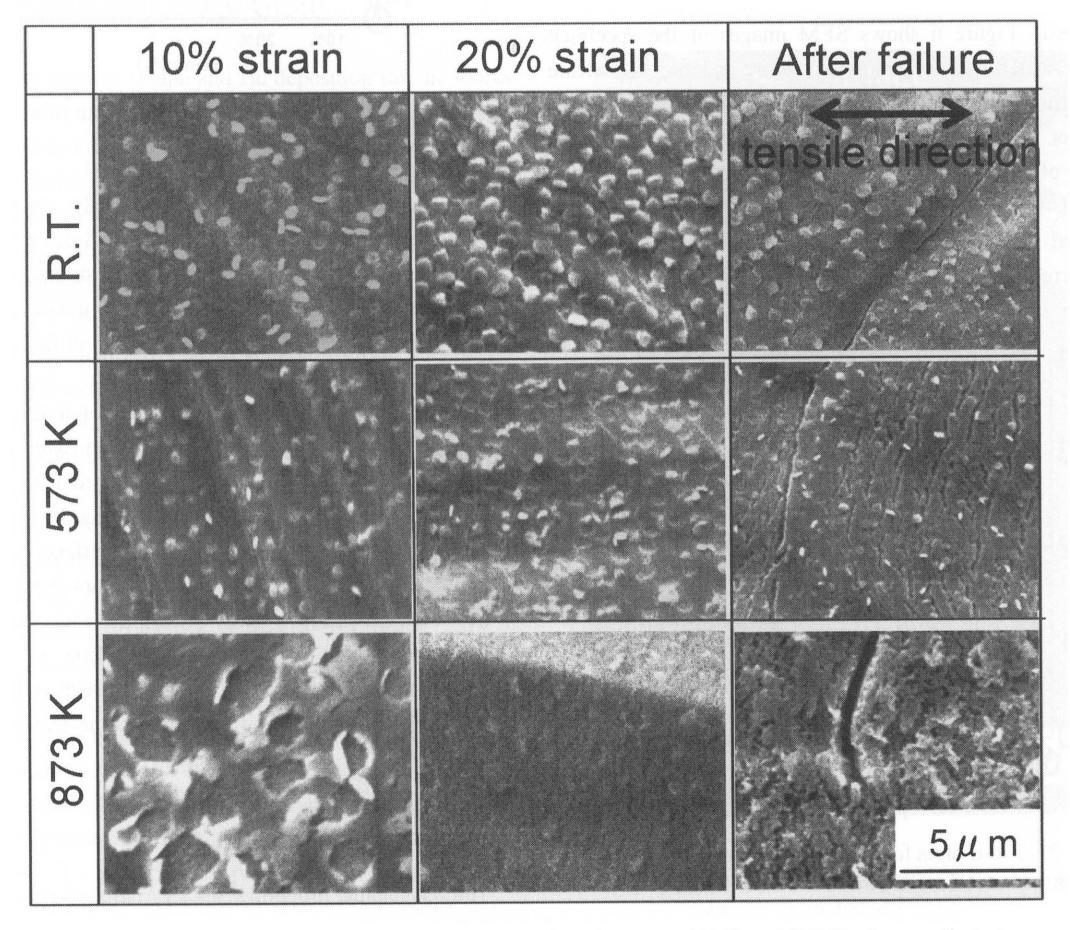
Figure 7 SEM images of specimen surfaces irradiated at R.T., 573 K and 873 K after tensile test.

the specimen after fracture. Additionally, in the case of specimens irradiated at 573 K and 873 K, exfoliation of surface layers occurred at 10% and 20% strains. Cracks were also seen after fracture. These surface modifications were considered to be caused by embrittlement of the surface layer irradiated by the helium.
