Roles of Pre-Existing Hydrogen Micropores on Ductile Fracture

Synchrotron X-ray microtomography was used to observe hydrogen micropores. Competitive growth between pre-existing high-density micropores and voids originating from damage during loading was observed in an aluminum alloy during a tensile test. Extensive and premature growth of pre-existing hydrogen micropores has been observed during tension, while the ordinary damage initiation increased rapidly more later. According to the estimation on the areal fraction of dimple patterns originating from the pre-existing hydrogen micropores, it has been concluded that the hydrogen micropores more or less make contributions to ordinary ductile fracture. [doi:10.2320/matertrans.M2009123]

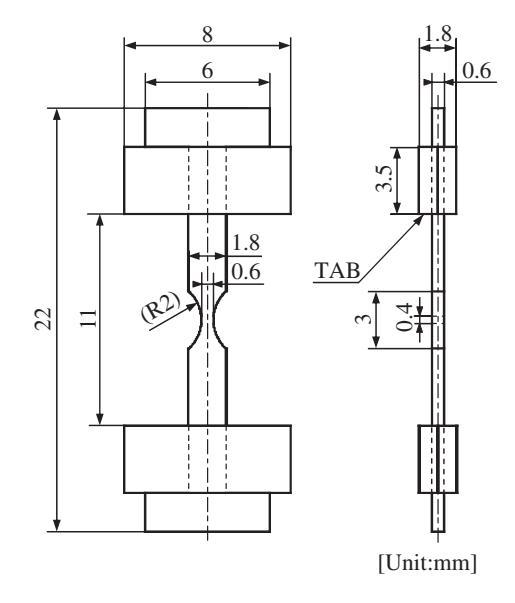
Fig. 1 Geometry of the tensile test specimen.

A rolled plate of a 2024-T3 aluminium alloy was tested in the L-T orientation. A small parallelepiped specimen shown in Fig. 1 was machined from the rolled plate in the rolling direction. The plate was solution heat-treated in advance for 7.2 ks at 768 K, and then quenched into ice water and naturally aged approximately for 2,300 ks at room temperature to provide a T3 temper condition.

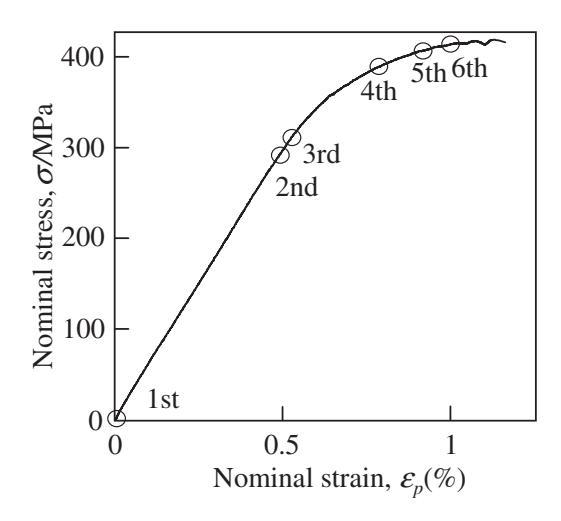
Fig. 2 Nominal stress-plastic strain curves during the tensile test with CT scans. Tomography scans were performed six times at the indicated strain levels.

The *ex-situ* techniques were utilized to observe a specimen during monotonic tensile loading at room temperature. Loading rate was 0.013 mm/s. The first tomography scan was performed without loading and the subsequent six scans were performed including the observation of a fractured specimen. A stress-strain relationship is shown in Fig. 2.

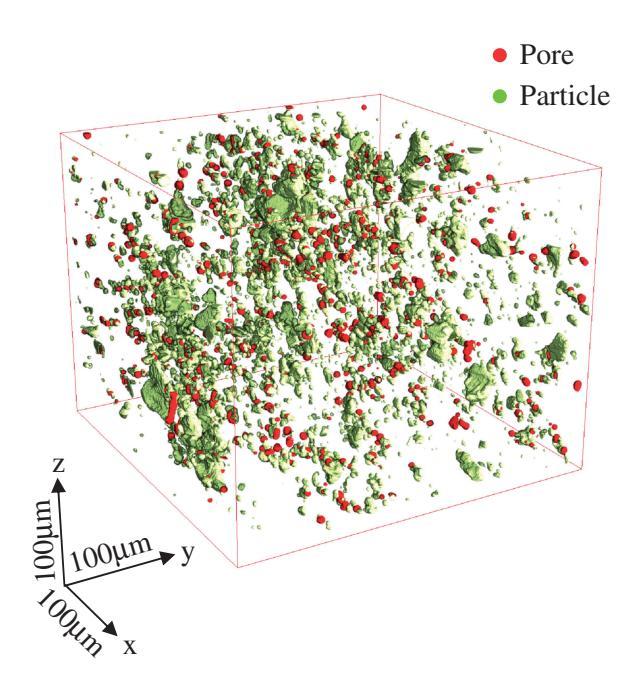
Fig. 3 3D perspective view of micro-pore, void and particle distributions in the 2024 aluminum alloy used. The image was taken at the 1st step.

Figure 3 shows the 3D distributions of micropores (shown in red) and particles (shown in green) before loading. A closer inspection revealed that the majority of micropores have been formed heterogeneously on constituent particles, which have been also confirmed more quantitatively for Al-Mg allovs in our recent paper.¹²⁾ In the previous study, a liquid gallium grain boundary wetting technique was applied to characterize a 3-D grain structure in a Al-4%Mg alloy.¹⁵⁾ It has been revealed that although some of micropores are located on grain boundaries, the majority of micropores are located in grain interior. Since void initiation during loading occurs either from particle fracture or interfacial debonding at particle/matrix interface, it might suggest that the preexisting hydrogen micropores and voids caused by damage cannot be distinguished only with their morphology. Therefore the sophisticated tracking analysis should be applied to it.

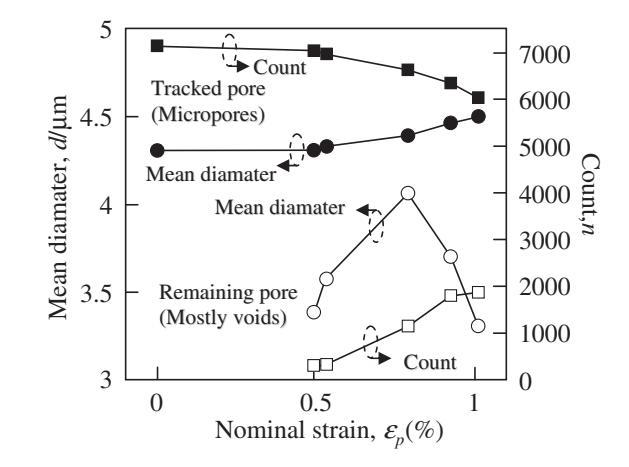
Fig. 5 Variations in number and mean diameter of tracked pores and remaining pores as a function of applied nominal strain.

It can be more clearly recognized with the results of tracking analysis shown in Fig. 5. Hydrogen micropores, which have been successfully tracked from the unloading state, started to grow from an early stage, while the ordinary damage initiation increased rapidly after plastic strain had been accumulated to some extent. Of the 7,143 hydrogen micropores observed in the first 3D image, 6,034 micropores could be tracked until the final loading step. The reason why the number of micropores tracked gradually decreased would

be both tracking errors and the coalescence of micropores. In the tracking procedure used, a matching probability parameter, *MPP*, was utilized to eliminate tracking errors. The maximum *MPP* should be larger than a pre-determined threshold value and difference between the first and second highest *MPP* should be larger than another threshold value. Only when the two criteria are satisfied at the same time in a couple of successive 3D image data sets, the set of microstructural features is accepted as exactly tracked features. Otherwise the set is pended in order to avoid tracking errors. On the other hand, the number of voids, which appeared from intermediate loading steps, rapidly increased after the onset of plastic deformation. Void diameter decreased after loading step 4 probably because the initiation of small voids was accelerated before fracture.

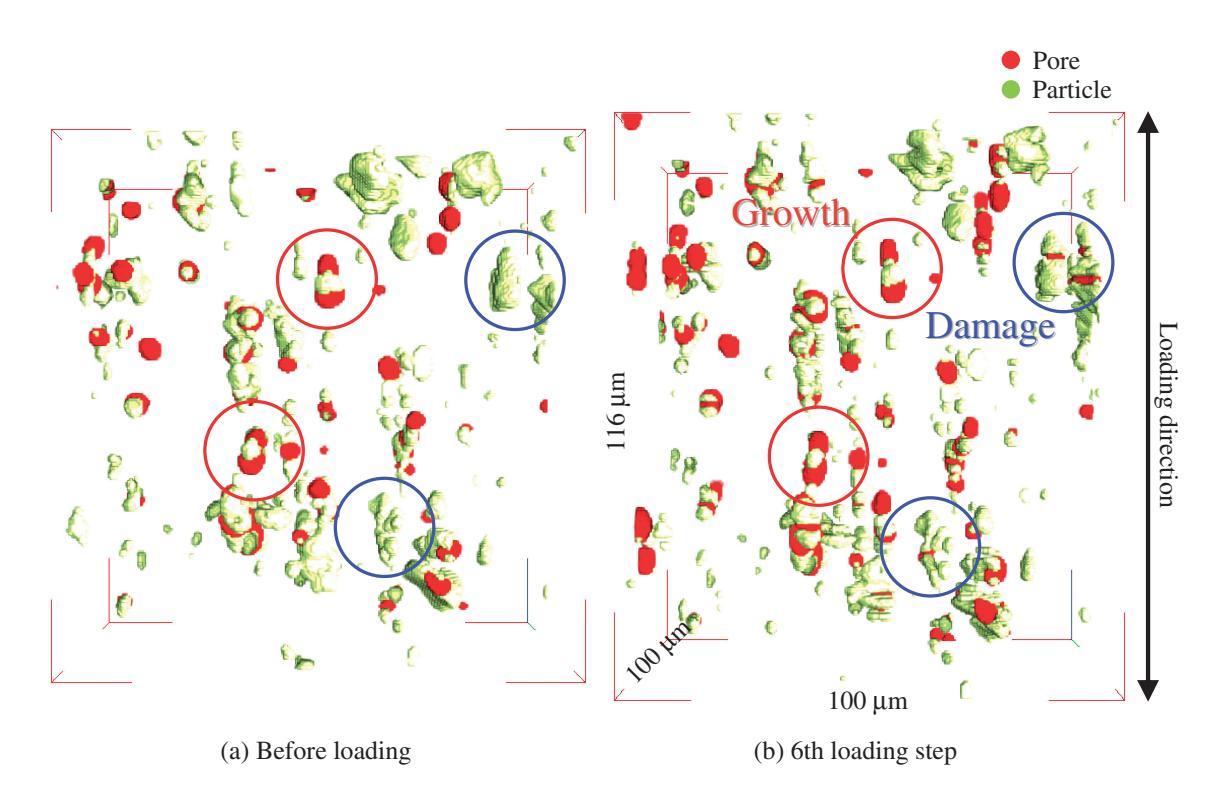
Fig. 4 3D perspective views of particles, pores and voids extracted from the tomographic volumes, representing micro-pore growth and void nucleation/growth in the material.

3D images captured before loading and at 6th loading step are shown in Fig. 4(a) and (b), respectively. Note that only micropores and particles are extracted, while underlying aluminum is not displayed in the figure. Blue circles in Fig. 4 indicate ordinary ductile fracture process that starts from the damage initiation at particles. Particle fracture at irregularly

shaped particles appears to be the major damage initiation event in the present material. On the other hand, red circles indicate the simple growth of pre-existing hydrogen micropores. It can be seen from Fig. 4 that the extent of growth seems to be different between hydrogen micropores and voids.

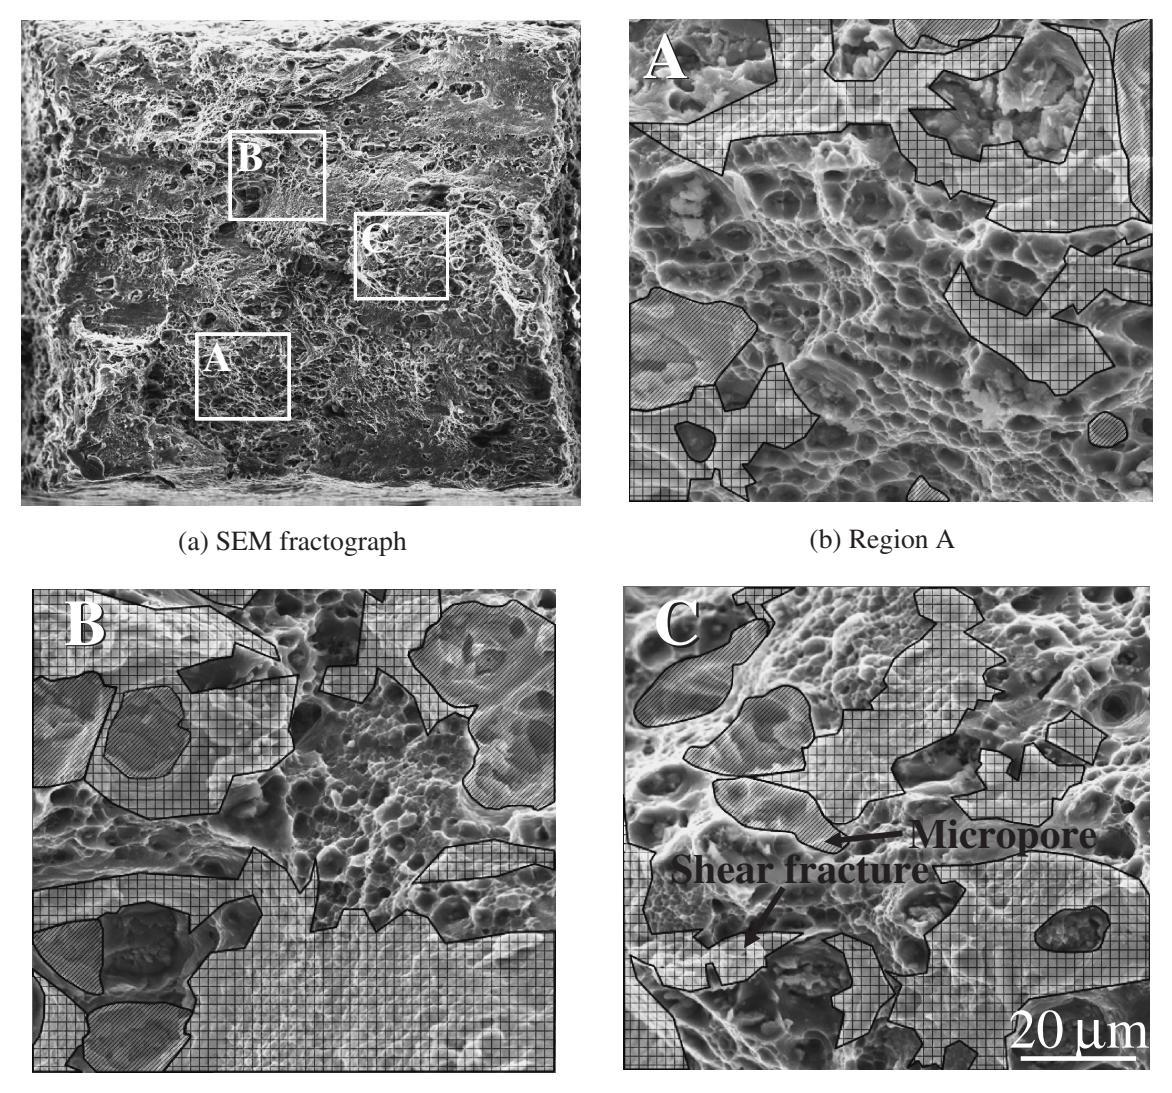
Fig. 6 (a) SEM fractograph and (b)-(d) magnified images where tomographic analysis was applied. Regions highlighted in hatched represent dimple patterns originating from micropore.

Figure 6(a) is an SEM image of a fracture surface and Fig. 6(b), (c) and (d) are magnified views of Fig. 6(a) on which hatched regions were identified as dimple patterns originating from the pre-existing hydrogen micropores. Areal

fractions of the dimple patterns originating from the preexisting hydrogen micropores are 7.7, 28.2 and 16.6% for the regions shown in Fig. 6(b), (c) and (d), respectively. Therefore it can be concluded that at least in some cases hydrogen micropores make contributions to ordinary ductile fracture that cannot be disregarded. It is noteworthy that the dimple patterns originating from the pre-existing hydrogen micropores appear to be coarse compared to those originating from damage initiation during loading. Figure 7 demonstrates the contribution of a hydrogen micropore on the formation of the fracture surface on virtual tomographic slices. It is obvious that the relatively coarse micropore was nucleated onto the coarse particle and that the micropore grew in both the loading and transverse directions, especially elongating in the loading direction. The coarse micropore has been left at the bottom of the dimple.

Local image analysis for the three regions shown in Fig. 6(b), (c) and (d) was performed and the result is summarized in Table 2. Cubic regions of $100 \times 100 \times 100 \times 100 \,\mu$ m were identified with the fracture surfaces as their vertical center in the 3D image captured before loading. In

the region with the highest micropore contribution, which is shown in Fig. 6(c), local volume fraction of micropore and number density were relatively high compared with the other regions, while no remarkable difference was observed in mean and maximum micropore size. It can be inferred that the agglomeration of hydrogen micropores might cause significant affects on mechanical properties.

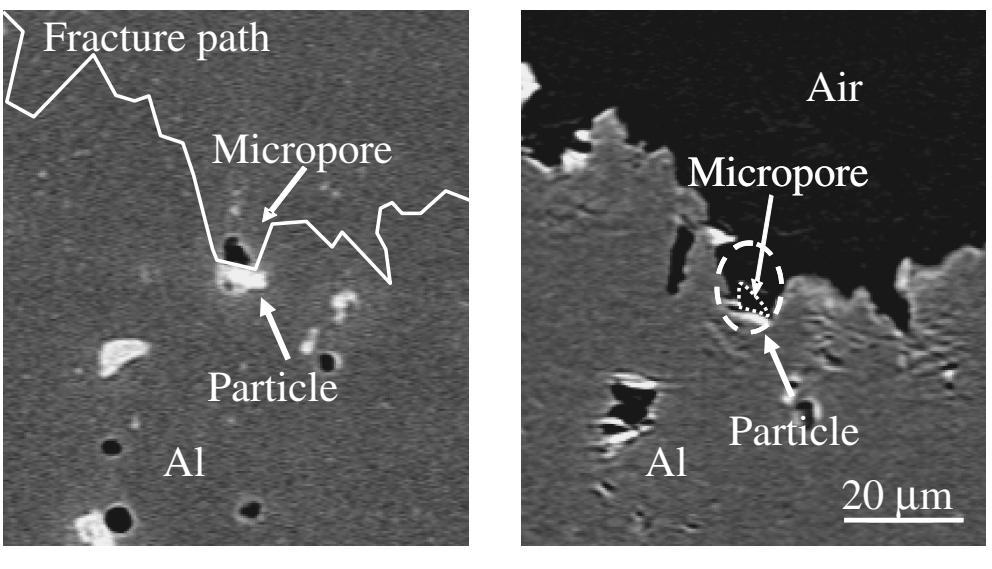
Fig. 7 Tomographic slices representing micro-pores heterogeneously nucleated on a particle where a crack passed during fracture.
