REPAIR STRATEGY OF REINFORCED CONCRETE BEAMS DAMAGED BY CHLORIDE-INDUCED CORROSION

Khalilah binti Kamarulzaman*, Pinta Astuti*, Rahmita Sari Rafdinal**, Hidenori Hamada*, Yasutaka Sagawa*, Daisuke Yamamoto* (*Department of Civil and Structural Engineering, Kyushu University; **P.S. Mitsubishi Construction Co. Ltd.)

<u>OBJECTIVE</u> : to determine repair strategy of severely damaged RC beam due to chloride-induced corrosion in order to extend the life time until about 70 years

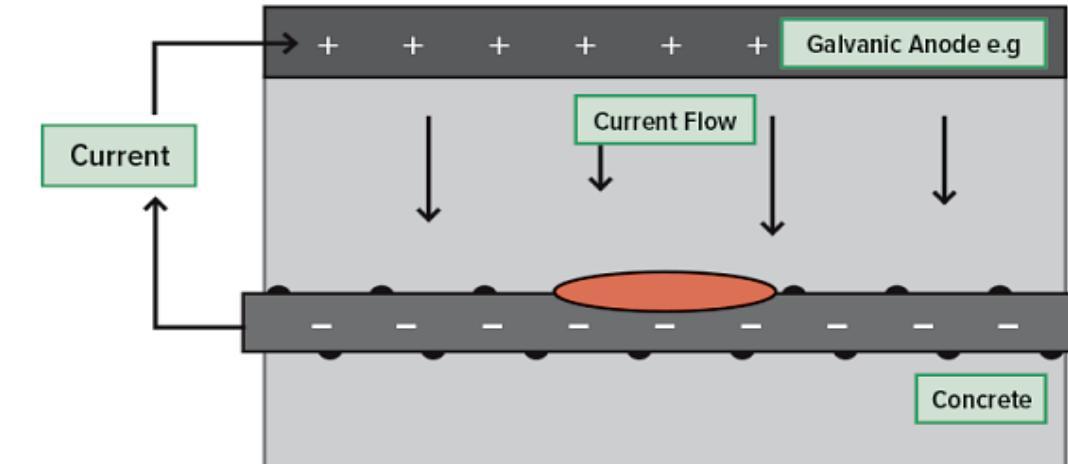
Application of Sacrificial Anode Cathodic Protection (SACP)

Simple method of protection connects the metal to be protected to a more easily corroded to act as the anode.

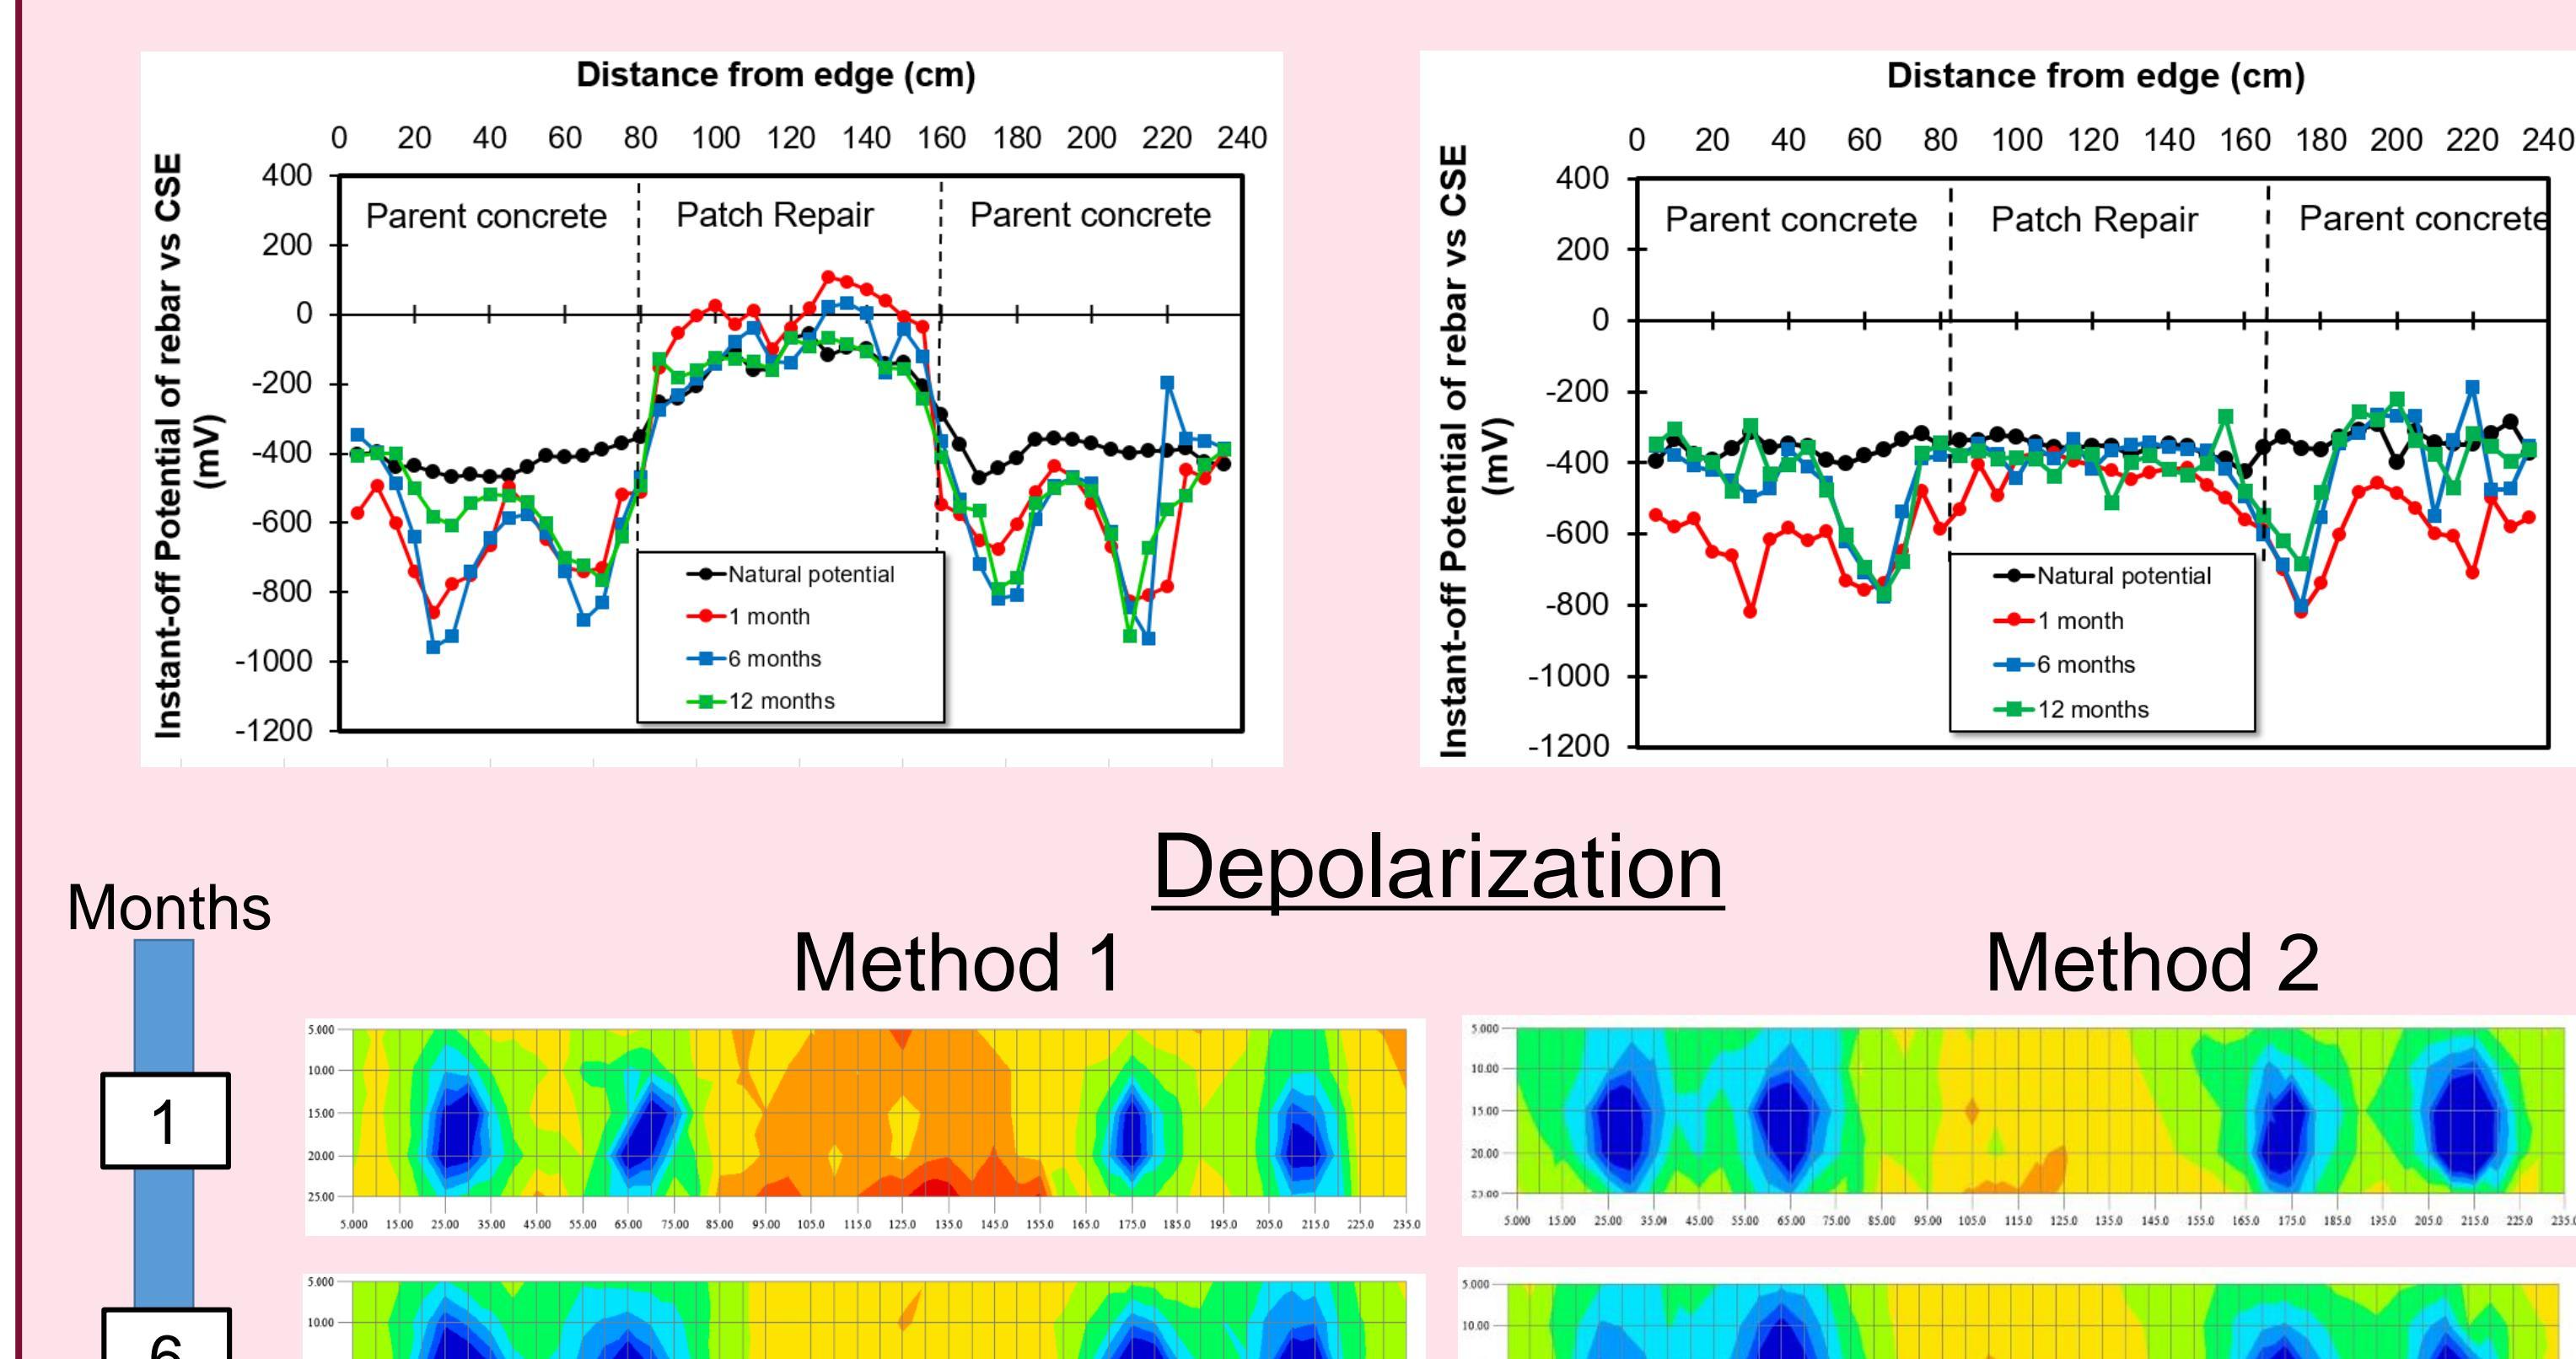
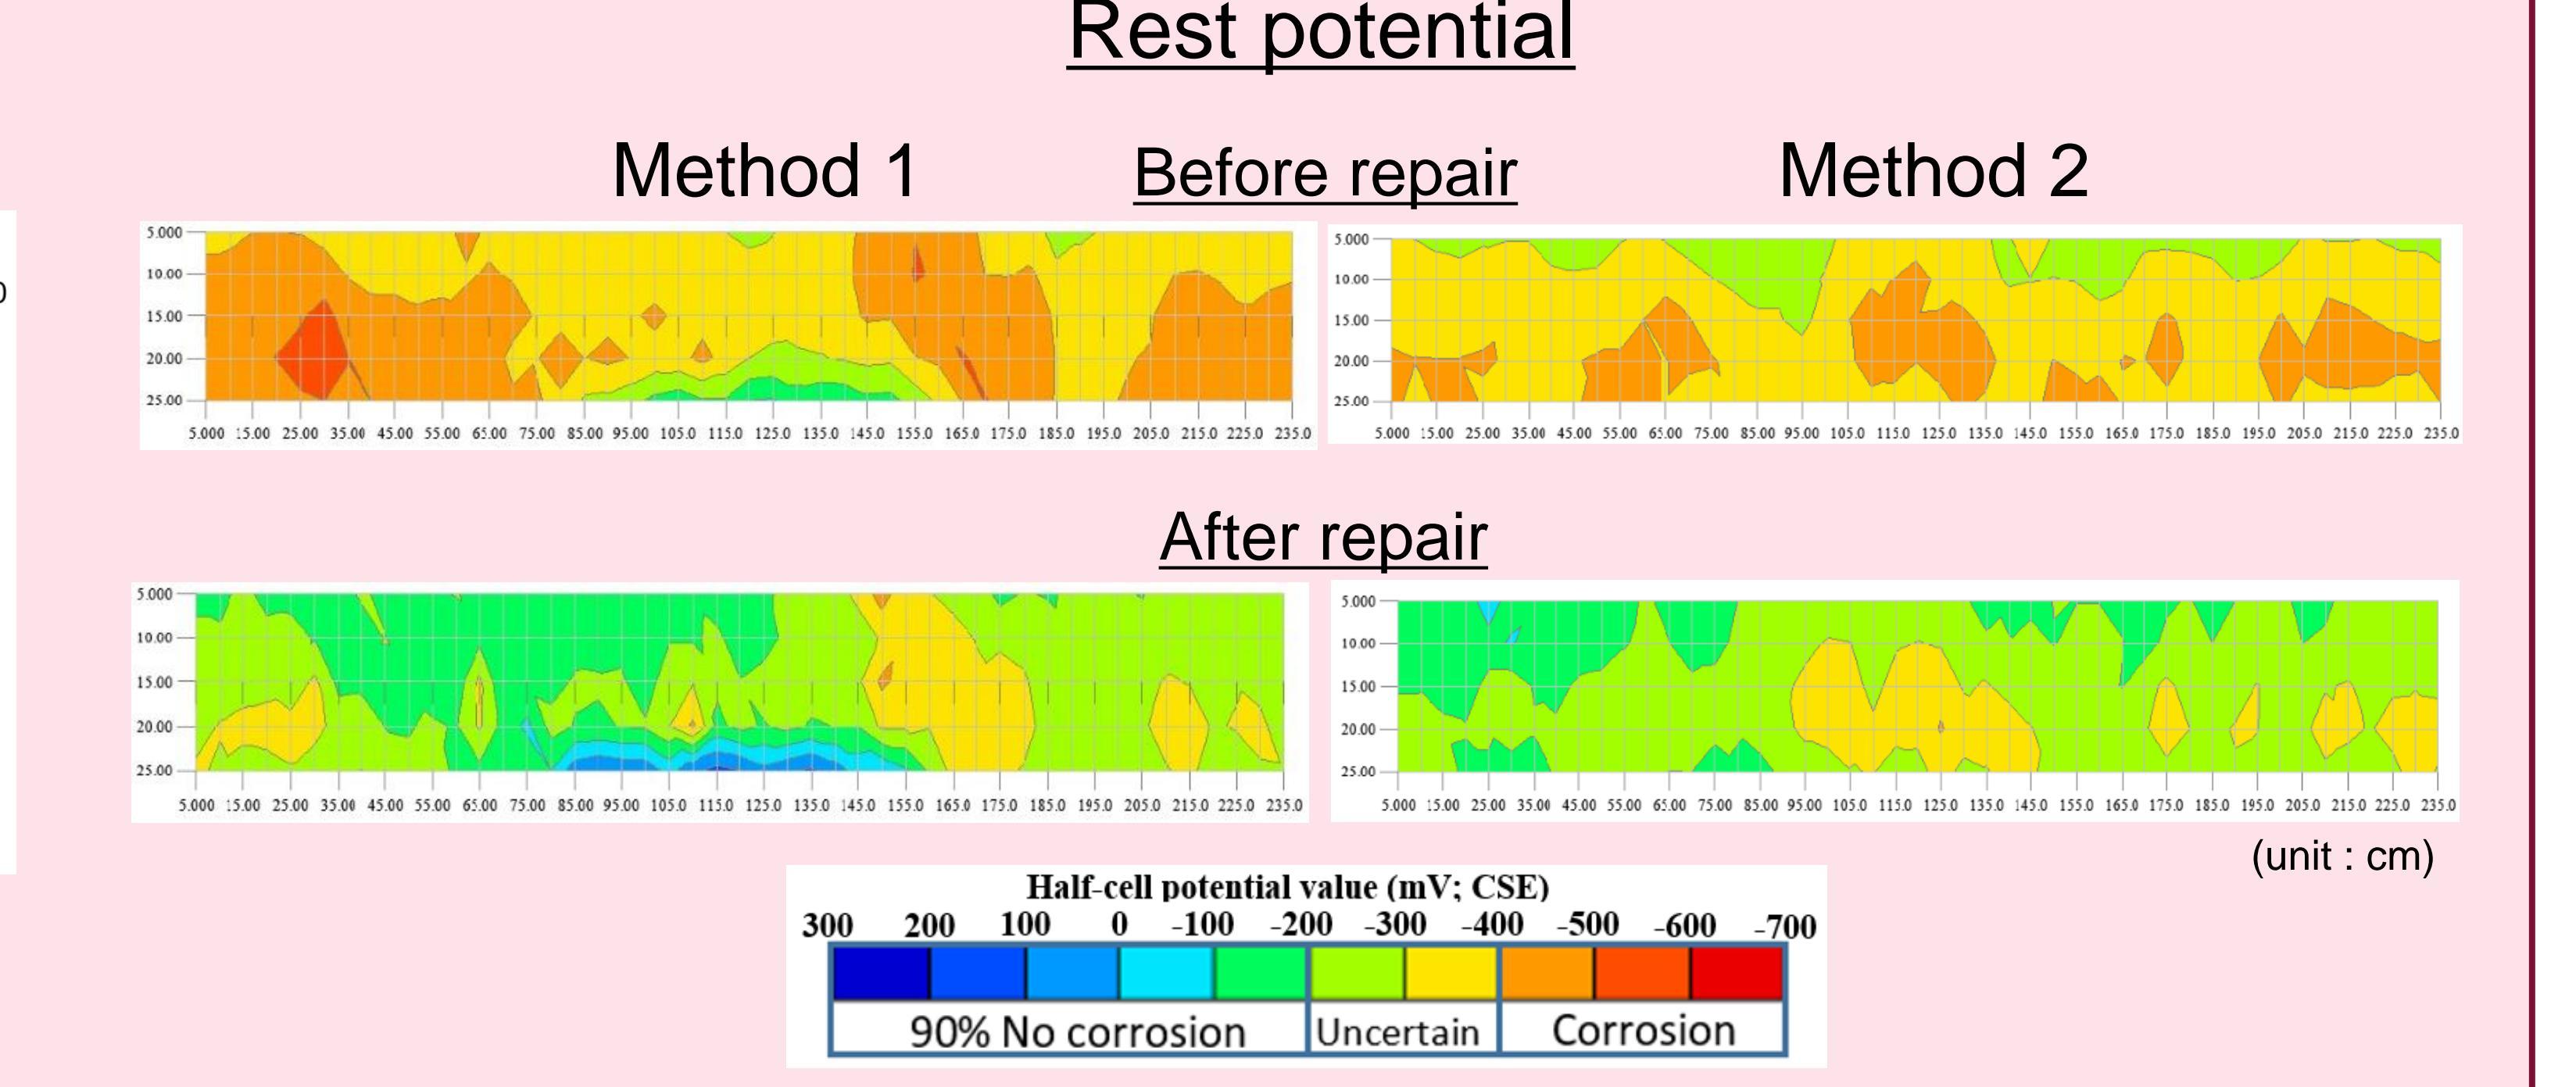
- In patch repair section, corrosion inhibitor prevented further corrosion of rebar, while SACP improved the condition of rebar.
- Overall, rebar in both specimens improved after 12-months of application.

- After 12 months of observation, result shows that both repair methods are capable to control corrosion on rebar surface.
- Even for deteriorated structures with such critical condition, its service life is still able to be extended when repair method is applied.

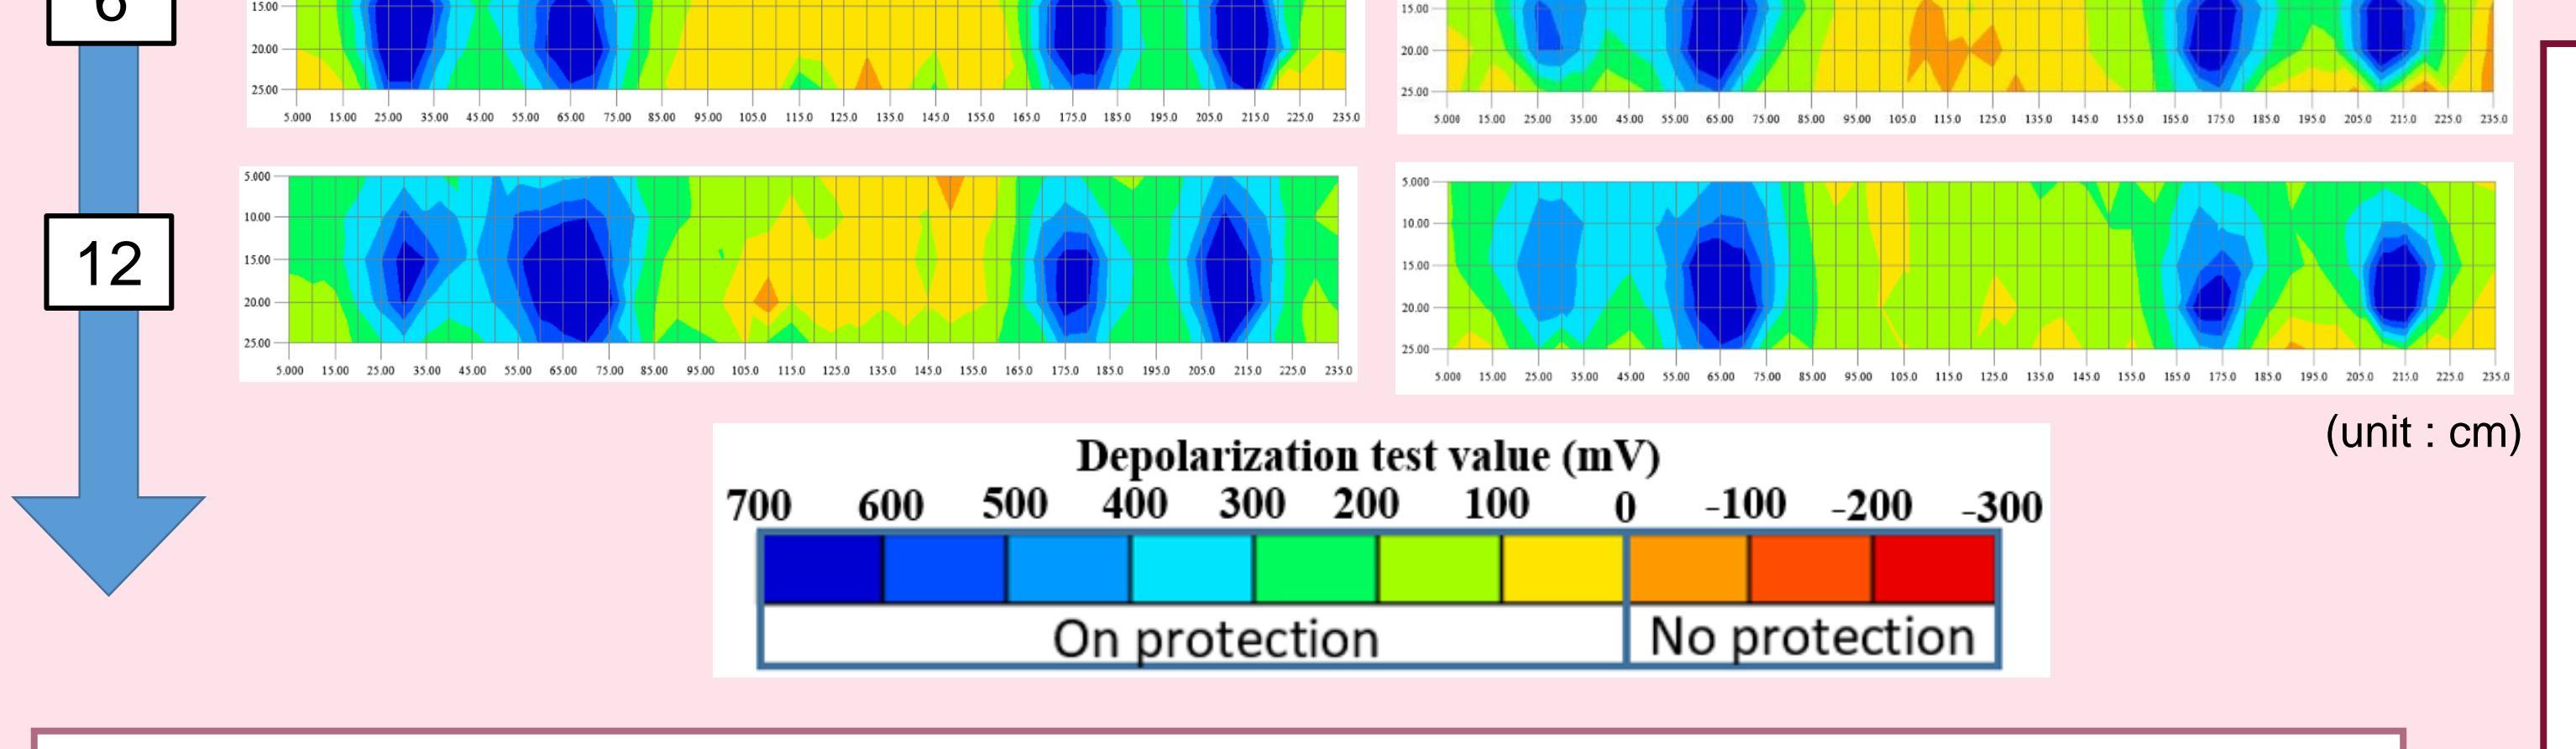
Effect of SACP focuses on surrounding of the anodes during early stage, however, it spreads throughout the beam.
