Light-weight Impact Sound Evaluation of CLT Wooden Building Floors

This study evaluated the lightweight impact sound of CLT (Cross Laminated Timber) made of plywood and square timber produced from domestic small–diameter larch wood. According to KS F 2810–1, the light–weight impact sound blocking performance of the CLT was evaluated by excitation with a tapping machine on the second floor and sound collection with a microphone from the lower floor. As a result, the light impact sound was 85 dB. The light impact sound blocking performance was poor, and additional studies are needed to improve the lightweight impact sound of CLT.

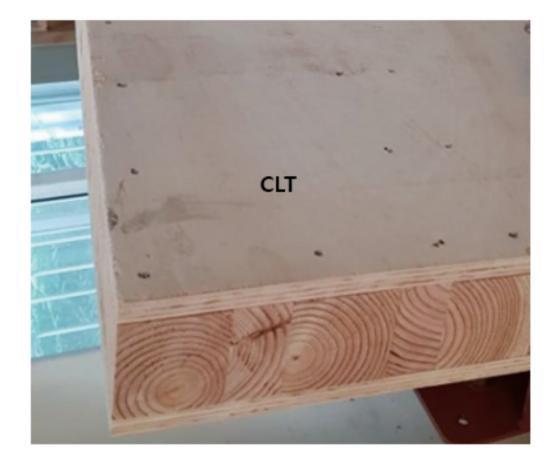
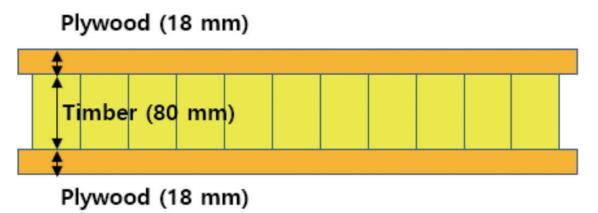
Fig. 1. Schematic diagram of CLT.

Larch logs with a diameter of 120 mm to 150 mm were sawn and dried, and the cross-section was made of a square material of 80 mm \times 80 mm. This square timber was bonded to the sides with an acetylated vinylbased adhesive to form a 1,200 mm \times 2,400 mm panel used as the core of the CLT wall panel. CLT wall panels were then fabricated using 18 mm thick structural plywood panels measuring 1,200 mm \times 2,400 mm as cross bands covering the surface and back of a small square wood core. A side view of the CLT panel used in this study is shown in Fig. 1. The average apparent density and moisture content of the CLT specimens were 0.5 g/ cm³ and 8%, respectively. Then, as shown in Fig. 2, a simple wooden building was manufactured to measure light impact sound, and CLT was installed.

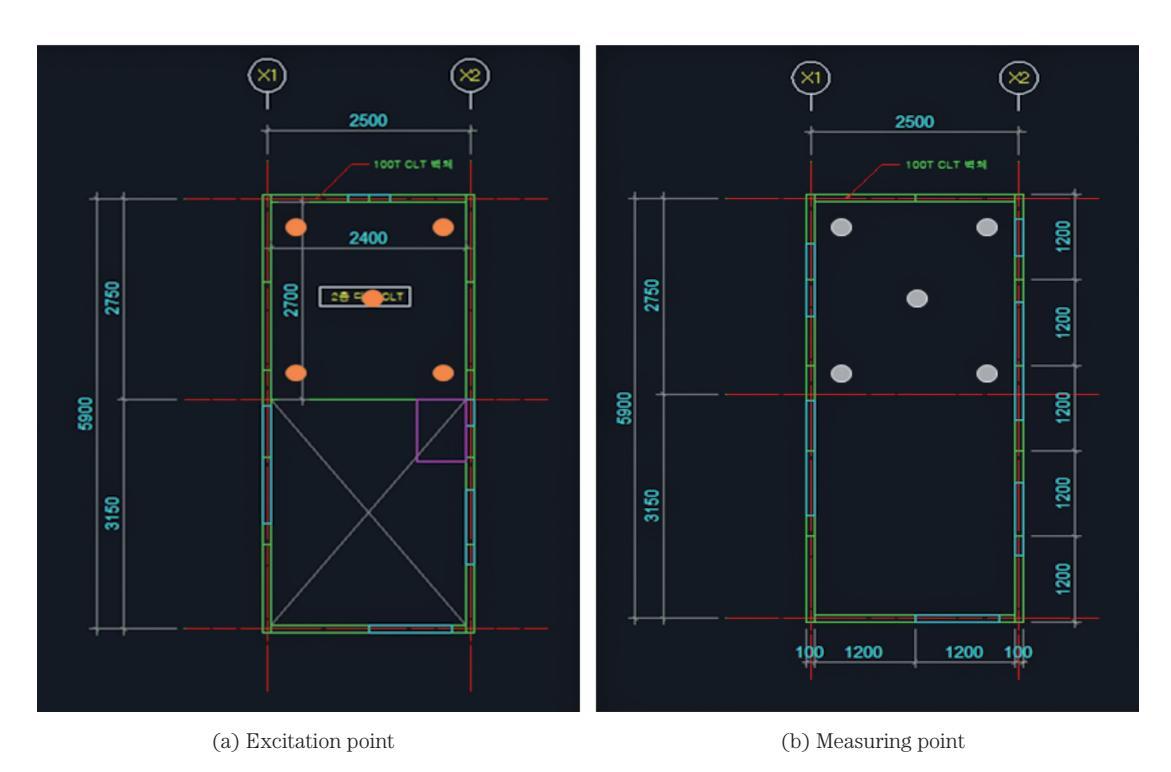
Fig. 3. Locations of excitation and measurement points.

In this study, after excluding the effect of background noise as much as possible, the evaluation of inter-floor noise by light impact sound was performed. Table 3 shows the results of light impact sound measured with microphones at five locations on the first floor after excitation of the second floor of the simple structure with a light impact sound device.
