Distribution of Houses Determined by Geomorphology, Landslides and People's Perception in Nallu Khola Watershed, Nepal

出版情報：九州大学大学院農学研究院紀要. 44 (3/4), pp.431-443, 2000-02. Kyushu University
バージョン：
権利関係：

Jagannath Joshi and Hiroshi Omura

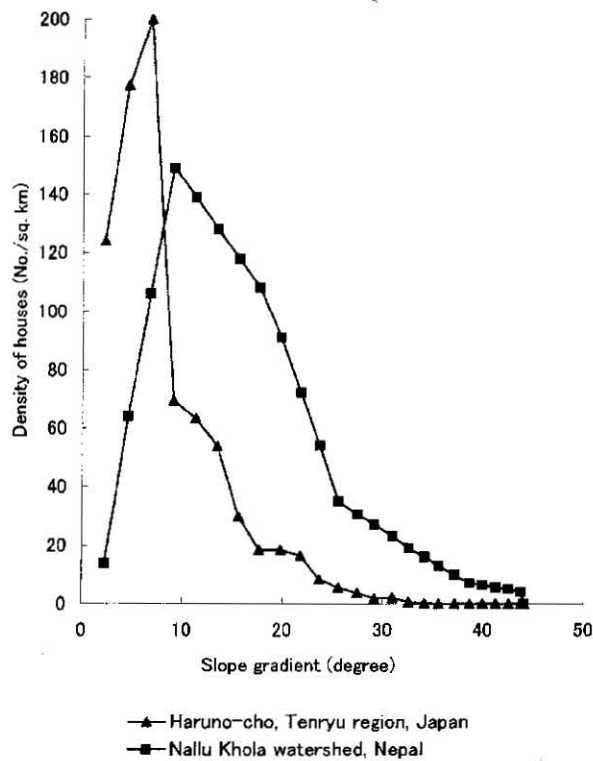
Fig. 4. Relationship between slope gradient and density of houses in Haruno-cho, Tenryu region, Japan and Nallu Khola watershed Nepal.

that have flooding or debris flow potentiality. Highest d_h is around 10° slope gradient, then decreases with the increase in slope gradient and becomes zero at 45° in Nallu Khola watershed. Relationship between slope gradient and density of houses in Haruno-cho, Tenryu region of Japan shows the similar trend (Omura 1978). But, more houses are distributed in steeper slopes in Nallu Khola watershed than Tenryu region. Figure 5 shows that d_h is highest where relief is 20 meters. This is the same area, which has about 10° slope gradient. Density of houses is highest where drainage frequency is zero and it decreases with increase in drainage frequency (Figure 6). It implies that people have a tendency to avoid gullied areas for residence as far as possible. Evidently, gullied areas are unstable. Distribution of houses with respect to elevation shows that highest percentage of house is located between 1800–1900 m (Figure 7), but d_h is highest between 1700–1800 m (Figure 8). This is mainly due to a link road, major part of which is constructed between 1700–1900 m. Since accessibility below 1700 m and above 1900 m is difficult due to lack of branch road, people have constructed many houses on both sides of link road for their convenience after its construction. From these relationships it can be inferred that the most preferred place for residence in the study area is a gently sloping land, having relief around 20 m, elevation between 1700–1800 m and least dissected by the drainage which is stable and convenient. Since, such stable as well as convenient areas are limited and population is ever increasing, people have constructed houses in such places where slope gradient is up to 44° , relief is up to 120 m and drainage frequency is up to 4 (no./cell).

Density of houses in relation to slope gradient is shown in Figure 4. Density of houses is relatively lower in almost flat area because such areas are mostly along the streamside

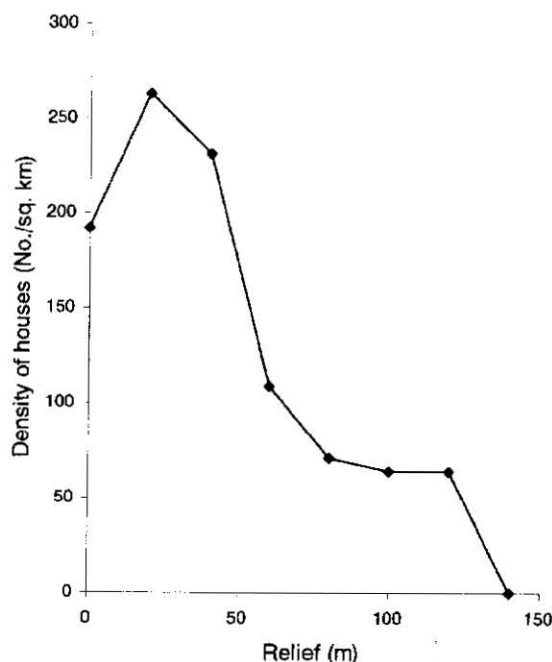
Fig. 5. Relationship between relief and density of houses in Nallu Khola watershed, Nepal.

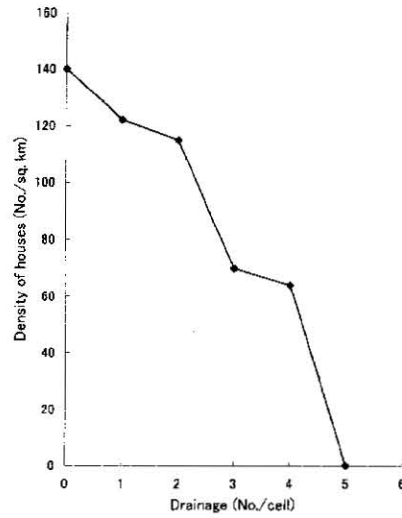
Fig. 6. Relationship between drainage frequency and density of houses in Nallu Khola watershed, Nepal.

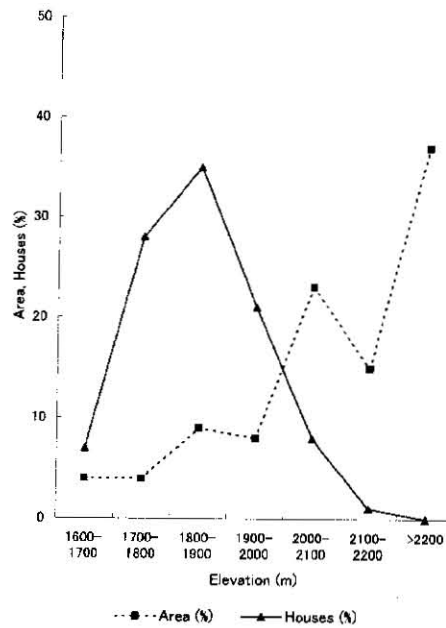
Fig. 7. Number of houses with respect to elevation in Nallu Khola watershed.

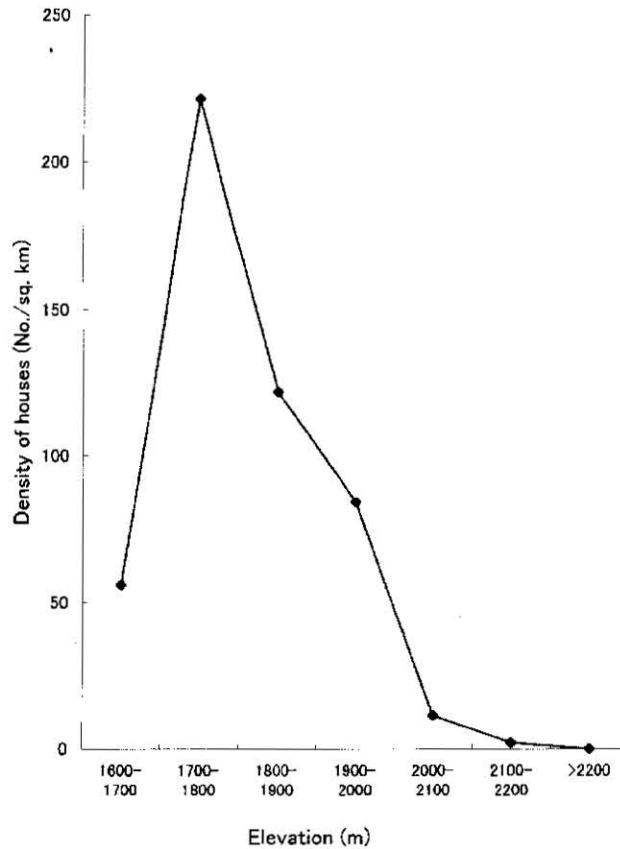
Fig. 8. Density of houses with respect to elevation in Nallu Khola watershed.

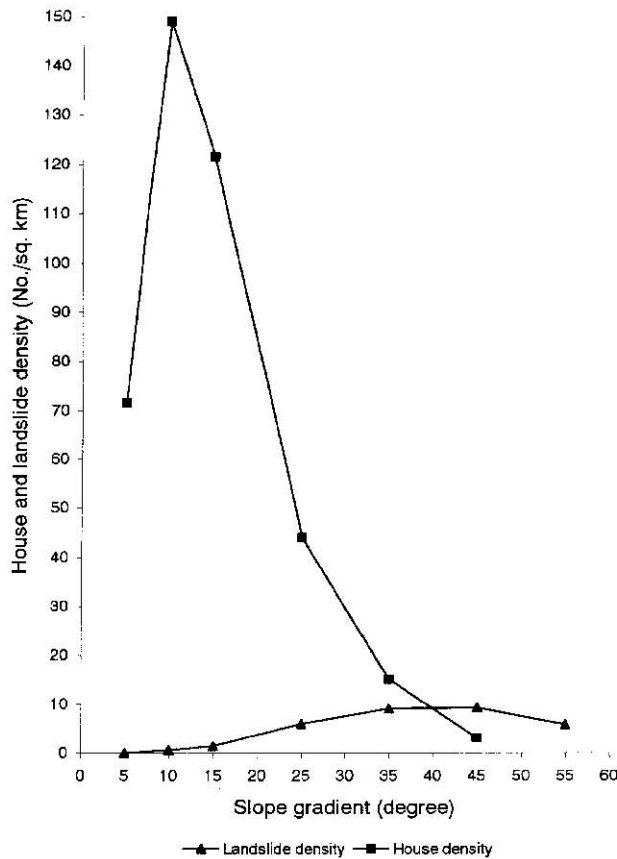
As shown in Figure 9, density of houses is highest where landslide density is lowest. It implies that majority of the people have avoided high landslide hazard areas for residence. However, there are some houses above 30° slope gradient, which is either high landslide hazard area or steep rock slope. It has been reported that the natural hill slopes with gradient between 30° and 40° are found to be most critical for failure in Nepal (Dikshit 1994, Joshi 1999). There are about 20% houses between 30° and 40° slope gradient, in Nallu Khola watershed. This is further supported by the landslide hazard map of the watershed, which shows 20% houses are constructed in dangerous locations that have been categorized as high hazard areas (Joshi, 1999). It means 101.8 houses are located in unstable areas. If a landslide or debris flow hits one house, 7.9 people will have potentiality of damage or may lose their life in an extreme case. In spite of such critical conditions, people are living there with their own perception of natural phenomena and

Fig. 9. Densities of houses and landslides with respect to slope gradient in Nallu Khola watershed.
