Research Article

Vertical Shaft Support Improvement Studies by Strata Grouting at Aquifer Zone

The shaft lining failure which occurs in deep alluvium is a sudden coal mine hazard. The strata grouting is one of the treatment methods for the shaft lining failure. To investigate the impact of grout injection pressure on the shaft lining, the field measurement and the numerical analysis of the shaft lining stress variation during the grouting were conducted. To improve the strata grouting, the underground continuous impervious curtain (UCIC) is proposed as a new method by using the chain conveyor cutter technique without the impact on the shaft lining. The effects of the new method were also analyzed by means of the numerical methods. The results show that the strata grouting in the deep alluvium needs a high injection pressure, and in the horizontal direction, the shaft lining sustains the repeat tensile and compressive force during the grouting process. The negative influence of strata grouting on the stability of the shaft lining is obvious and serious. The UCIC built around the shaft lining can restrain the stress concentration induced by the aquifer drawdown. The triangular UCIC

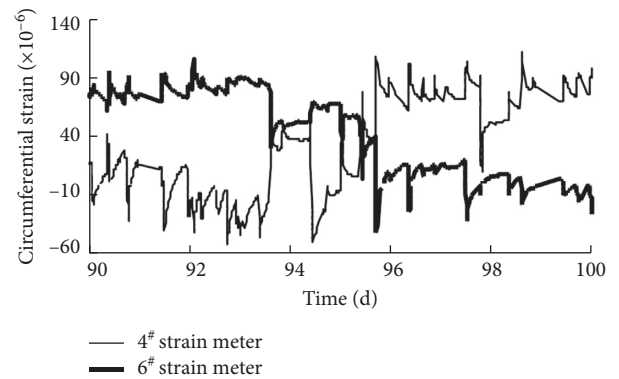
FIGURE 4: Circumferential strain curves during alternately grouting at the third measuring level [27].

Figure 4 shows the horizontal circumferential strain curves of the measuring points during alternately grouting in –129 to –131 m depths (Z5 and Z7). From the curves obtained, when grouting was conducted in Z5, the strain meter 4[#] had the relative tensile strain at the third measuring level, and the other side strain meter 6[#] at the third measuring level had the relative compressive strain. On the other hand, when grouting was conducted in Z7, the relative tensile strain was measured in strain meter 6[#] and relative compressive strain was measured in strain meter 4[#].

Two tensile zones and two compressive zones were observed in the inner margin. Two tensile zones were generated at neighborhood and remote area of the grouting hole. The central angle of the compression zone or tensile zone was about 90°. From the results, it can be concluded that the shaft lining would bear the overload nonuniform horizontal stress by the improper selecting of grouting
