Vertical Shaft Support Improvement Studies by Strata Grouting at Aquifer Zone

The shaft lining failure which occurs in deep alluvium is a sudden coal mine hazard. The strata grouting is one of the treatment methods for the shaft lining failure. To investigate the impact of grout injection pressure on the shaft lining, the field measurement and the numerical analysis of the shaft lining stress variation during the grouting were conducted. To improve the strata grouting, the underground continuous impervious curtain (UCIC) is proposed as a new method by using the chain conveyor cutter technique without the impact on the shaft lining. The effects of the new method were also analyzed by means of the numerical methods. The results show that the strata grouting in the deep alluvium needs a high injection pressure, and in the horizontal direction, the shaft lining sustains the repeat tensile and compressive force during the grouting process. The negative influence of strata grouting on the stability of the shaft lining is obvious and serious. The UCIC built around the shaft lining can restrain the stress concentration induced by the aquifer drawdown. The triangular UCIC has a similar eff

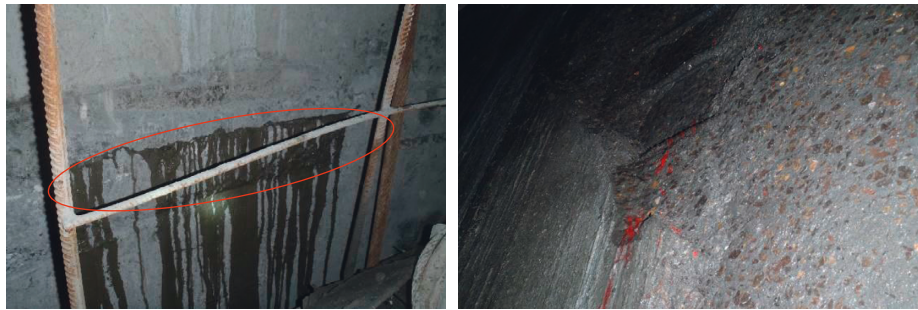
FIGURE 2: Leakage and failure during the grouting.

The strata grouting in deep alluvium needs a high injection pressure. In the aquifer, the water pressure is high due to the confined aquifer, and the injection pressure needs to be higher than the water pressure. So, the risk of shaft lining failure is raised due to the influence of the injection pressure on the shaft lining. Though the strata grouting has the functions to restrain and release the additional vertical stress, it may cause the damage to the shaft lining inversely. In some cases, due to the improper control of the injection pressure and the uncertain distribution of the fracture, the leakage of grouting material or even more the failure would occur in the shaft lining (Figure 2). Therefore, the impact of grout injection pressure on the shaft lining needs to be investigated.
