Development of Improved Loop Joint Applied for Precast PC Deck Slab

Technical report

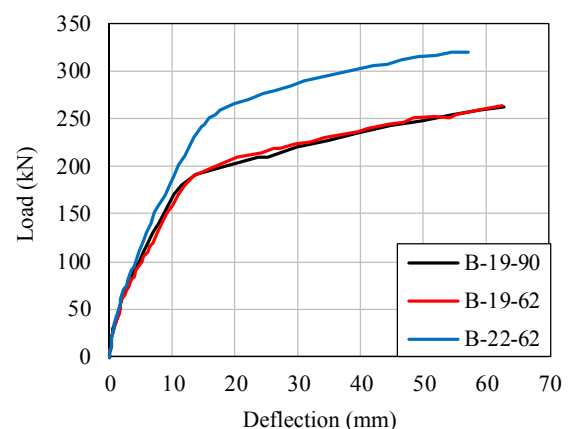
Fig. 8 Load versus midspan deflection.

The load versus mid-span deflection of each specimen is shown in Fig. 8. Table 3 shows the results of the theoretical calculation and the experiment. The difference in

the three points of LVDTs in the transverse direction is less than 1 mm in every specimen; hence, the plotted values represent the average values of the three points. In addition, the cracking and yielding loads are calculated using the elastic theory of RC, and the ultimate load is calculated using the equivalent stress block. In all the specimens, the fracture was due to tensile failure, in which the upper surface of the concrete was crushed after the tensile reinforcing bar was yielded. A comparison of the specimens AN and A-19-90 of Series A indicated that the behavior of each specimen was the same under all loads. Hence, it can be said that the loop joint is an effective joint for reinforcing bar connections. It was observed that A-19-90 and A-19-75 exhibit similar behavior until cracks occur. However, A-19-75 shows a slightly larger displacement at the same load than A-19-90. This is because the effective depth of A-19-75 is 5 mm lower than that of A-19-90, and which is not due to the influence of the inclination. In A-19-60, the load-carrying behavior is the best of all specimens in Series A, as shown in **Table 3**. Although the effective depth of A-19-60 is lower than that of A-19-90, the amount of reinforcing bar of A-19-60 is greater than that of A-19-90. However, the deflection of A-19-45 is significantly larger than those of the other specimens. This is because the beam thickness of A-19-45 is the smallest among all the specimens, which causes a significant decrease in flexural rigidity. Focusing on the theoretical and experimental results for the ultimate load shown in **Table 3**, the results suggest that the loop joint inclined up to 45° still maintains the required performance as a joint system.

In Series B, the load-carrying behavior was the same as in Series A. From the test results, it was observed that B-19-90 and B-19-62 exhibited similar behavior in every load step; thus, it can be inferred that the inclination of the loop reinforcing bar does not affect the structure of the joint until 62°. Additionally, the behavior of B-22-62 is similar to the other specimens, and the experimental and calculated values are approximately the same. However, for the same effective depth of the loop reinforcing bar, the influence of the inclination of the loop rebar was not confirmed.

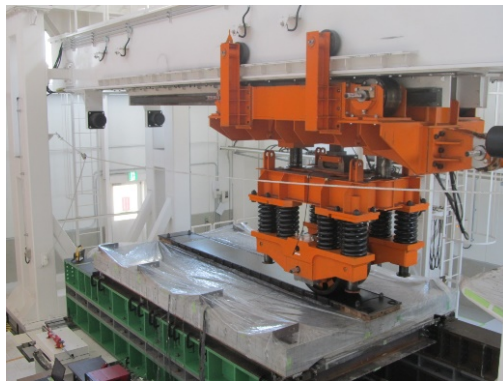
Fig. 13 Wheel moving load test machine.

The test was conducted using a wheel moving load test machine, as shown in **Fig. 13**. The iron wheel of the test machine has a diameter of 0.7 m and a width of 0.5 m. It operates in reciprocating motion. The maximum load during running of the iron wheel is 490 kN. The maximum reciprocation speed is 15 reciprocations per minute, and the test is performed at a speed of 10–15 reciprocations per minute.

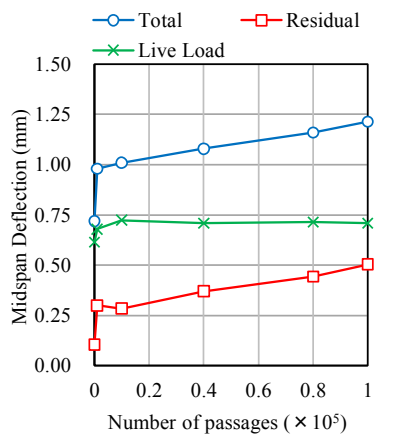
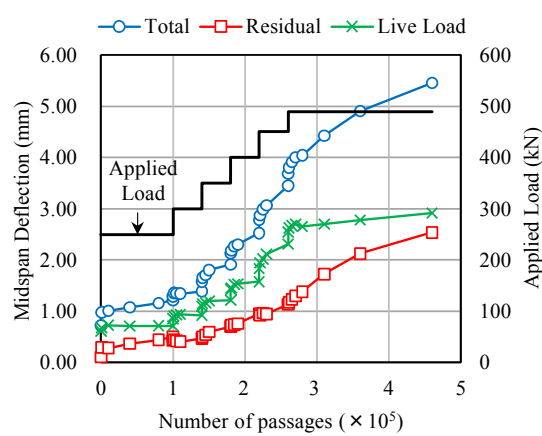
Fig. 16 Changes of mid-span deflection.

Figure 16 shows the changes in deflection at the center of the slab. Figure 16(a) shows the details of 250 kN \times 100 000 passages, which is equivalent to 100 years, and Fig. 16(b) shows the results of the total load steps. The live load deflection δ_{live} is calculated using Eq. (3) as:

where δ_{total} is the total deflection measured by the LVDT at the maximum load in each loading stage, and $\delta_{residual}$ is the residual deflection measured during unloading. The total and residual deflections gradually increased with an increase in loading. However, the deflection after the loading of 490 kN tended to increase more than before. By contrast, the live load deflection was almost constant

at all loading stages. A similar tendency was observed for the other LVDTs, and no drastic change was observed in the deflection due to the loop joint.

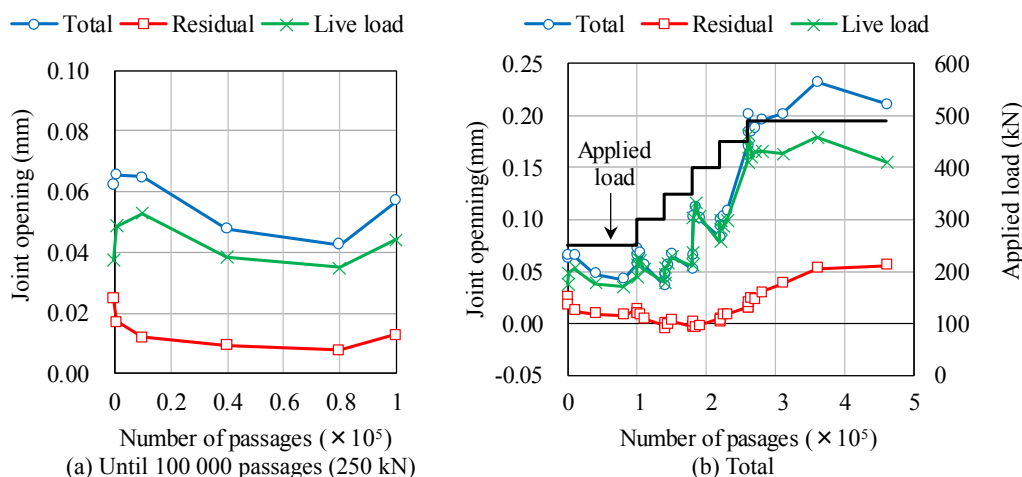
Fig. 18 Changes of joint opening between deck slab and in-situ part.

Figure 18 shows the changes in the joint opening between the PC deck slab and in situ part. The figure shows the values below the loading point, which is the largest value among all six locations. The legend color is the same as that shown in **Fig. 16**. As shown in **Fig. 18(b)**, the joint opening at each load stage fluctuated and did not show a constant value, unlike in the case of deflection. It can be inferred that a small level difference in the vertical direction occurred during each run owing to the impact of the wheel load. However, the fatigue durability of $250 \text{ kN} \times 100\,000$ passages that is equivalent to 100 years in **Fig. 18(a)** resulted in the largest joint opening of 0.07 mm, which was very small. No water leakage from the
