## Light-weight Impact Sound Evaluation of CLT Wooden Building Floors

This study evaluated the lightweight impact sound of CLT (Cross Laminated Timber) made of plywood and square timber produced from domestic small-diameter larch wood. According to KS F 2810-1, the light-weight impact sound blocking performance of the CLT was evaluated by excitation with a tapping machine on the second floor and sound collection with a microphone from the lower floor. As a result, the light impact sound was 85 dB. The light impact sound blocking performance was poor, and additional studies are needed to improve the lightweight impact sound of CLT.

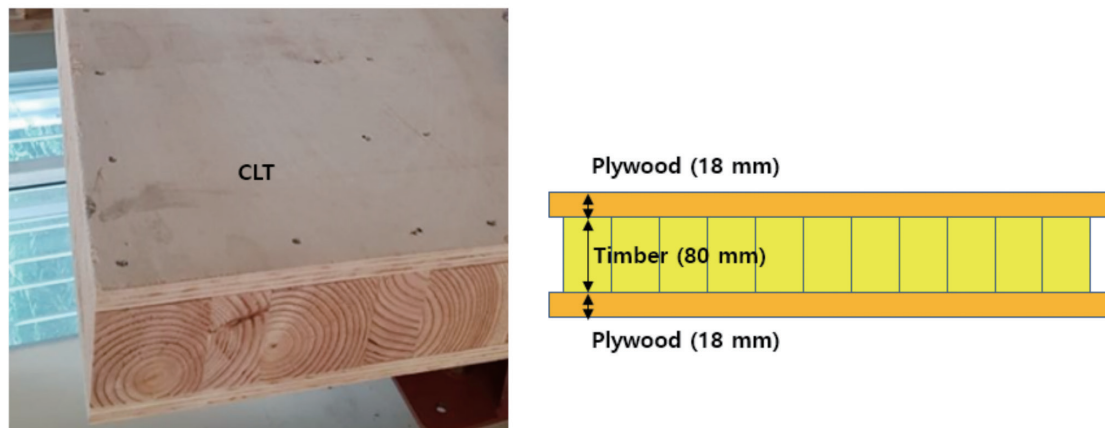
Fig. 1. Schematic diagram of CLT.

Larch logs with a diameter of 120 mm to 150 mm were sawn and dried, and the cross-section was made of a square material of 80 mm  $\times$  80 mm. This square timber was bonded to the sides with an acetylated vinyl-based adhesive to form a 1,200 mm  $\times$  2,400 mm panel used as the core of the CLT wall panel. CLT wall panels were then fabricated using 18 mm thick structural plywood panels measuring 1,200 mm  $\times$  2,400 mm as cross bands covering the surface and back of a small square wood core. A side view of the CLT panel used in this study is shown in Fig. 1. The average apparent density and moisture content of the CLT specimens were 0.5 g/cm<sup>3</sup> and 8%, respectively. Then, as shown in Fig. 2, a simple wooden building was manufactured to measure light impact sound, and CLT was installed.

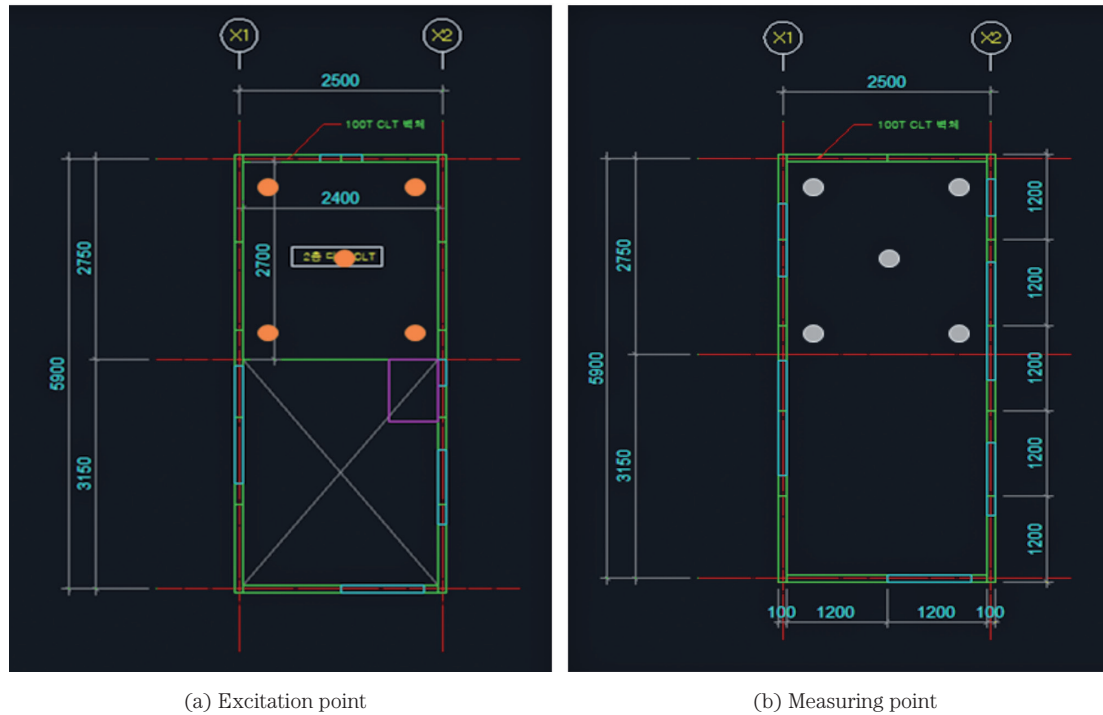
**Fig. 3.** Locations of excitation and measurement points.

Excitation points for light impact sound measurement were installed at a distance of 0.5 m from the peripheral wall by KS F 2810-1 (2015) and KS F 2810-2 (2012), including the central point (Fig. 3-a). The microphone locations for light impact sound measurement were five, including the central point, 0.5 m away from the peripheral wall of the room and installed at the height of 1.2 m from the floor (Fig. 3-b). Table 1 shows the analyzers used for noise analysis for this study.
